Stonehaven Bay Coastal Flood Protection Study

Geotechnical Desk Study Report

Final Report

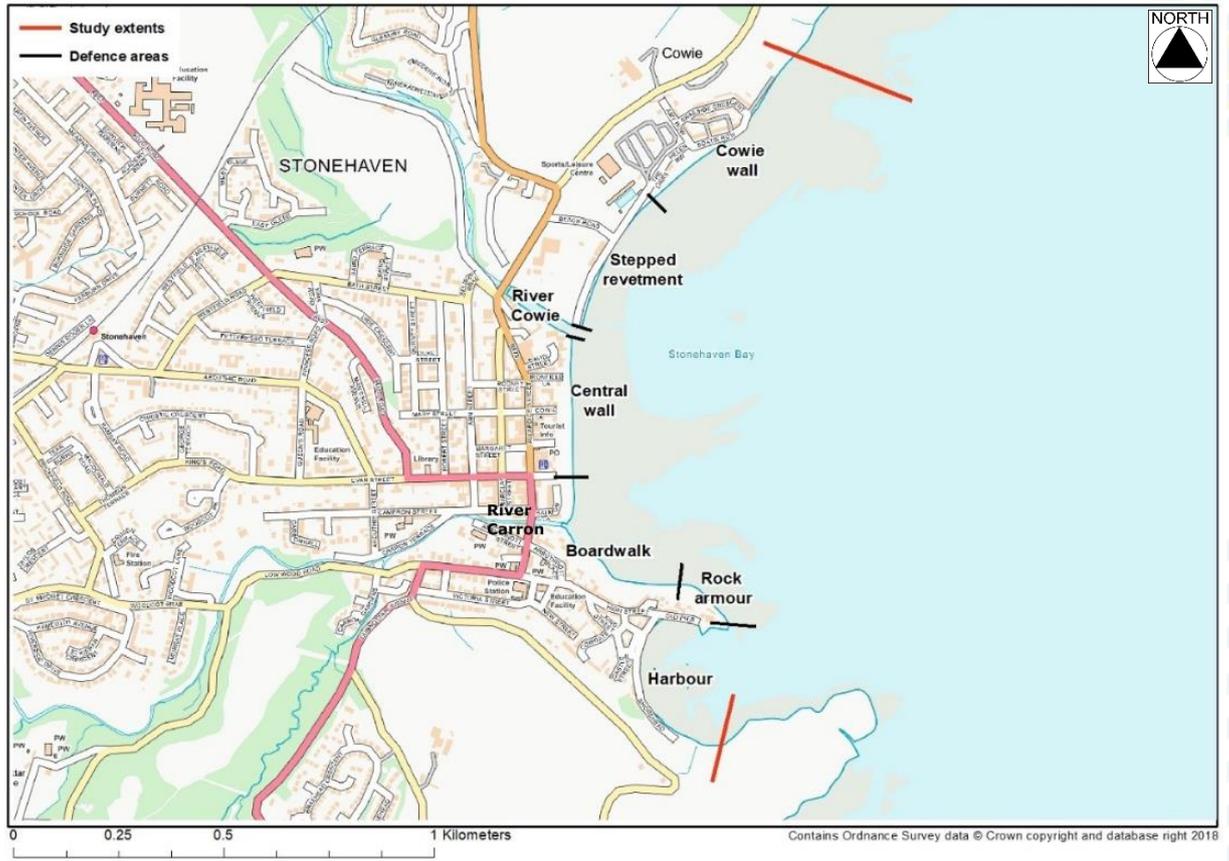
Figure 2-2: Subdivision of existing sea defences in Stonehaven Bay

The area is protected by existing sea defences along the Stonehaven and Cowie frontage. The general arrangement of the different defences within Stonehaven Bay is shown on Figure 2-2 below.

Each of these areas are summarised below, running from south to north.

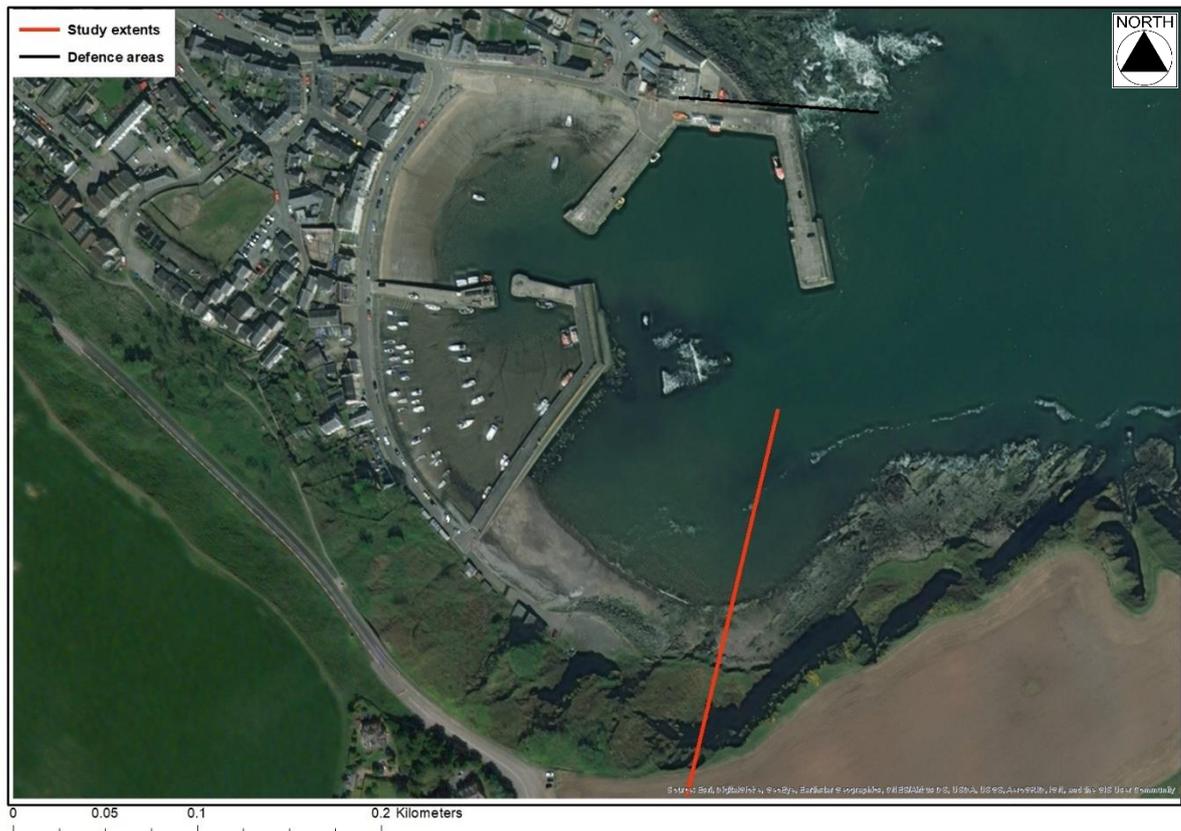
Figure 2-3: Aerial image of harbour area

The harbour area of the sea front is prone to flooding from a combination of high sea levels and the action of waves that can enter the harbour mouth and run along the walls of the inner basin. This area is extended from the red line to the black line, on the outer side of breakwater. A review of the historic flood records shows that the properties along Shorehead have flooded in the past as well as several near misses when sandbags have been deployed as a precaution.

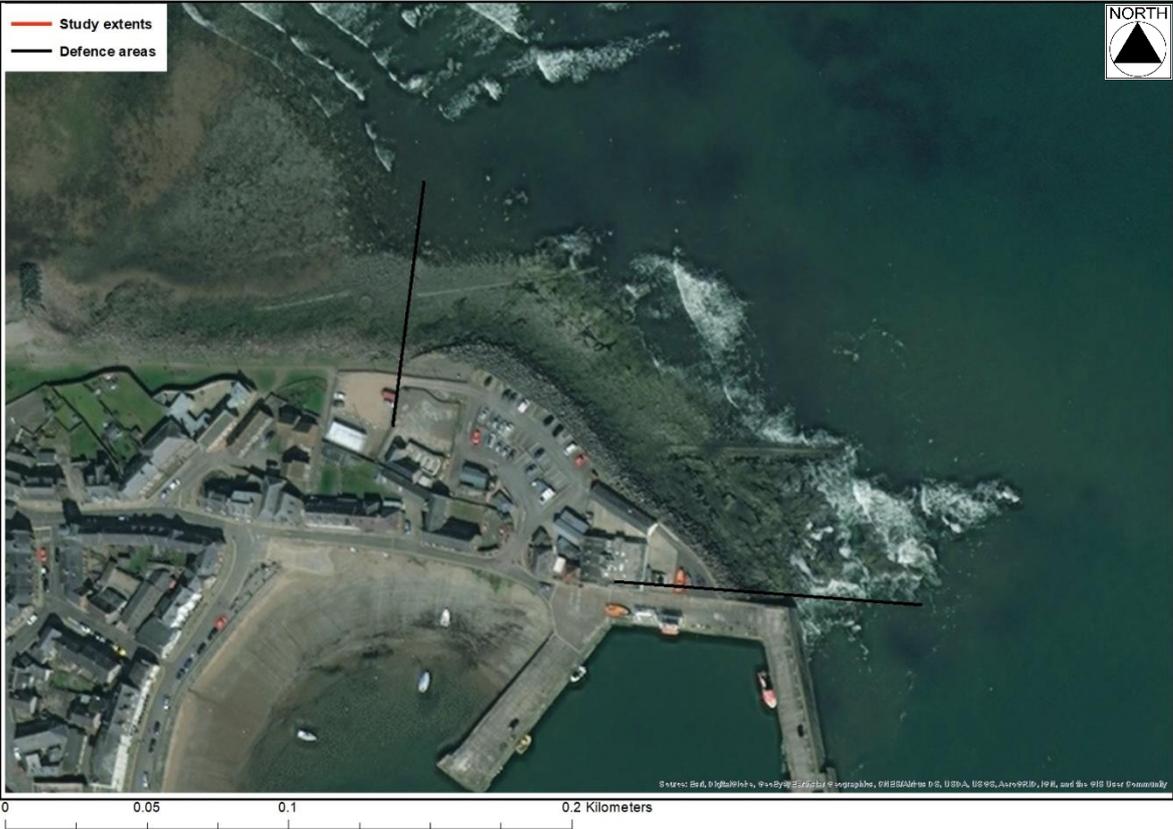
Figure 2-4: Aerial image of the rock armour section

To the north of the harbour is a public car park that is fronted by a substantial rock armour revetment. This is placed along the headland extending from the outer breakwater into the bay.

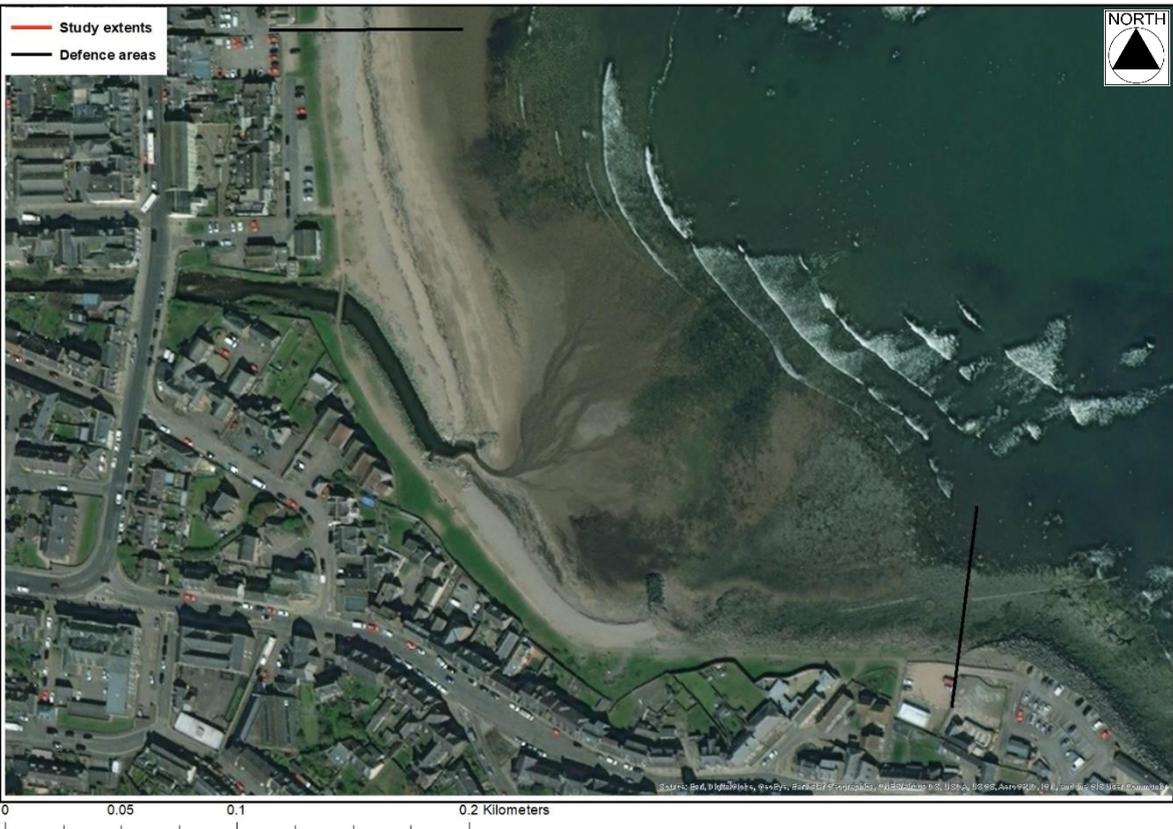
Figure 2-5: Aerial image of the boardwalk section

The boardwalk section is a mixture of shingle beach to the north and a rock armour structure to the south. The beach is understood to be prone to erosion and the timber walkway washed away during the Dec 2012 event. Shingle deposited in the mouth of the River Cowie to the north is periodically recycled and redeposited along the beach of the Boardwalk section as a coastal protection measure.

The section also includes the outfall of the River Carron; the mouth of which is trained by rock armour structures.

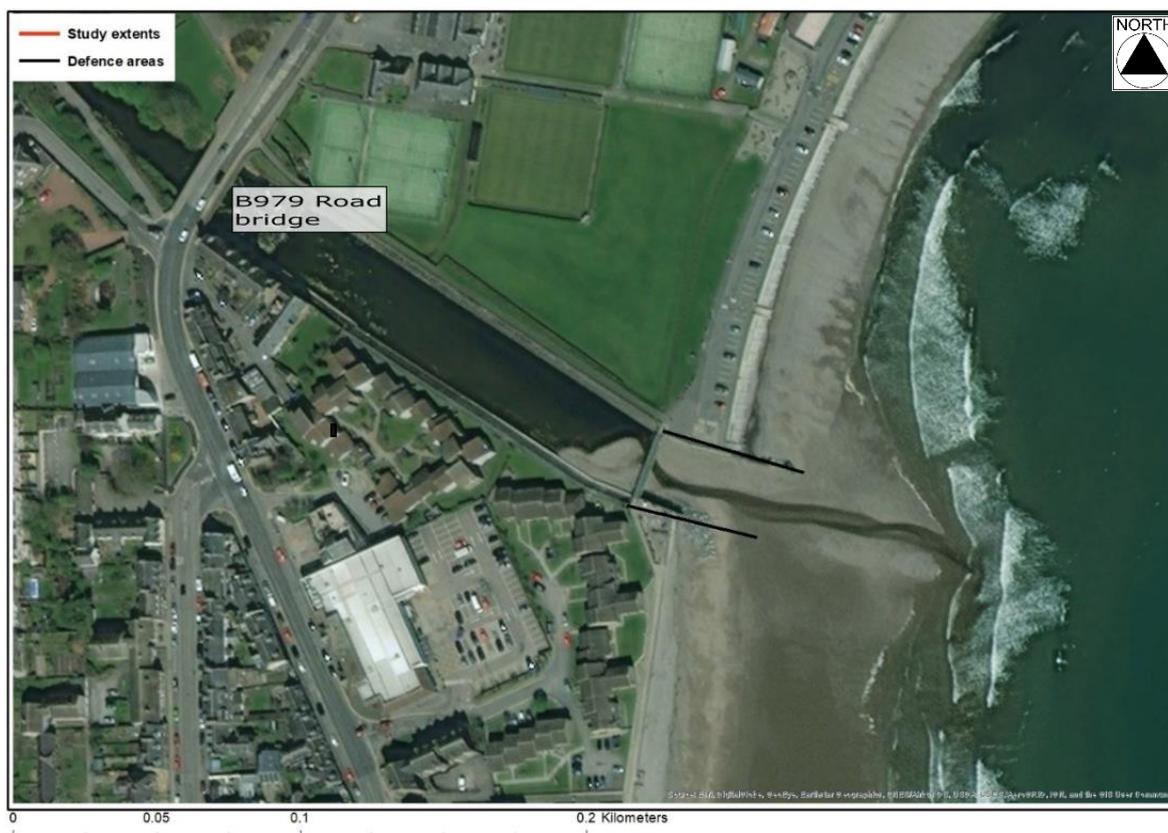
Figure 2-7: Aerial image of the River Cowie section

The River Cowie section consists of a combination of concrete walls, concrete revetments, and steel sheet piles. The defences extend from the mouth of the River to the B979 road bridge that is approximately 200m upstream. During storm events, waves can propagate into the mouth of the river and break on the weir beneath the B979 road bridge. The south bank of the river is also at risk from overtopping from oblique waves that enter the mouth and roll along the revetment. It is understood that the section of wall on the north bank has been undermined in the past and will likely require engineering works to stabilise it.

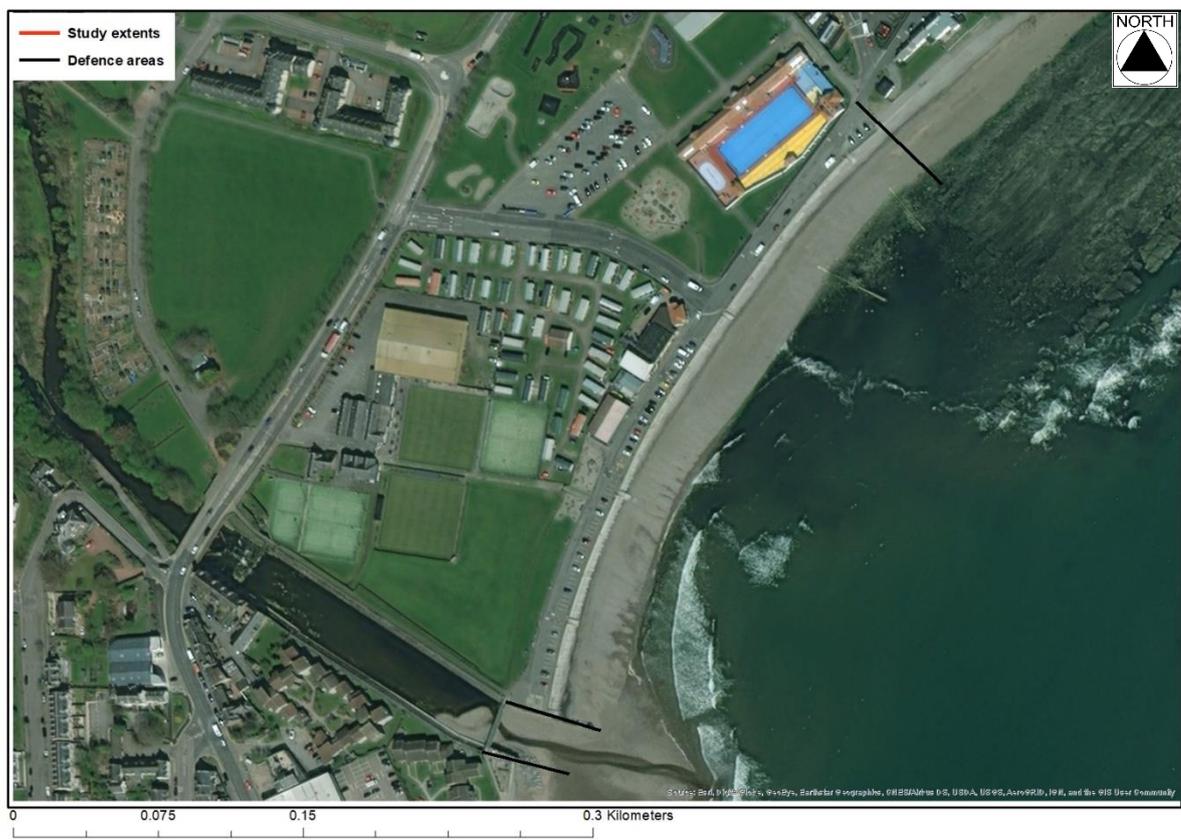
Figure 2-8: Aerial image of the stepped revetment section

The stepped revetment section forms the main coastal defence along Cowie promenade. It runs from the mouth of the River Cowie to the northern end of the open-air pool. It consists of a stepped concrete revetment with a wave return wall at the crest; a rock armour toe was added to the defence in 2006. There is also a short steel piled section at the north, in front of the parking spaces opposite the swimming pool. The sheet piles were recently undermined, with a sink hole opening up behind; this has been rectified, with concrete now backing the defence.

Over the years there has been significant damage to the structure from undermining and scour at the toe, as well as the high frequency of overtopping causing significant damage to the shorefront commercial properties due to the local topography.

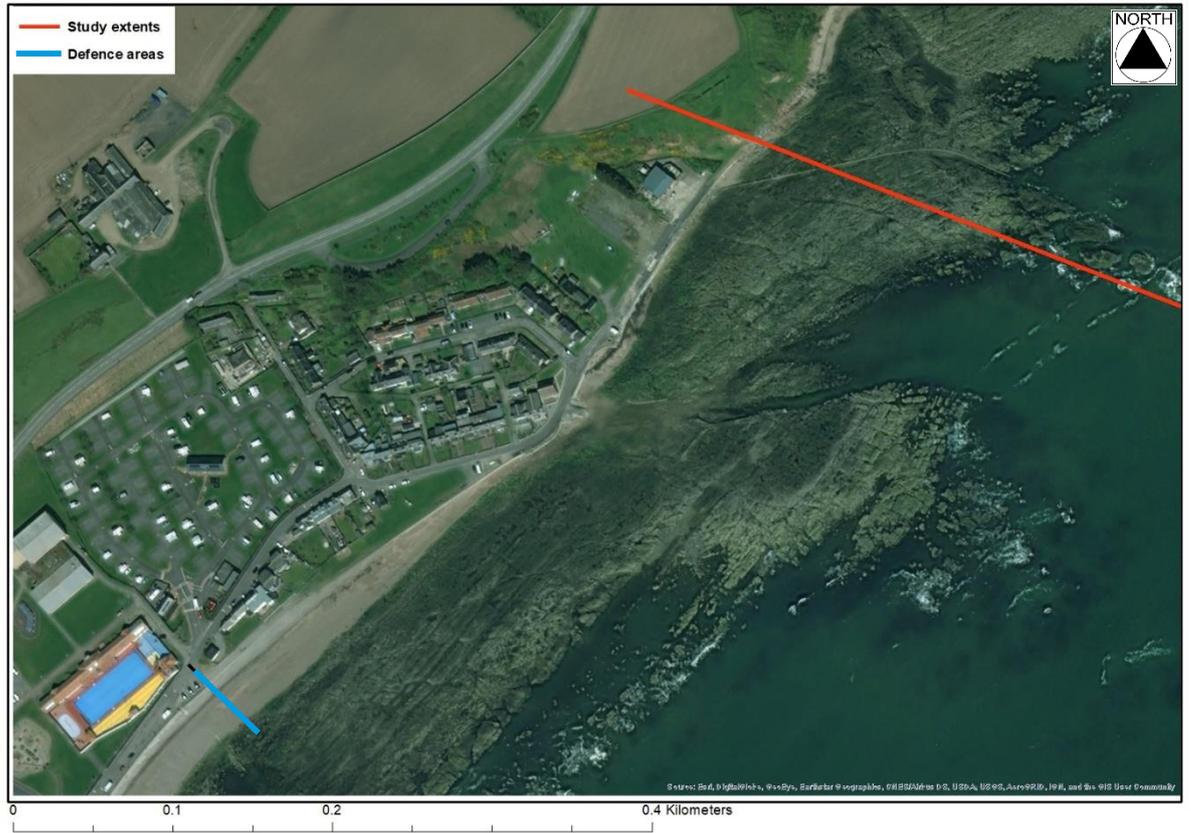
Figure 2-9: Aerial image of the Cowie wall section

The Cowie wall section runs from the open-air pool to north of the pumping station in Cowie. There is a concrete wall for part of the length, the height and construction of which varies. At the north end there is a masonry wall and in the middle a short section of exposed steel sheet piling. The natural rocky foreshore provides a degree of protection from incoming wave energy, but frequent overtopping occurs and results in flooding of properties during the more extreme events.
