Stonehaven Bay Coastal Flood Protection Study

Final Report

December 2019

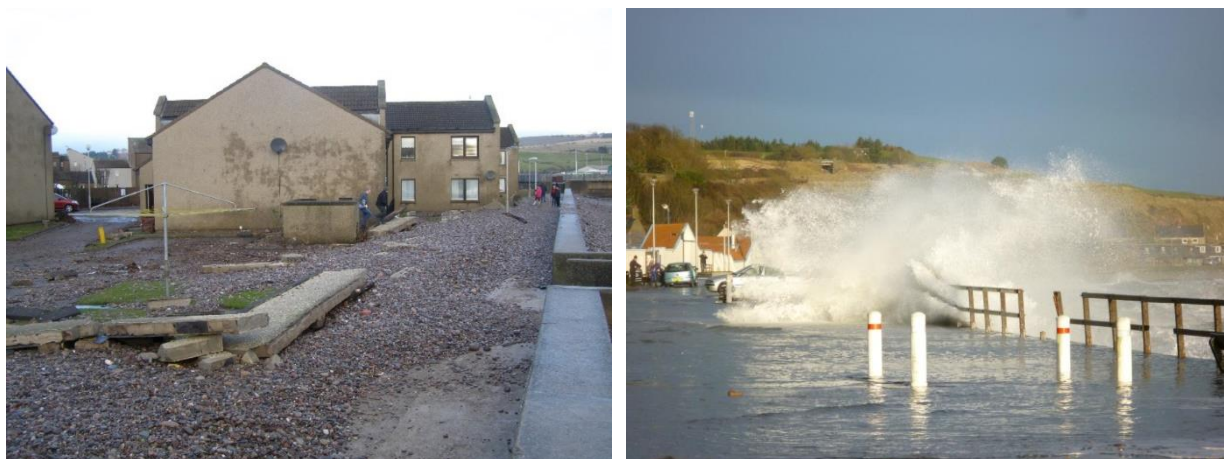
Figure 2-1: December 2012 – damage to central wall section following event³ (left) and overtopping at Cowie promenade³ (right)

Historical flood information is important to develop an understanding of local flood mechanisms, as well as providing an evidence base for model development and calibration. The most significant events in recent years are those of December 2012 and October 2014, both of which resulted in the flooding of properties, structural damage and risk to life.

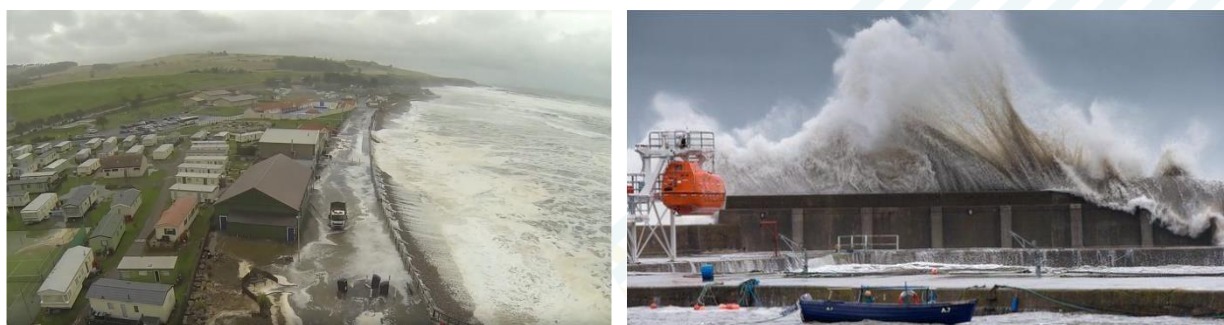
Figure 2-2: October 2014 – flooding of Cowie promenade⁴ (left) and waves crashing over the harbour breakwater⁵ (right)

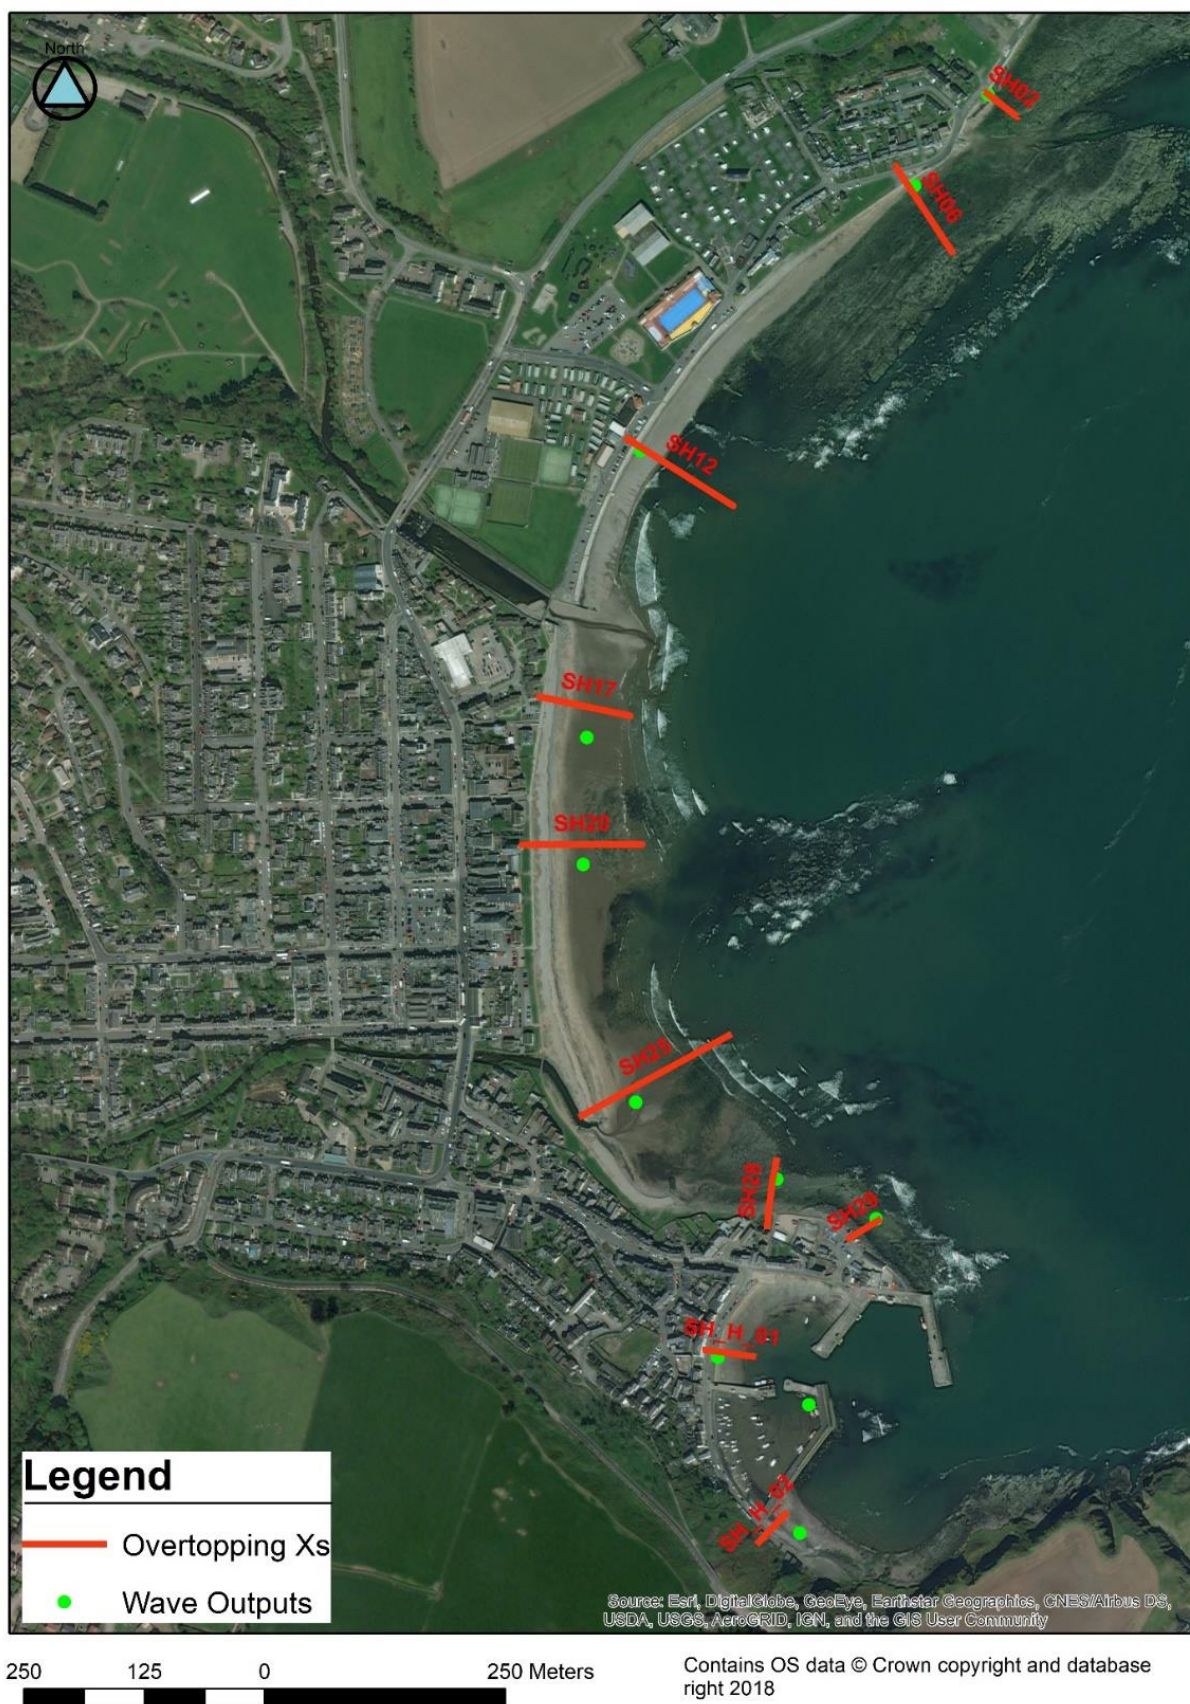
Figure 3-1: Overtopping profile locations

It should be noted that the overtopping values calculated are relevant to the beach profile, as was present when the topographic survey was undertaken. Natural variation in beach levels means that the overtopping rates will vary for similar storm events depending upon the beach profile at the time.

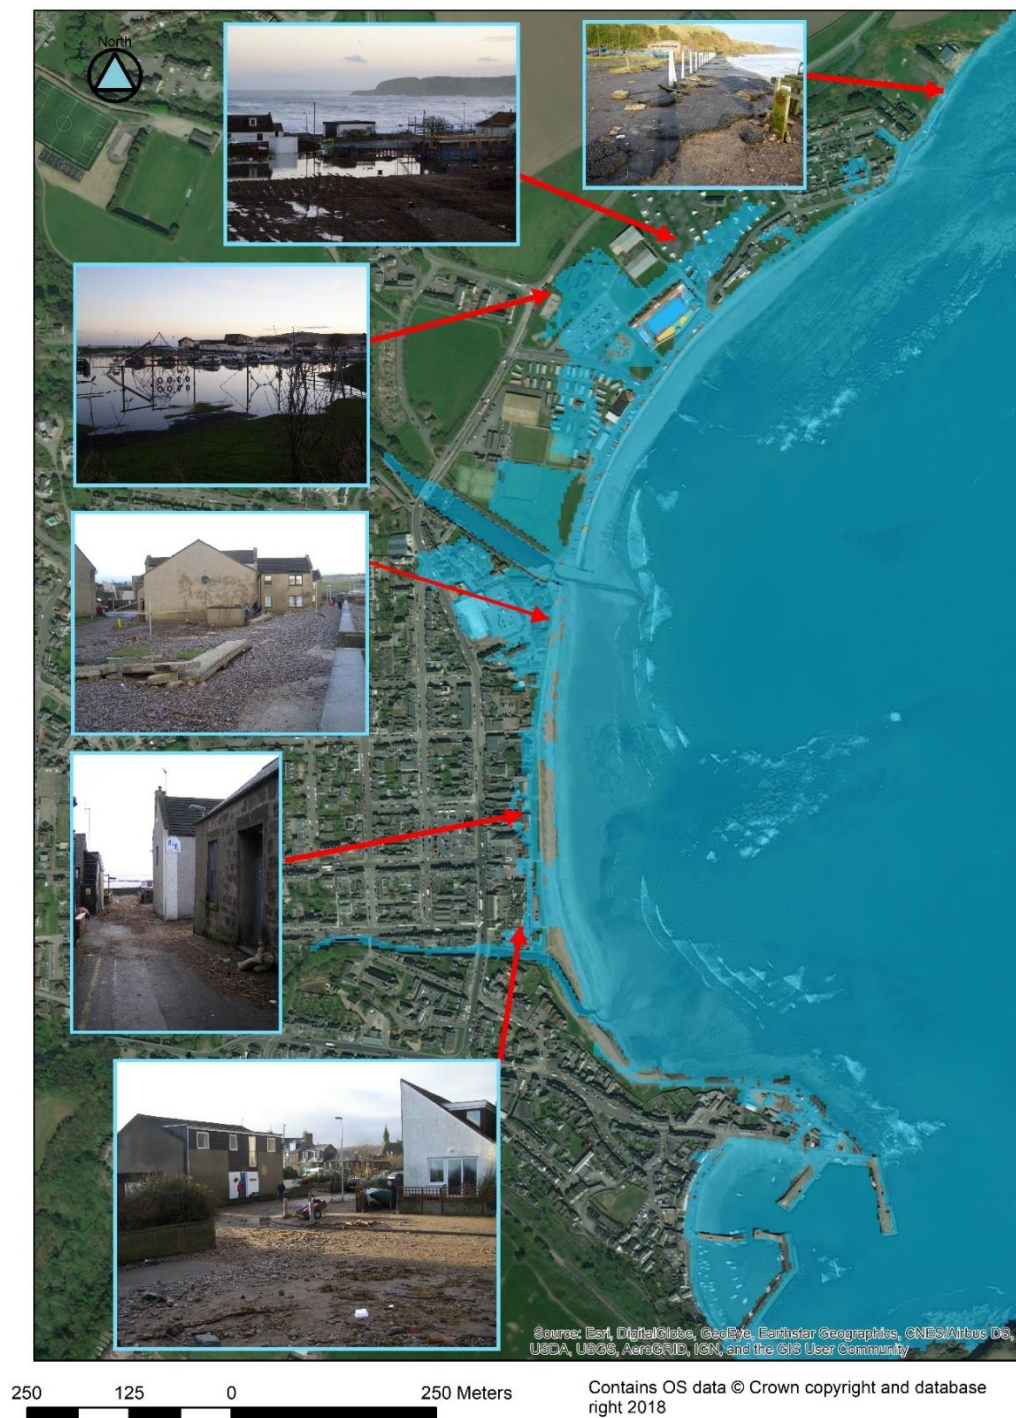
Figure 3-2: Modelled flood extent for 15th December 2012 event, along with photographic evidence from Aberdeenshire Council

An existing TUFLOW model developed for SEPA's coastal flood map updates was used as the basis of a detailed flood inundation model. This was forced by an offshore tidal graph in conjunction with overtopping inflows so as to produce a single flood extent that represents the risk from both mechanisms. The model was validated using the December 2012 flood event, with the modelled flood extent compared to photographic evidence within Figure 3-2.

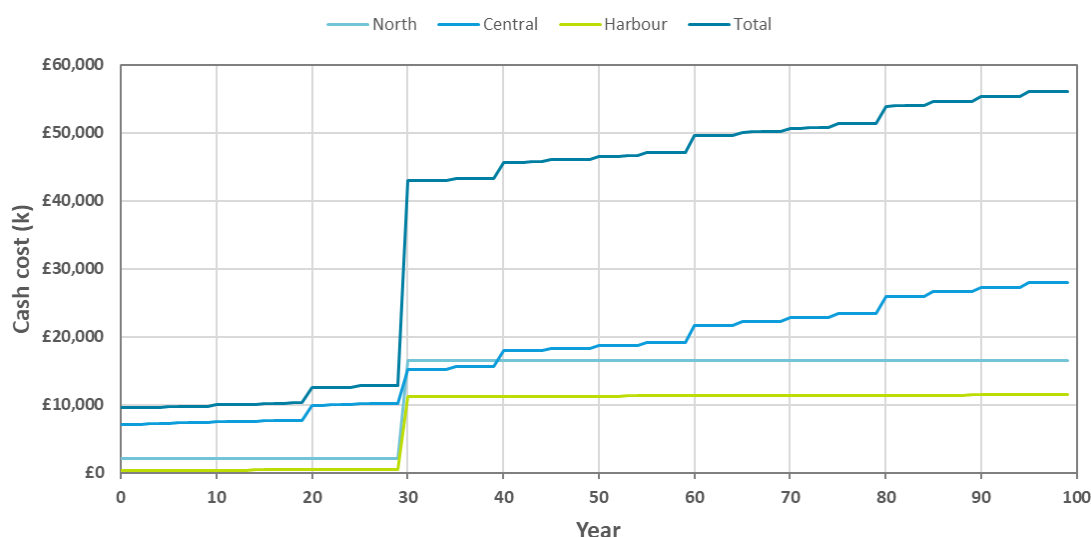
Figure 6-1: Cumulative cash contributions over the 100 year appraisal period

In terms of overall cash contributions required, this is estimated to be £56 million over the 100-year appraisal period. Much of this spend is delayed until after the residual life of the existing structures (year 30).

Figure 6-1 provides a breakdown of the cumulative cash contributions for the preferred option over the 100-year appraisal period.

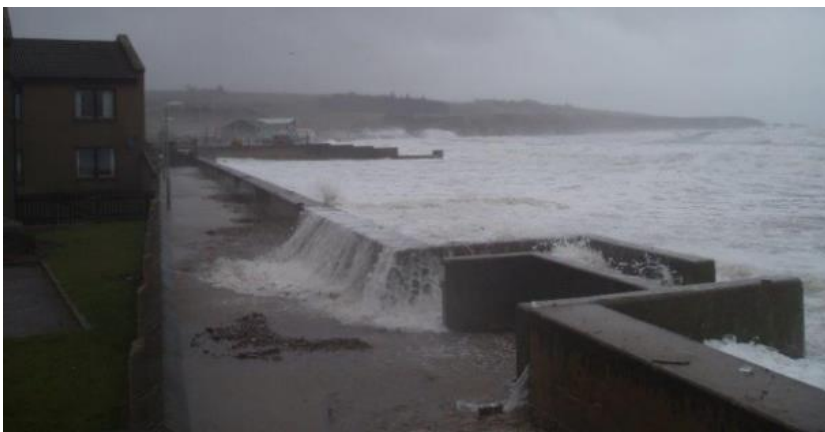
Overtopping of central wall section. Photograph supplied by Aberdeenshire Council.

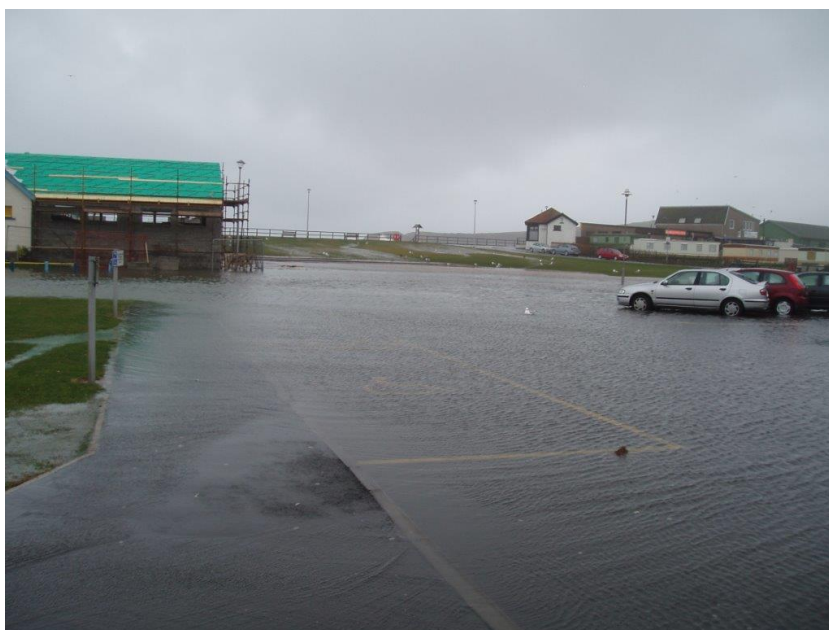
Flooding of car park behind swimming pool due to overland flow from overtopping of Cowie promenade. Photograph supplied by Aberdeenshire Council.

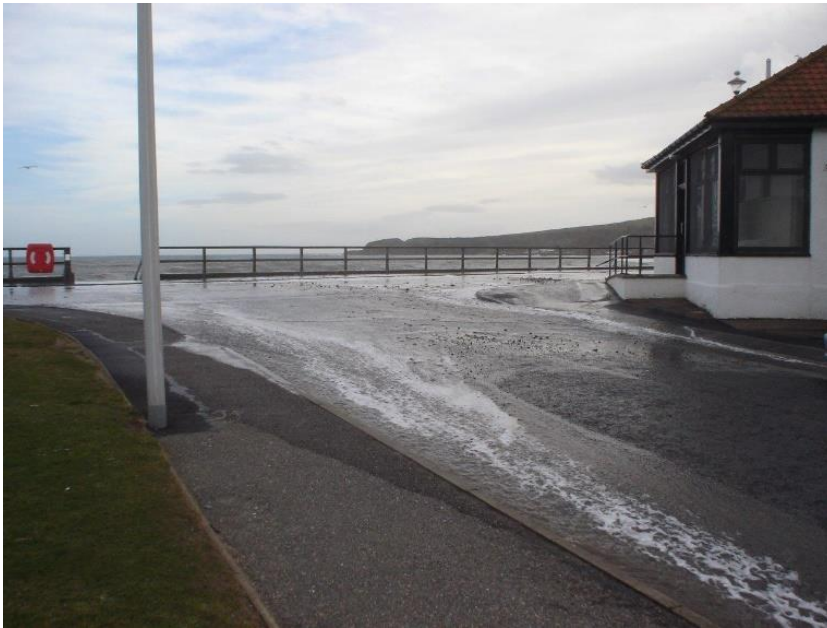
Overland flow due to overtopping at Cowie promenade. Photograph supplied by Aberdeenshire Council.

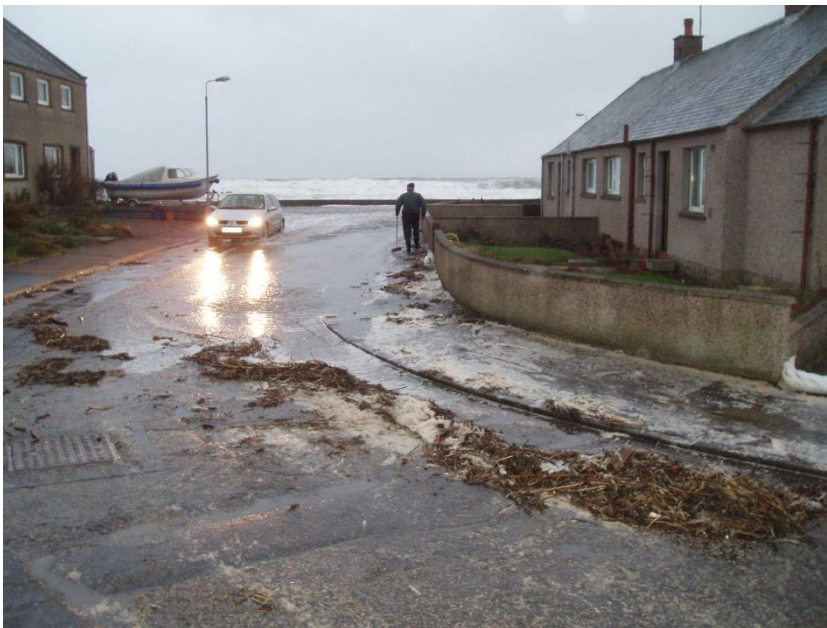
Flooding in Cowie village due to overtopping. Photograph supplied by Aberdeenshire Council.

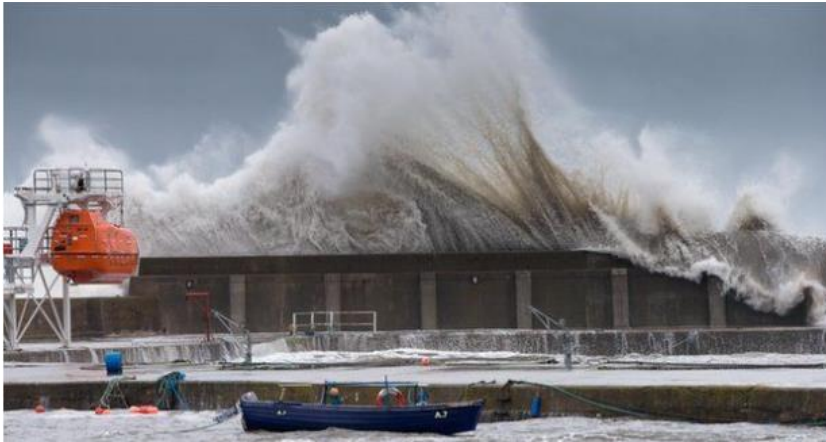
Waves crashing on the outer breakwater, Stonehaven harbour. Photograph source: <http://www.bbc.co.uk/news/uk-scotland-tayside-central-29519440>

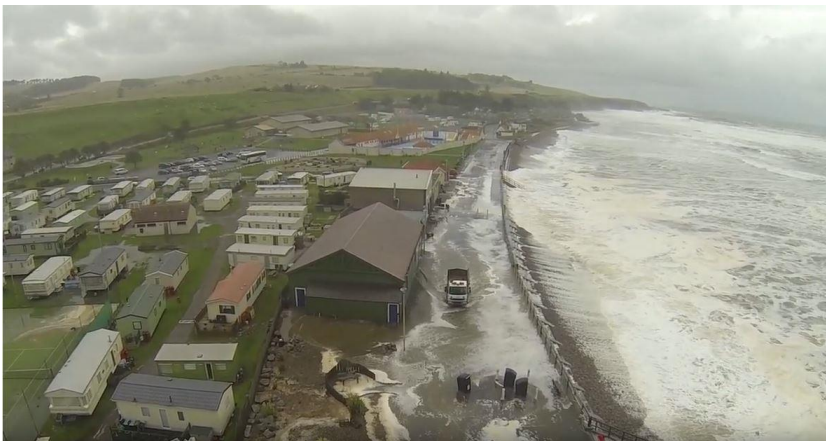
Photograph from drone footage showing wave overtopping along Cowie promenade. Photograph source: <https://www.youtube.com/watch?v=V82zGT6-J0g>

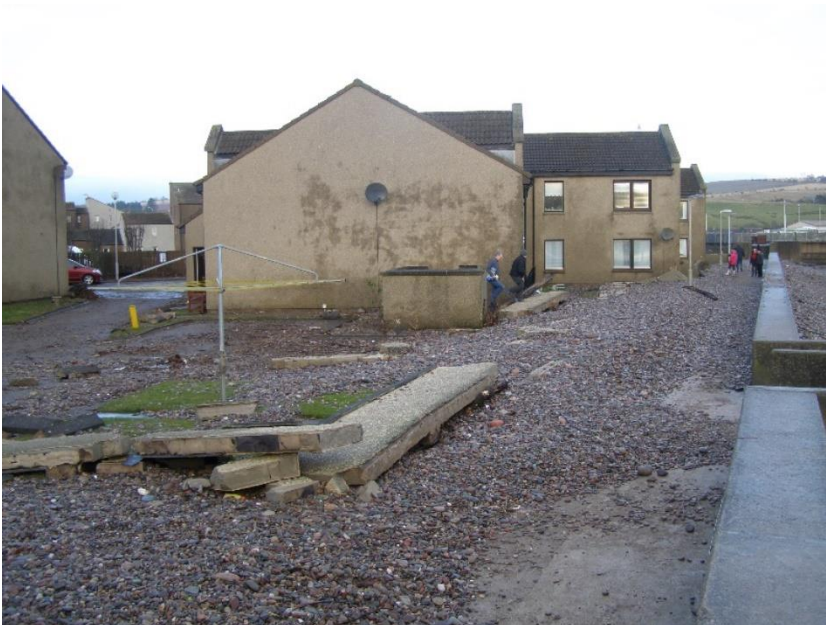
Aftermath along central wall section due to wave overtopping. Photograph supplied by Aberdeenshire Council.

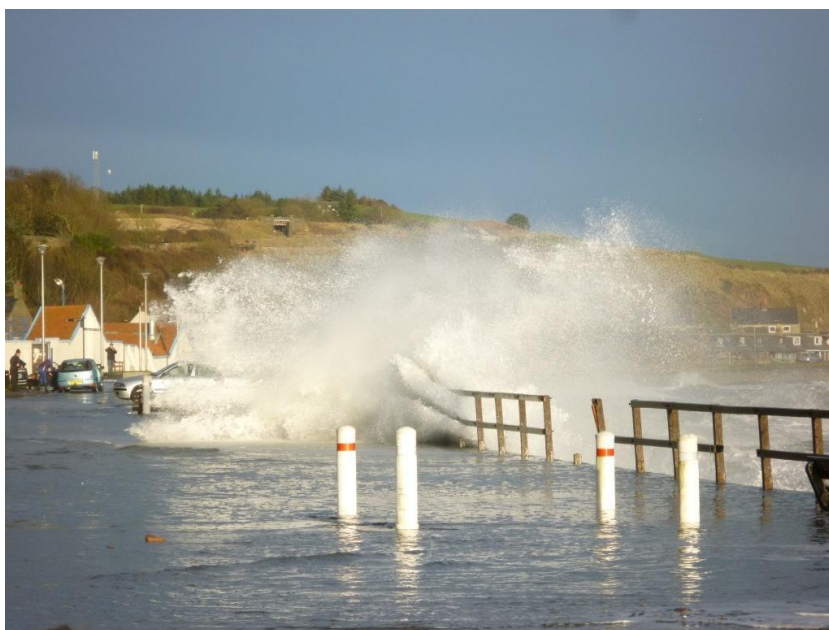
Overtopping of stepped revetment at Cowie promenade. Photograph supplied by Aberdeenshire Council.

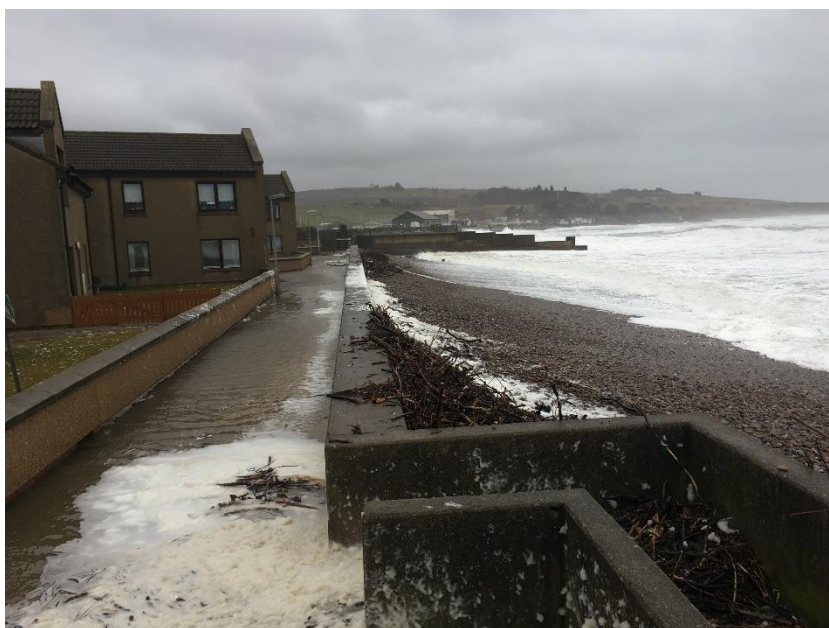
Overtopping of central wall section. Photograph supplied by Aberdeenshire Council.

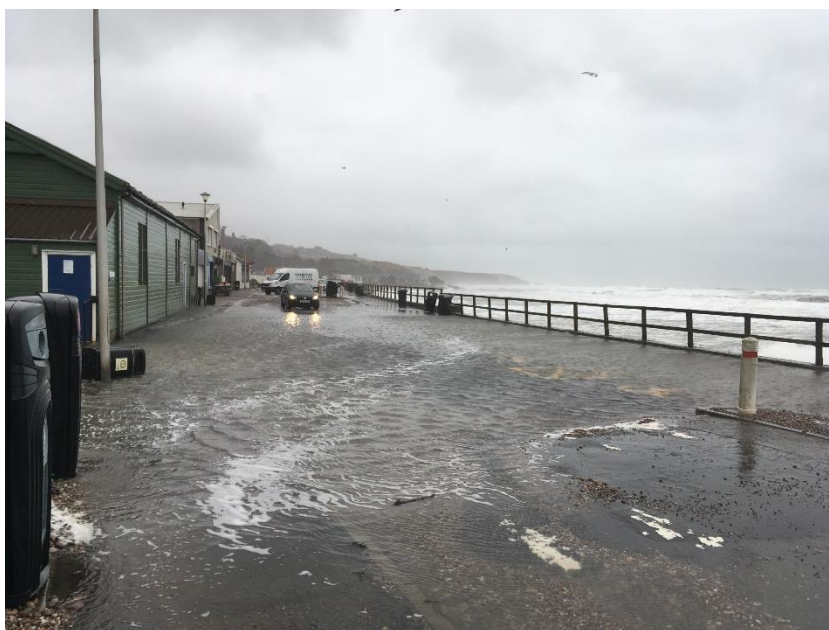
Overtopping at Cowie promenade. Photograph supplied by Aberdeenshire Council.

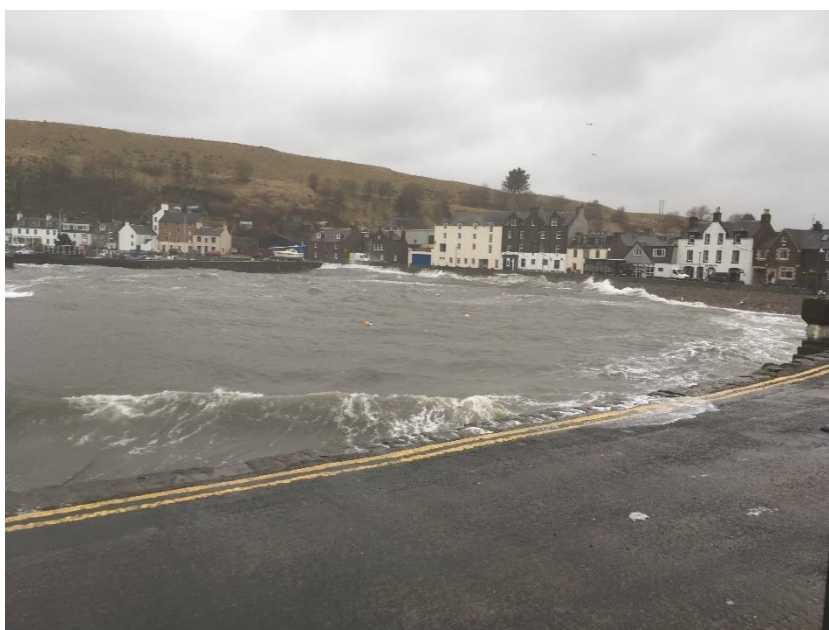
Wave action within the harbour. Photograph supplied by Aberdeenshire Council.

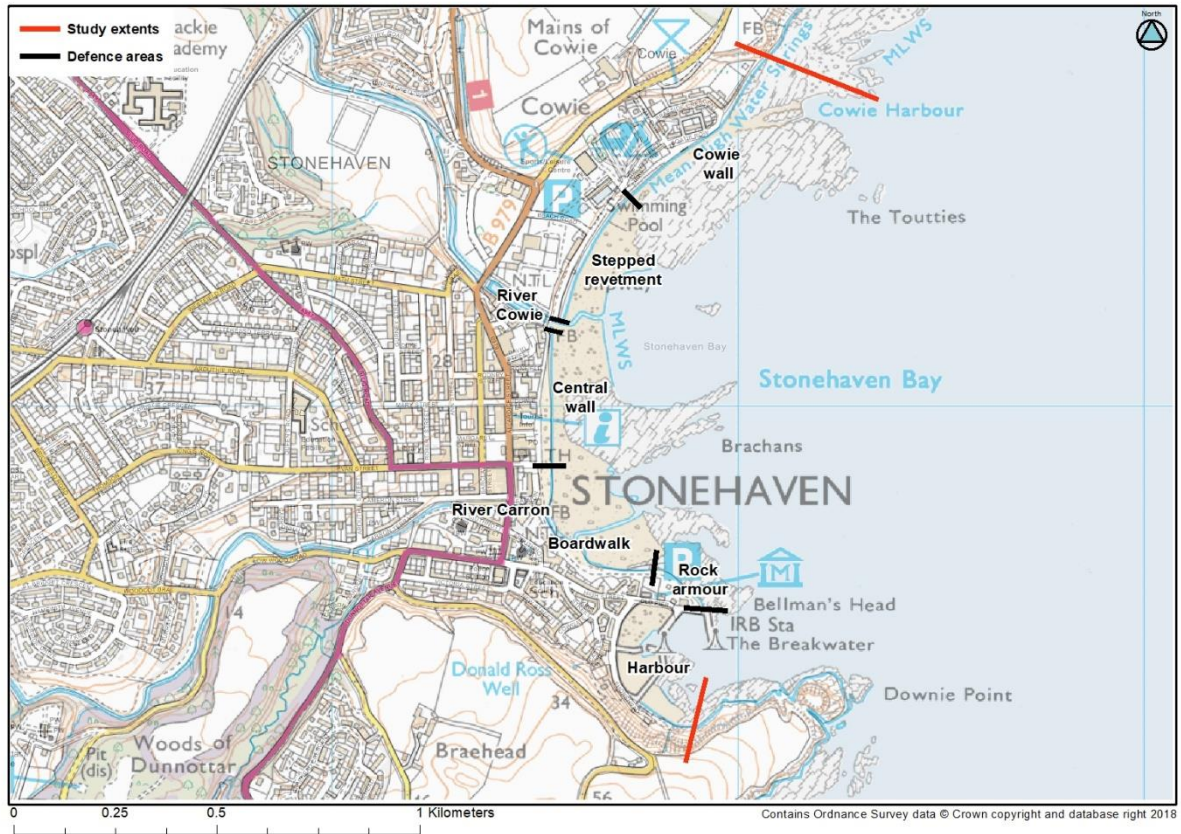
Figure 4-1: Areas and defence types within Stonehaven Bay

The frontage varies through Stonehaven and Cowie, with the general areas denoted within Figure 4-1 below.

Each of these areas/defence types is summarised below, running from south to north. Aberdeenshire Council's records and the Scottish Flood Defence Asset Database (SFDAD) website were checked for any details of any of the defences.

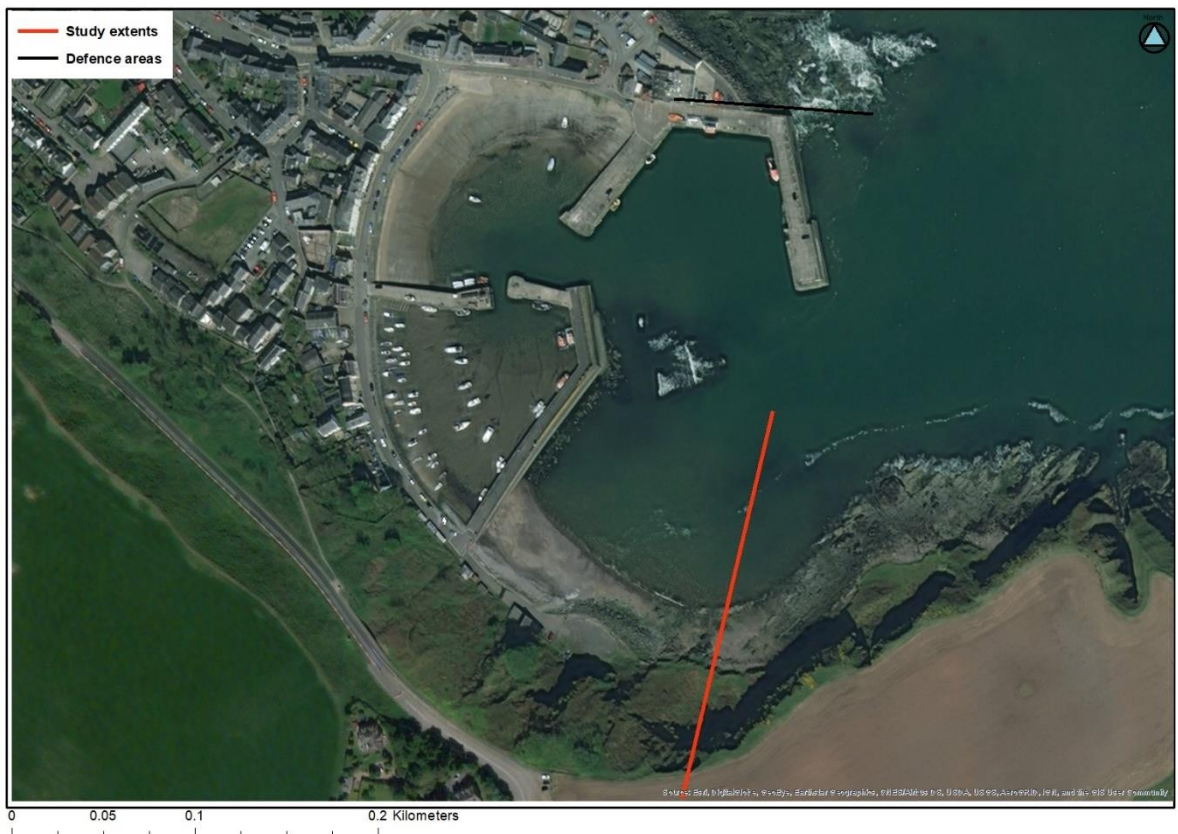
In 2017, Aberdeenshire Council commissioned an inspection of the structural assets within the harbour. This concluded that several of the elements are in very poor condition with multiple structural defects. The content and recommendations made here will be reviewed in detail during the structural surveys, with a focus on any defects or works likely flood risk. It is understood that the diver inspection was repeated in May 2018; this up to date information is to be provided by Aberdeenshire Council once available.

Figure 4-2: Aerial image of harbour area

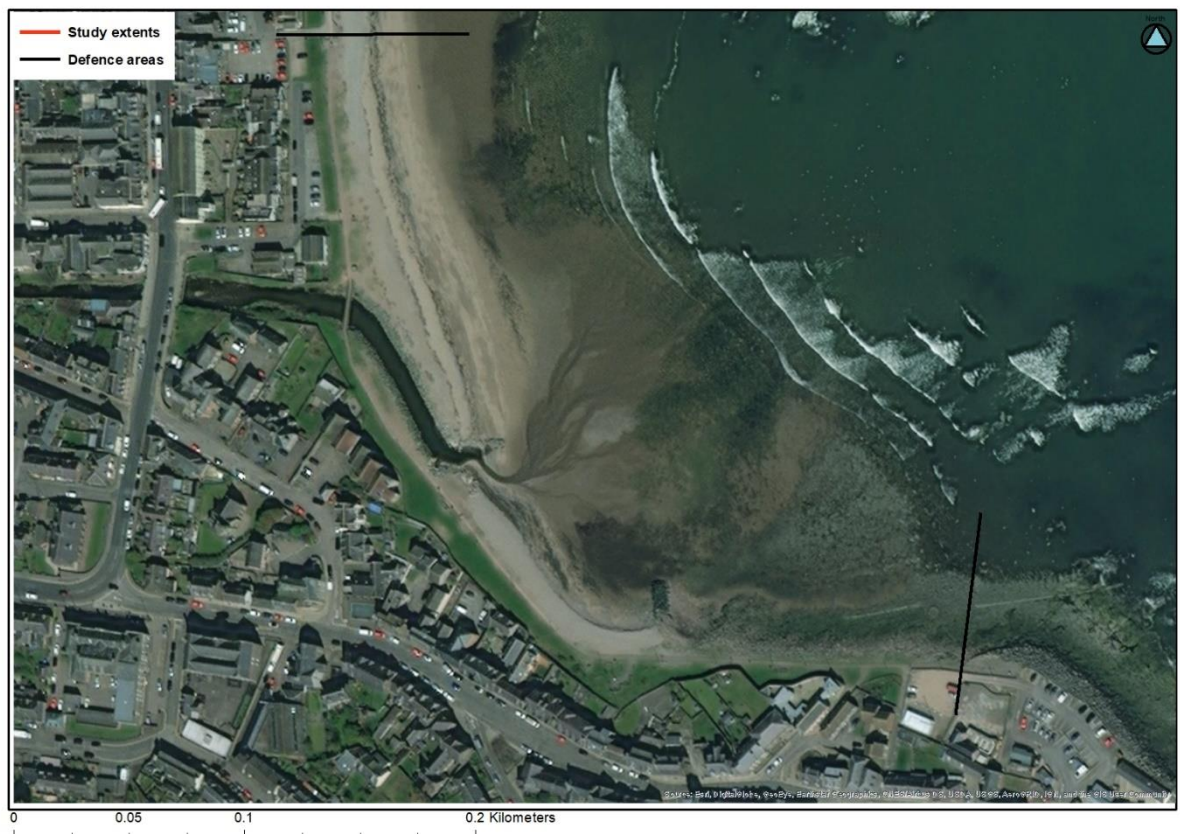
South of the Carron, the beach is prone to erosion with the timber walkway washed away during the December 2012 event. This is likely a combination of wave energy and the influence of the mouth of the River Carron, which directs flow longshore towards the area. Shingle deposited in the mouth of the River Cowie is periodically recycled and placed here to reduce erosion, with limited success.

Figure 4-4: Aerial image of boardwalk section

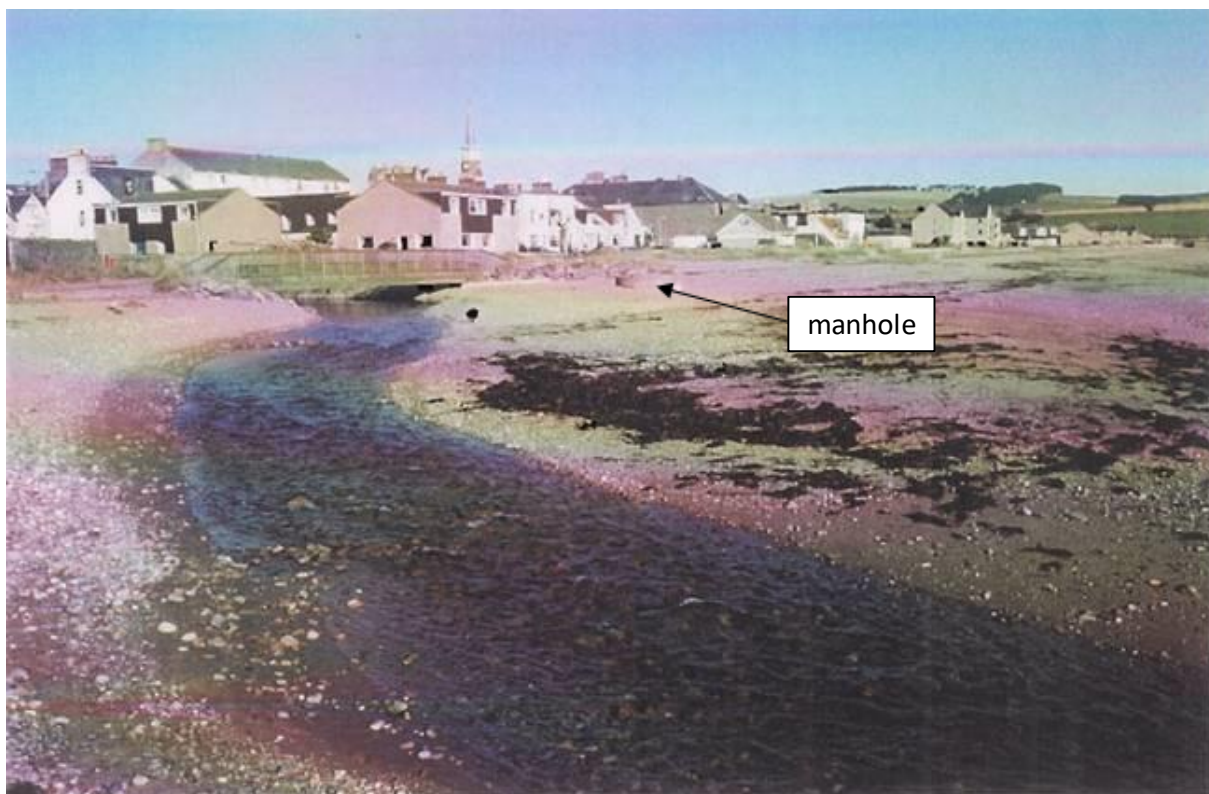
Figure 4-5: Historical natural outfall of the River Carron

Historically the River Carron discharged freely across the beach (Figure 4-5). In 1998 HR Wallingford were commissioned by Aberdeenshire Council to consider options for maintaining a channel for the River Carron across the beach; concerns were that the discharge of floodwater was being hampered by the low clearance of the footbridge crossing the channel and the deflection and partial siltation of the channel across the beach. The report³ considered a number of training wall configurations, with the recommended option presented within **Figure 4-6**.

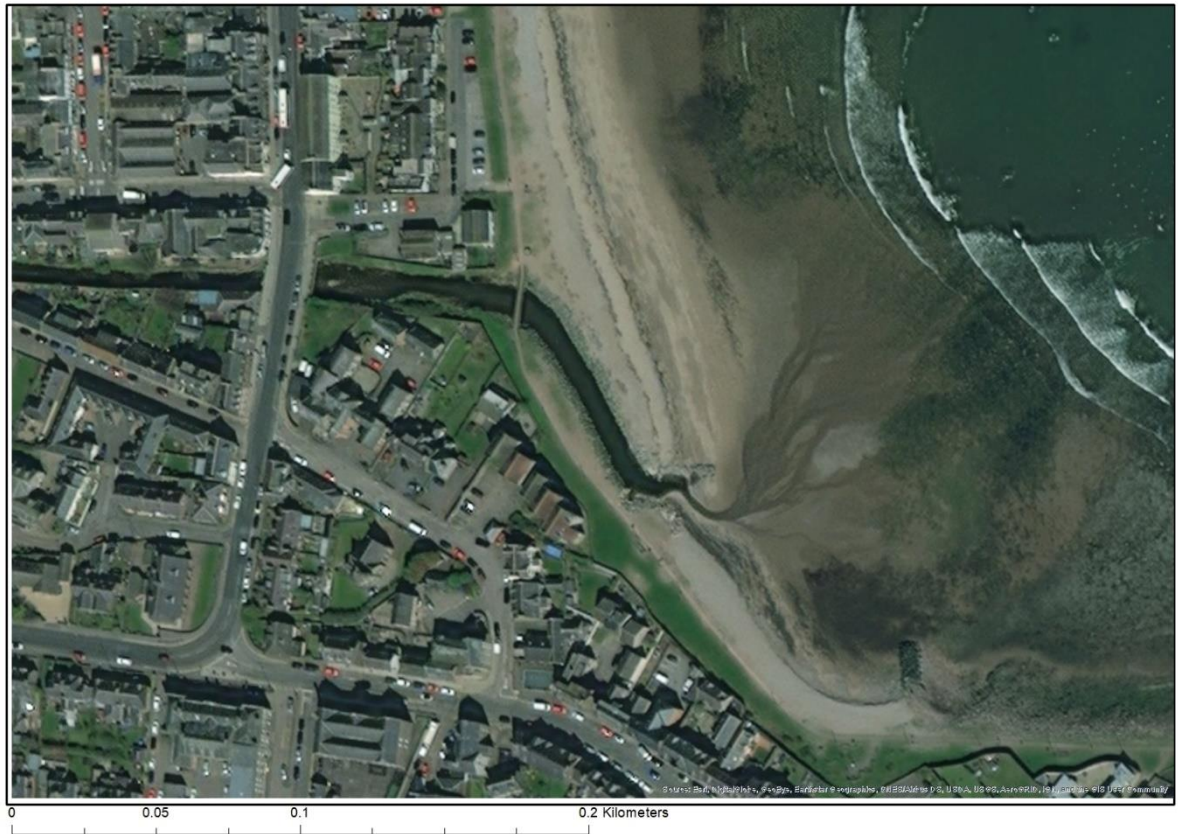
Figure 4-7: Current configuration at the mouth of the River Carron

The configuration of the rock armour training structure that was built at the mouth of the Carron differs from that shown above. Details of the final design and the date of construction have been requested from Aberdeenshire Council, and these details will be incorporated into future phases of the study once they are made available. The current configuration at the mouth of the Carron can be seen in **Figure 4-7**.

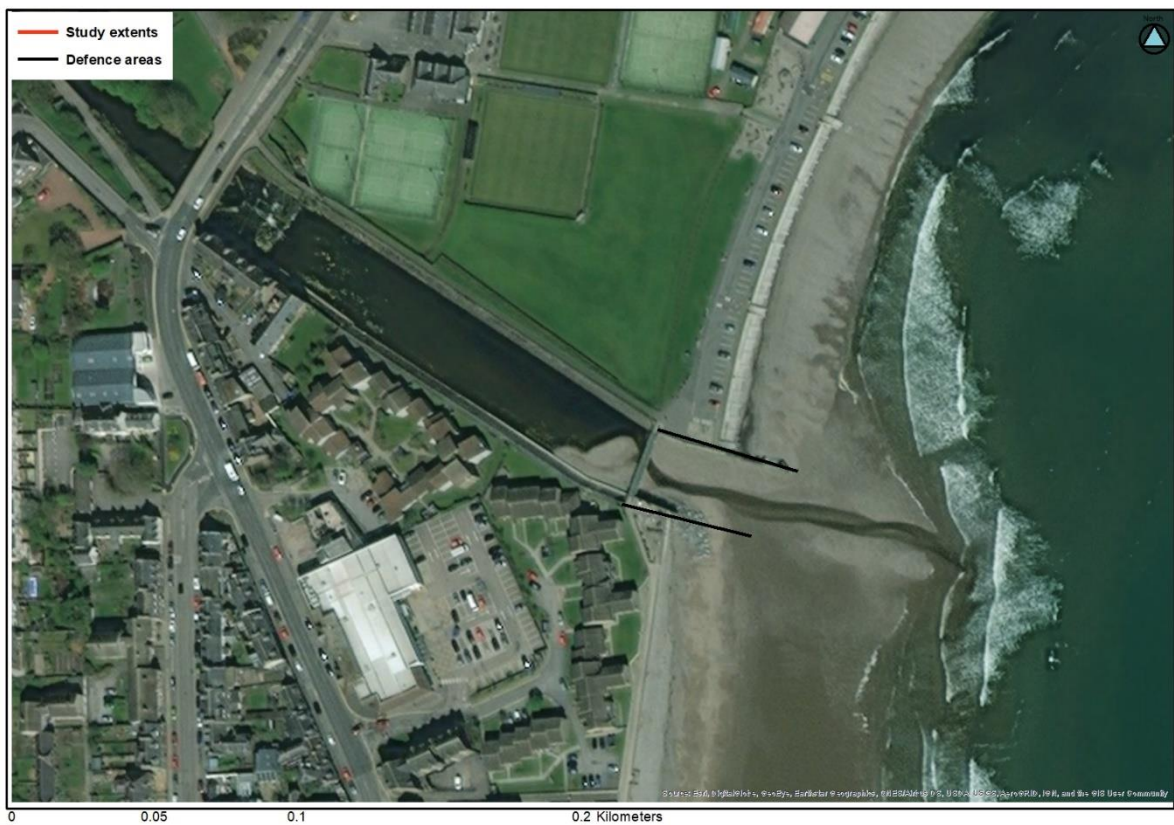
The River Cowie section consists of a combination of concrete walls, concrete revetments, and steel sheet piles. The defences extend from the mouth of the River to the B979 road bridge, 200m upstream. During storm conditions, waves can propagate into the mouth of the river and break on the weir at the road bridge. The south bank of the river is also at risk from overtopping from oblique waves that enter the mouth and roll along the revetment.

Figure 4-9: Aerial image of River Cowie section

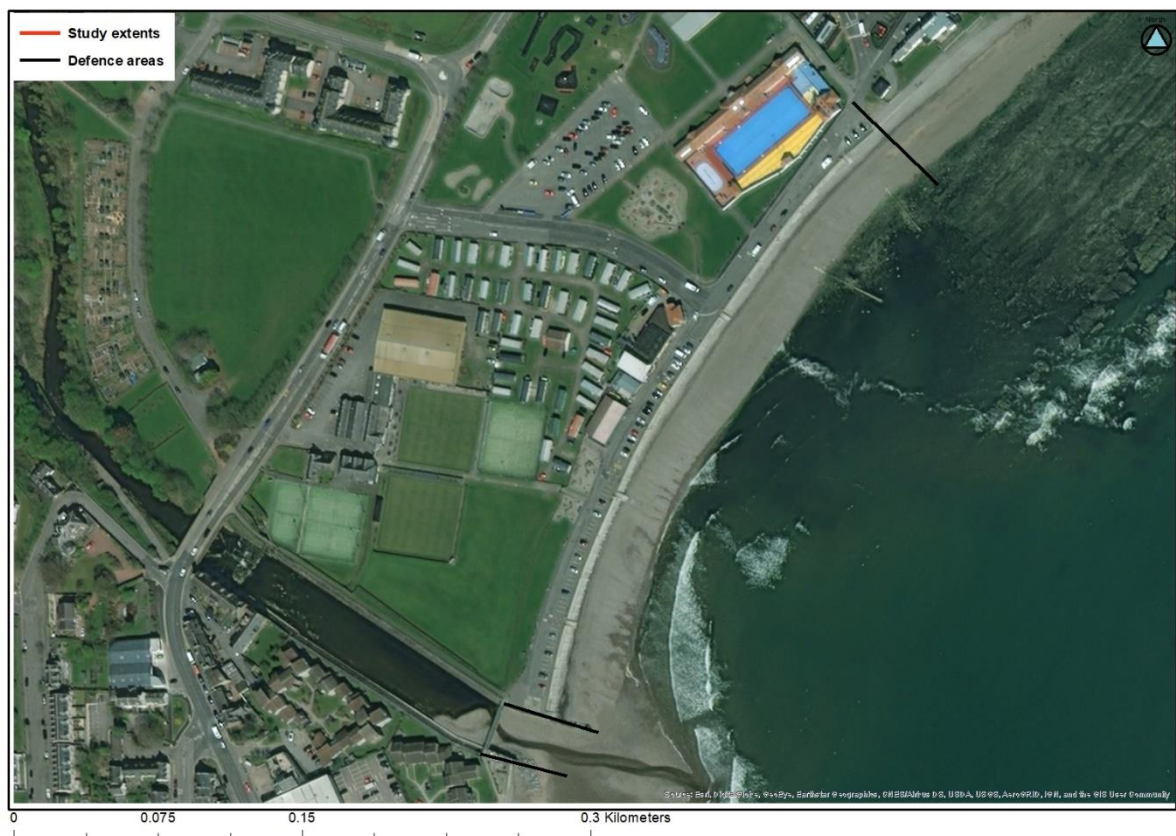
Over the years there has been significant damage to the structure from undermining and scour at the toe. Currently most of the toe is buried under a considerable depth of sediment. The sediment here is much finer than further south in the bay, with rock armour installed along the toe of the defences in 2006.

Overtopping here happens regularly, with significant damage to the shorefront commercial properties occurring in recent years. The local topography means that when significant overtopping occurs water will flow west, flooding the leisure centre car park, caravan park, and bowling club.

Figure 4-10: Aerial image of stepped revetment section

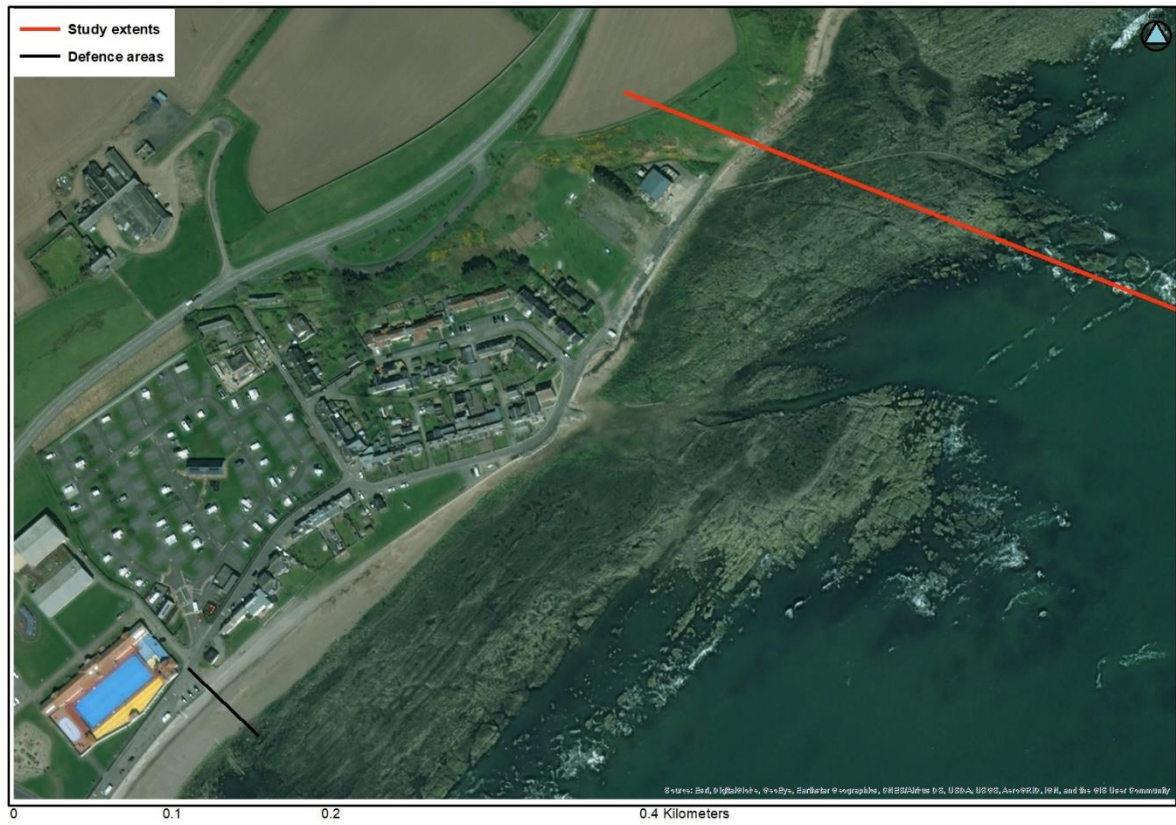
The Cowie wall section runs from the open-air pool to the limit of the residential properties in Cowie. It is a vertical concrete wall that experiences extremely variable sediment depths at the toes. The natural rocky foreshore provides a degree of protection from incoming wave energy, but frequent overtopping exists. Flooding to properties here also occurs during the more extreme events.

Figure 4-11: Aerial image of Cowie wall section

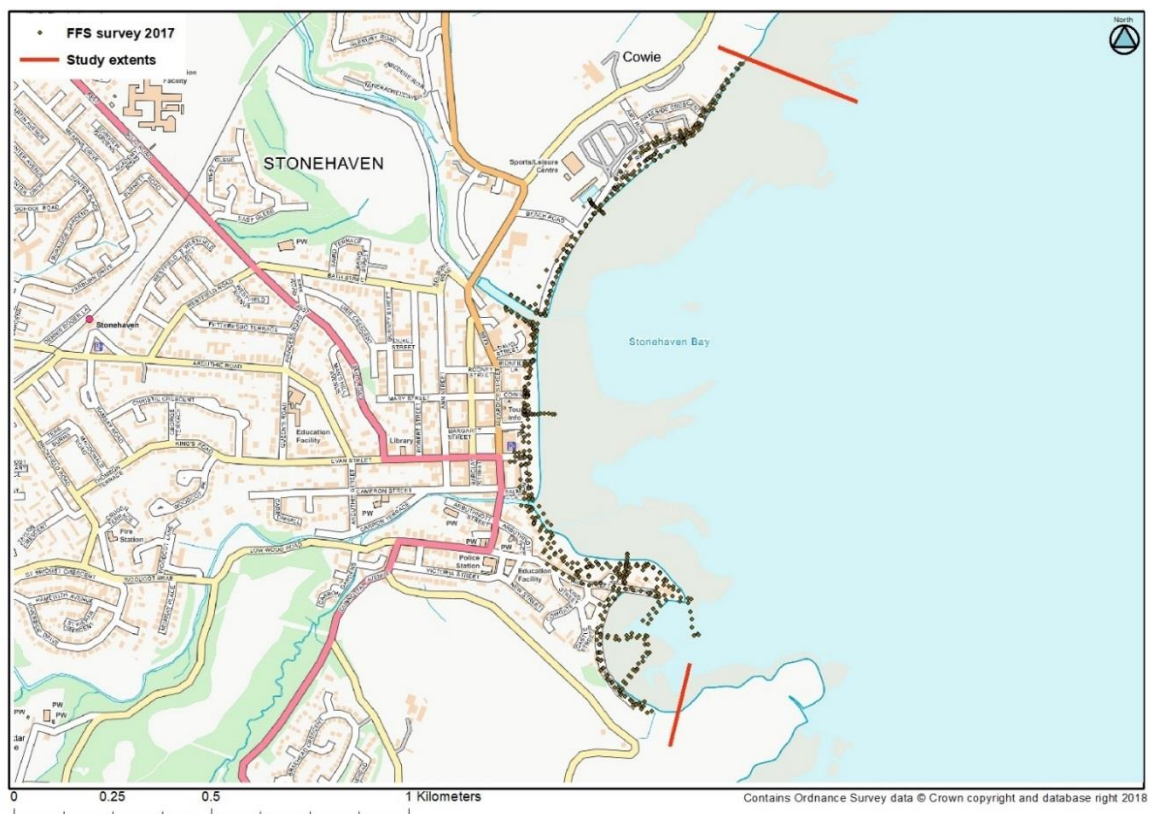
Figure 6-5: Extent of the 2017 FFS survey

The extent of the two beach surveys are shown in Figure 6-4, the extent of the 2017 FFS survey presented within Figure 6-5 and the locations of the existing threshold surveys shown in Figure 6-6.

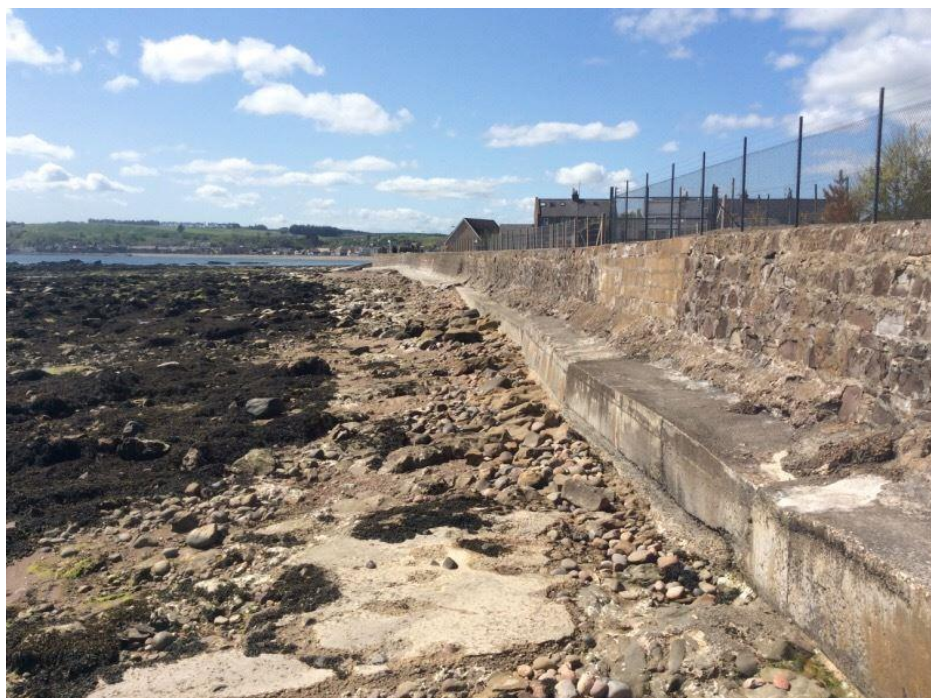
Description: View of Section B (looking south)
Asset Type: Defence
Sub Type: Wall
Elements: Exposed face (concrete), exposed face (sheet piles) and crest
Photo number: 2

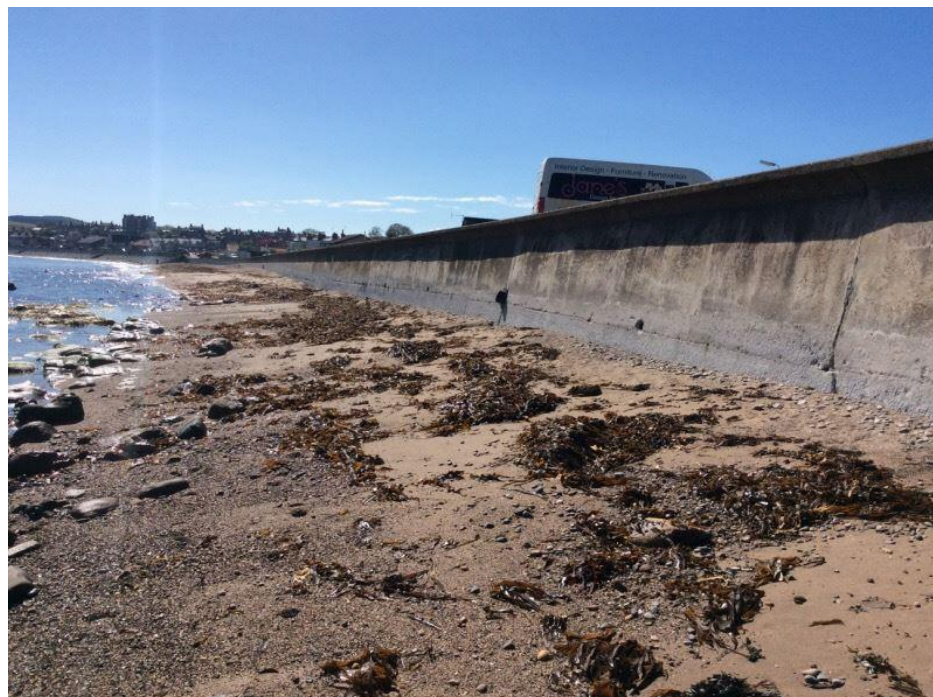
Description: View of Section C (looking north)
Asset Type: Defence
Sub Type: Revetment
Elements: Exposed face, sea wall and rock armour
Photo number: 6

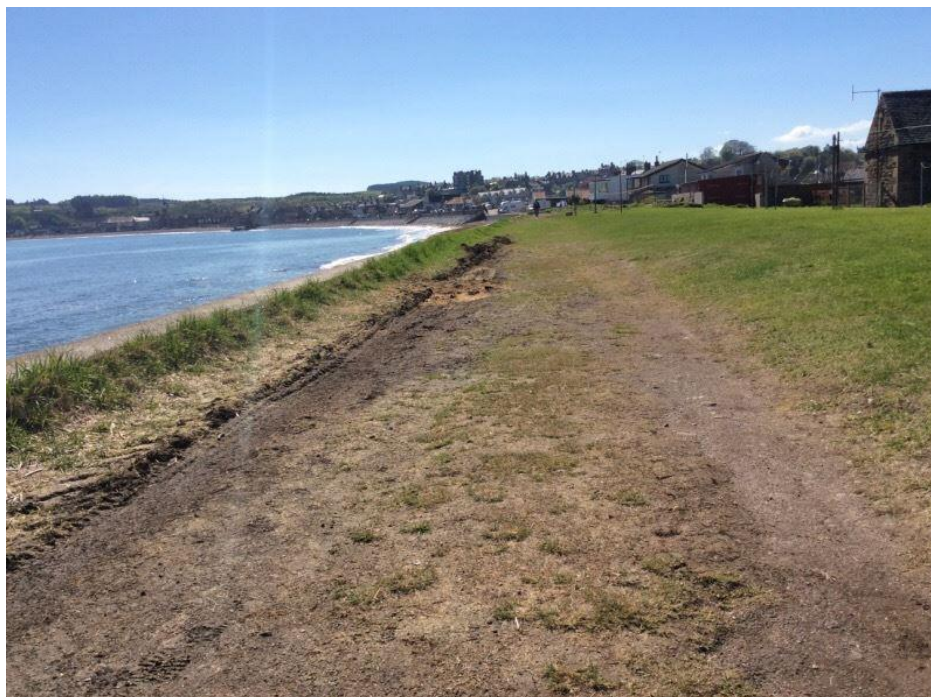
Section B
Crest
Defect Ref: D2
Description: D2 - Depression of crest
Photo number: 64
