Stonehaven Bay Coastal Flood Protection Study

Final Report

December 2019

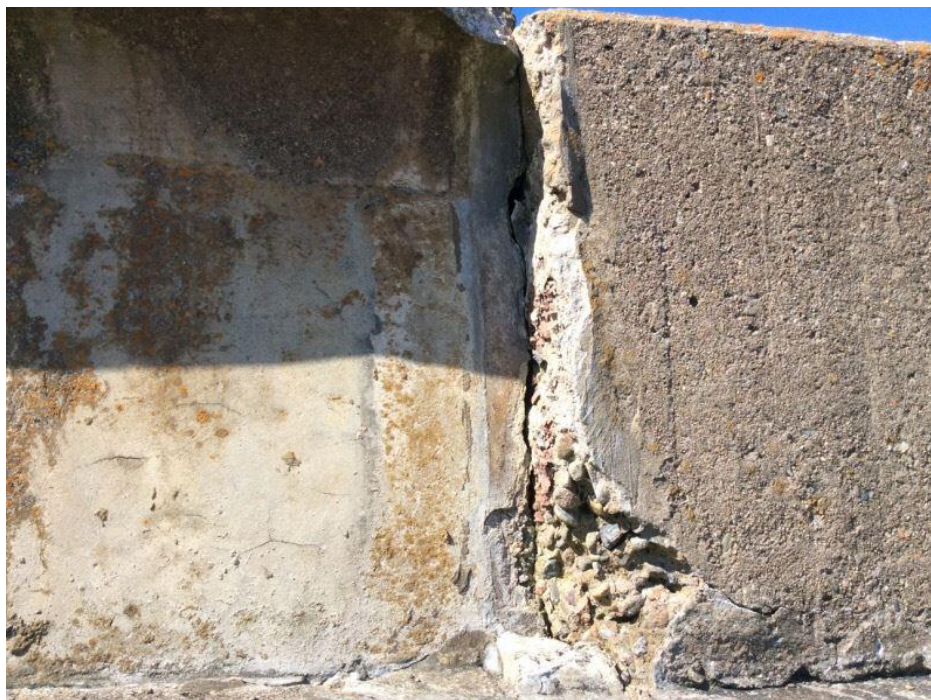
Section B
Exposed face
Defect Ref: D4
Description: D4 -
Spalling concrete
Photo number: 49

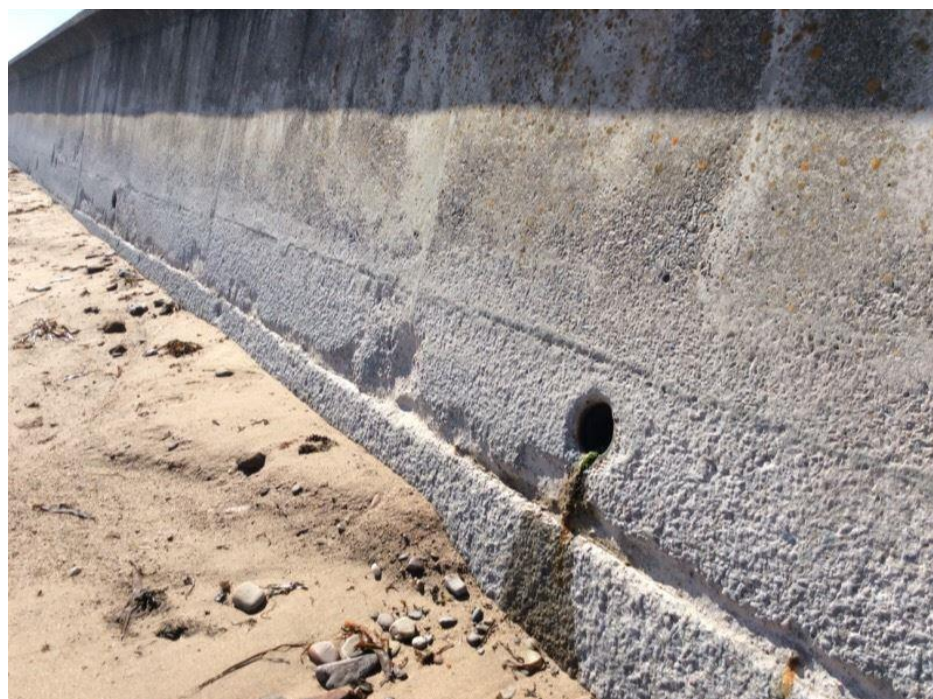
Section B
Exposed face
Defect Ref: D7
Description: D7 - 12
missing flap valves
Photo number: 52

Defect Recommendation	Defect <input type="checkbox"/>
Resurface vegetated crest.	D1
Resurface vegetated crest.	D2
Breakout and repair corroded area.	D6
Consider installing flap valves.	D7
Patch repair damaged recurve.	D9
Patch repair damaged recurve.	D10
Repoint crack.	D19
Monitor and consider replacing rendering to prevent further deterioration.	D27
None.	D37
Replace timber handrails with a more durable solution.	D52
Replace timber handrails with a more durable solution.	D57
Monitor and consider replacing with a more formal coastal protection.	D76
Consider installing flap valves.	D82
Consider rebuilding slipway if still in use.	D83
Consider replacing parapet.	D91
Consider reprofiling rock armour profile.	D95

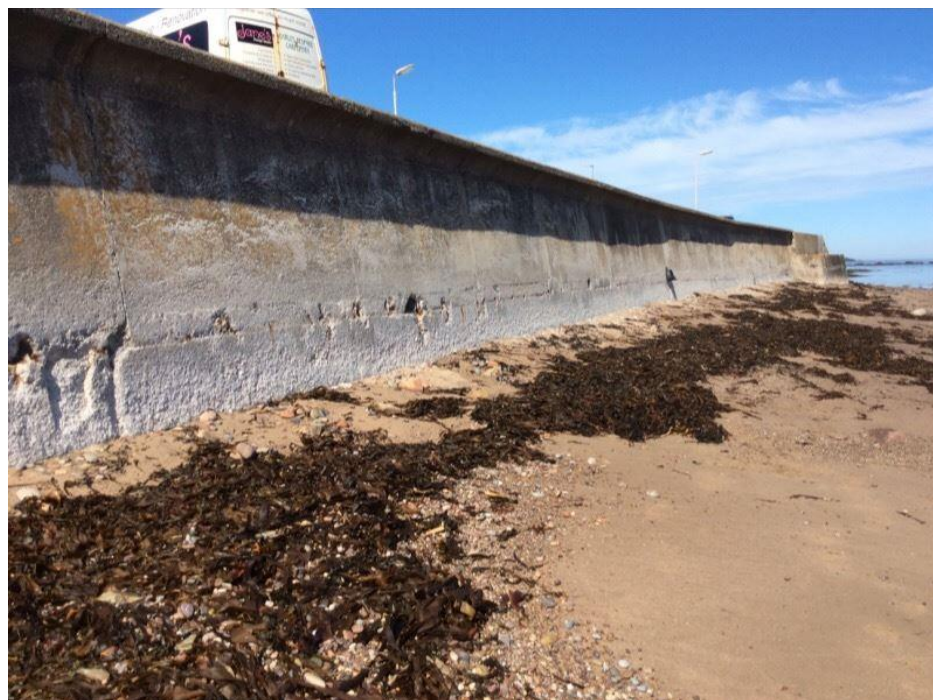
Section B
Exposed face
Defect Ref: D8
Description: D8 -
Spalling concrete
Photo number: 53

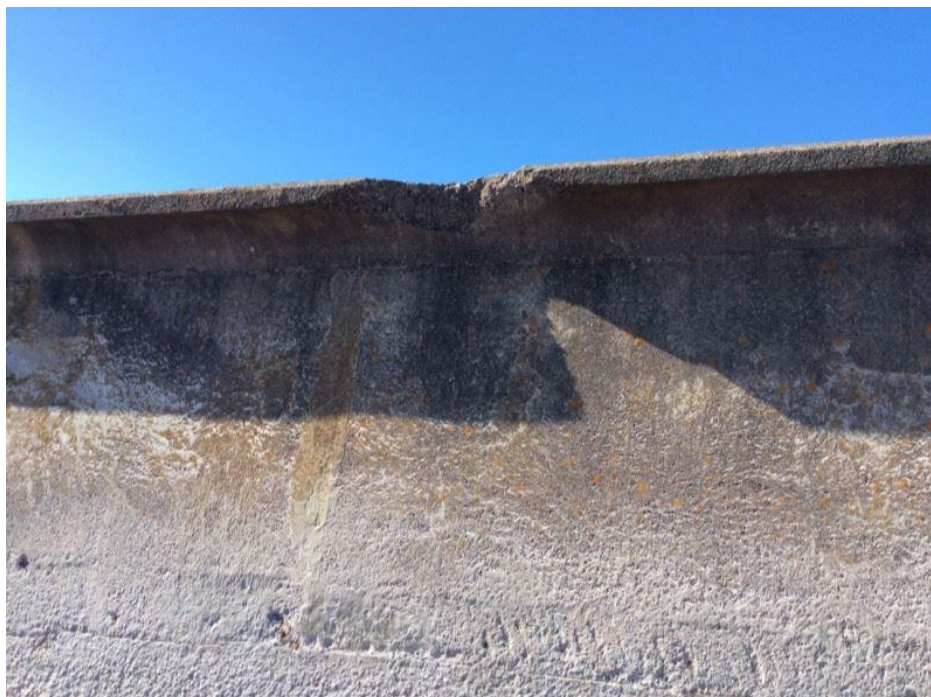
Section B
Exposed face
Defect Ref: D9
Description: D9 -
Damaged recurve
Photo number: 54

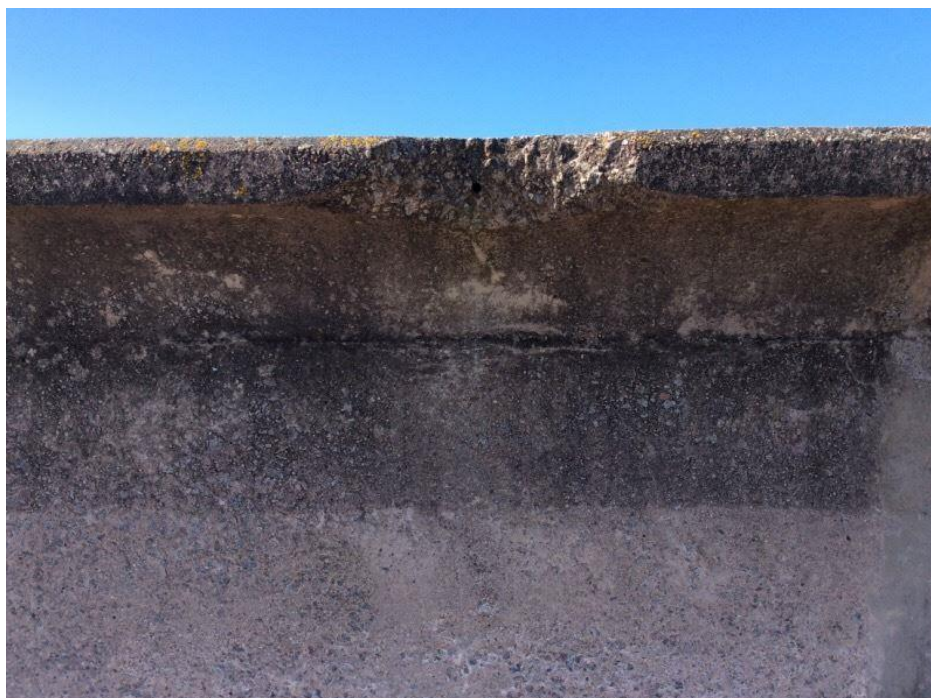
Section B
Exposed face
Defect Ref: D10
Description: D10 -
Damaged recurve
Photo number: 55

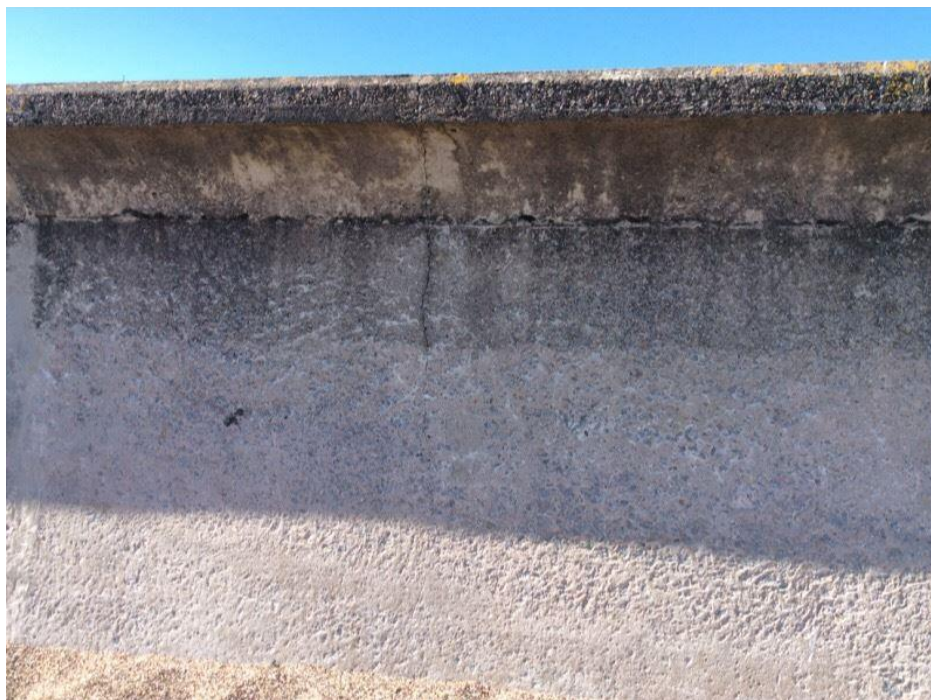
Section B
Exposed face
Defect Ref: D11
Description: D11 -
Vertical crack
Photo number: 56

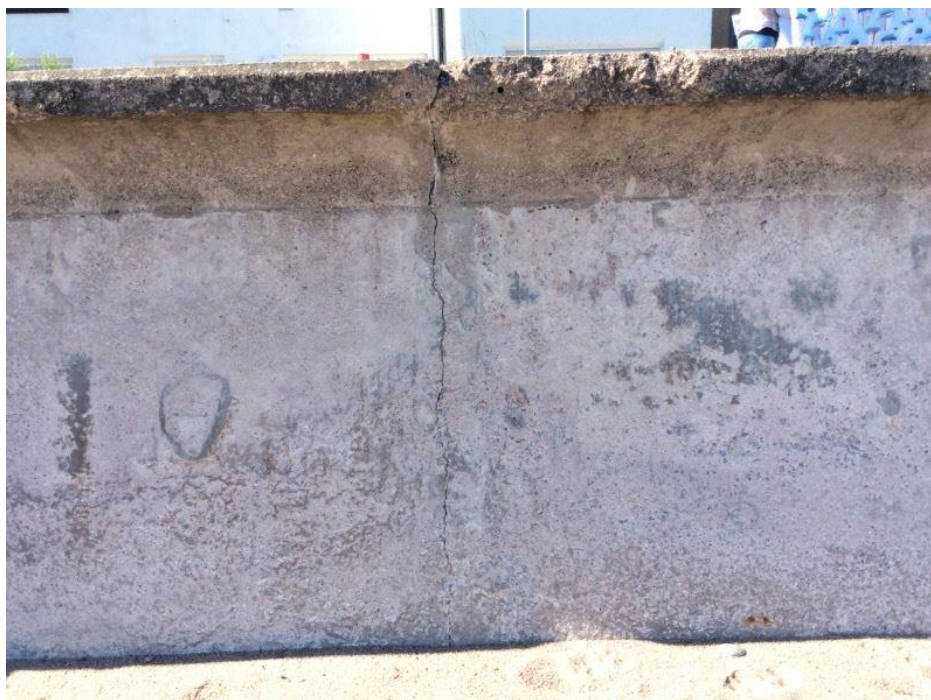
Section B
Exposed face
Defect Ref: D12
Description: D12 -
Vertical fracture
Photo number: 57

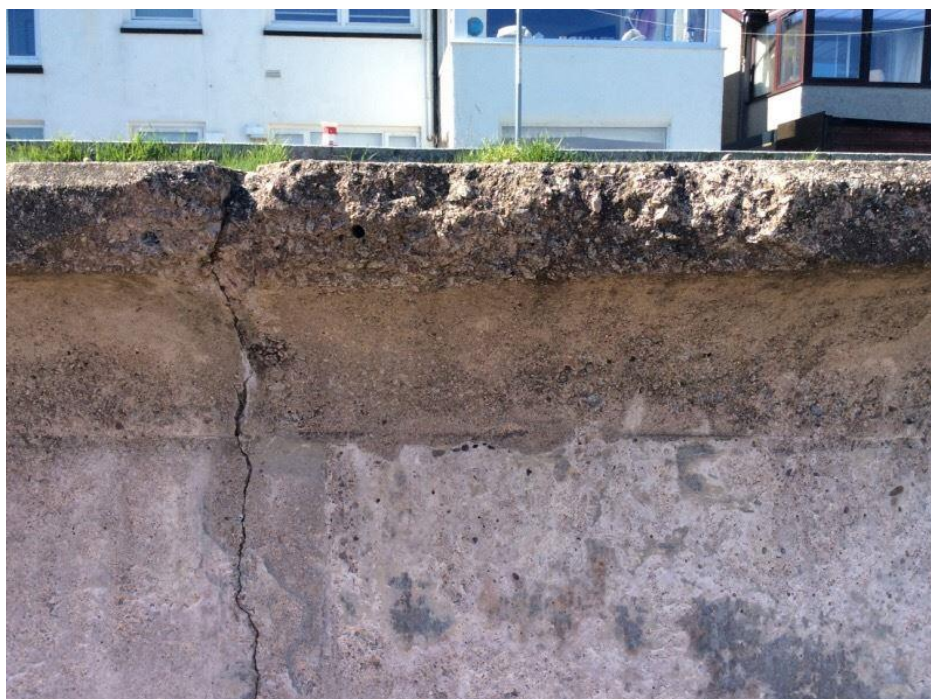
Section B
Exposed face
Defect Ref: D13
Description: D13 -
Damaged recurve
Photo number: 58

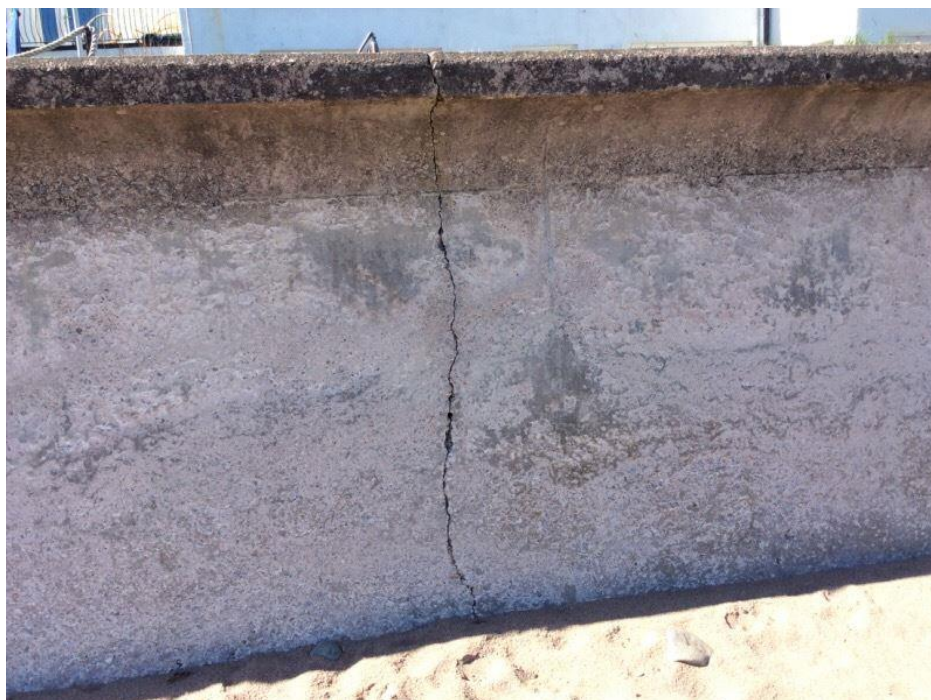
Section B
Exposed face
Defect Ref: D14
Description: D14 -
Vertical crack
Photo number: 59

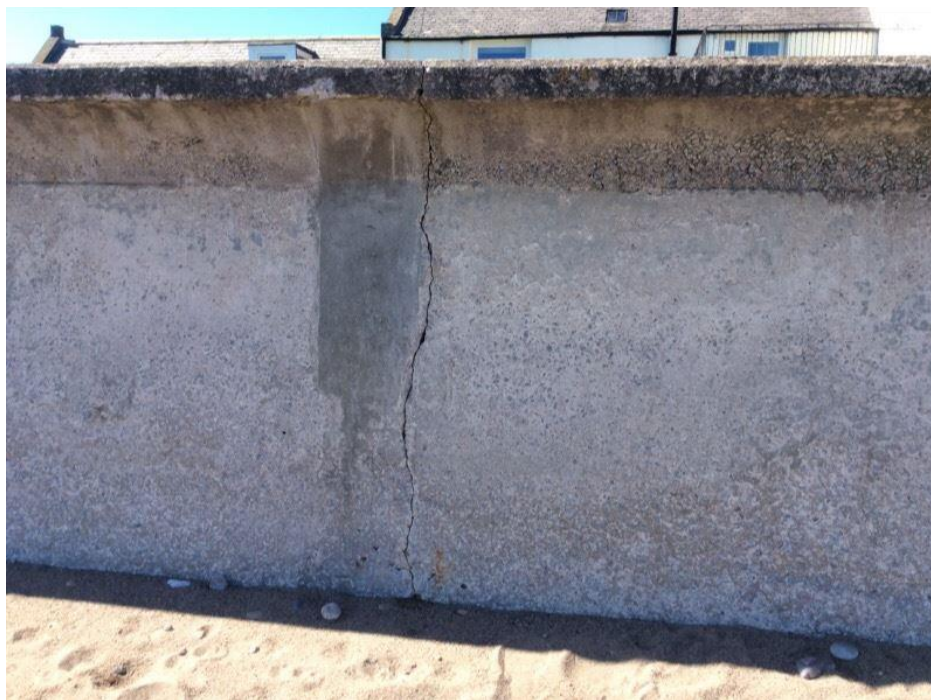
Section B
Exposed face
Defect Ref: D15
Description: D15 -
Vertical fracture
Photo number: 60

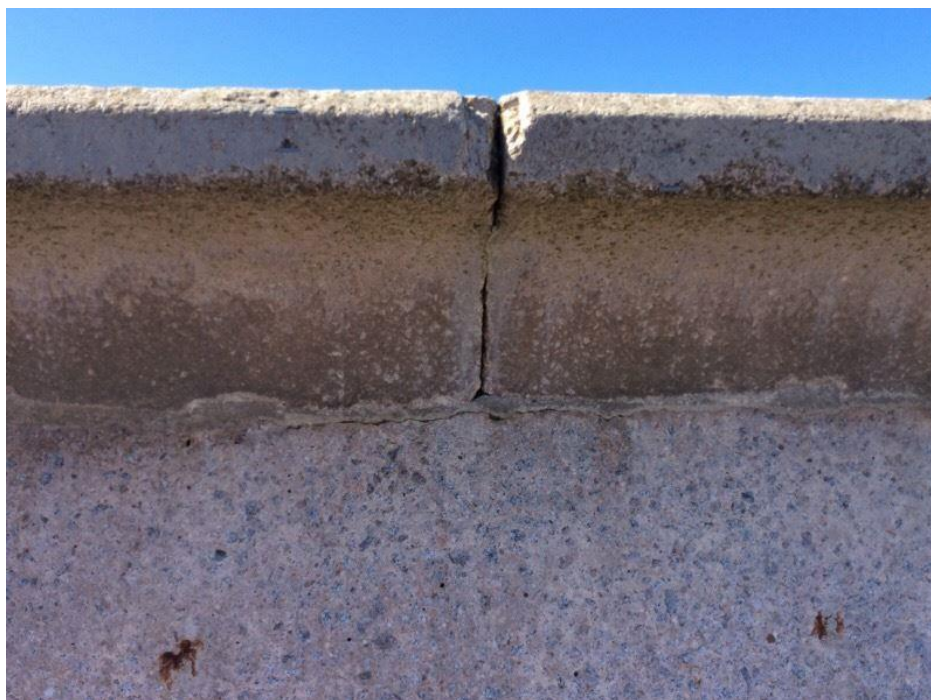
Section B
Exposed face
Defect Ref: D16
Description: D16 -
Missing pointing between
recurve units
Photo number: 61

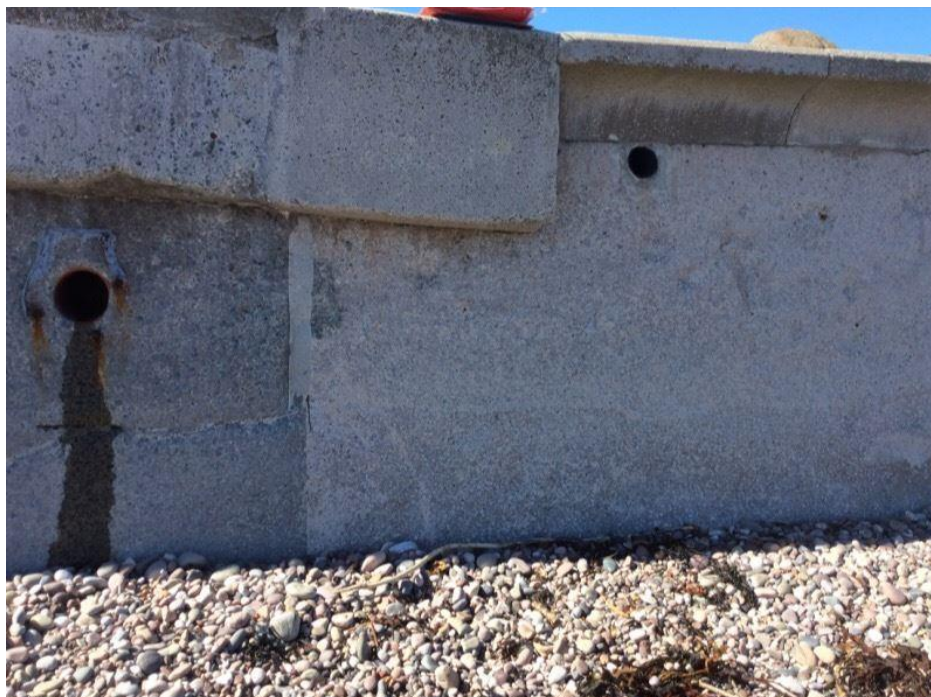
Section B
Exposed face
Defect Ref: D17
Description: D17 -
Blocked drainage pipes
Photo number: 62

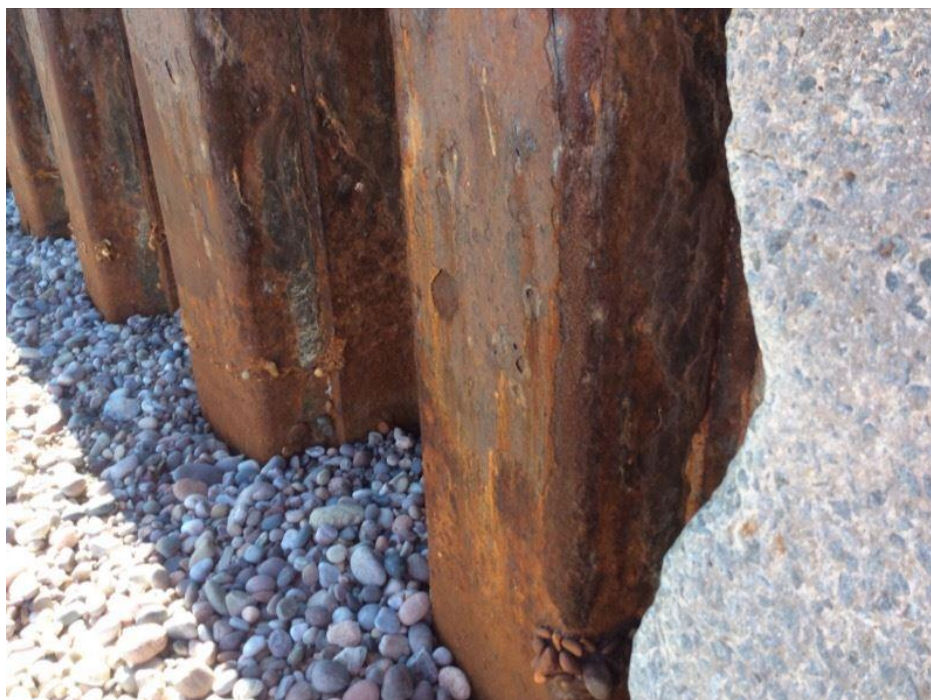
Section B
Exposed face
Defect Ref: D18
Description: D18 -
Corroded sheet piles
Photo number: 65

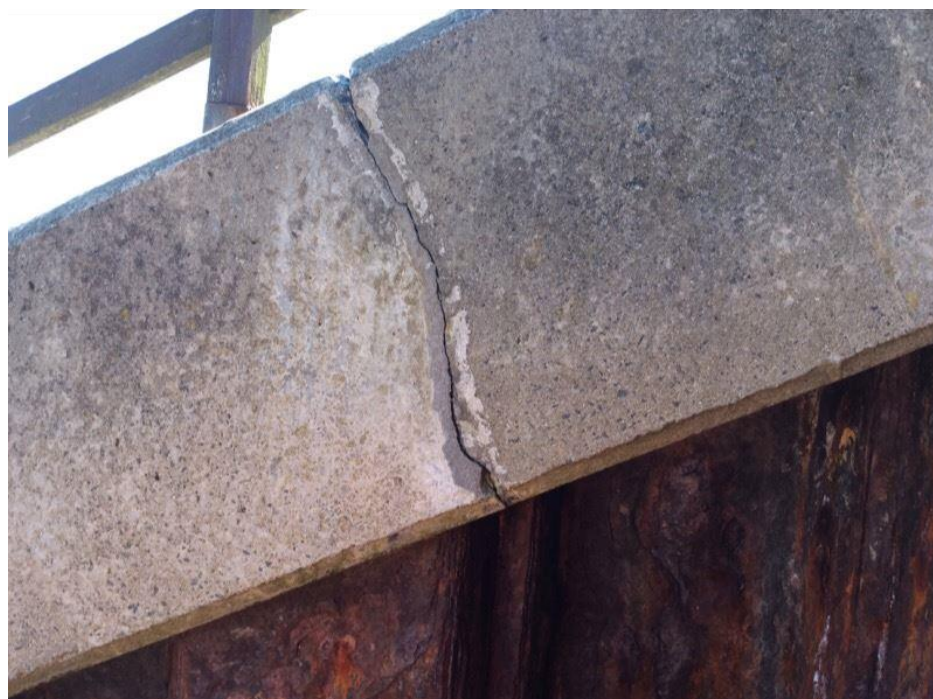
Section B
Exposed face
Defect Ref: D21
Description: D21 -
Crack in the capping
beam
Photo number: 68

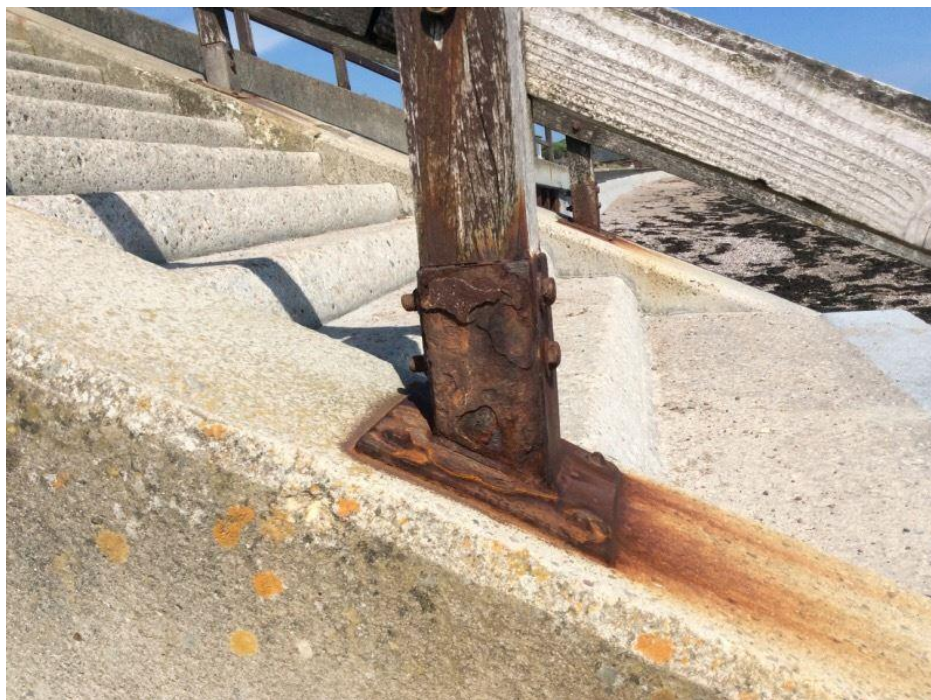
Section C
Exposed face
Defect Ref: D23
Description: D23 - Corroded handrailing support.
Photo number: 70

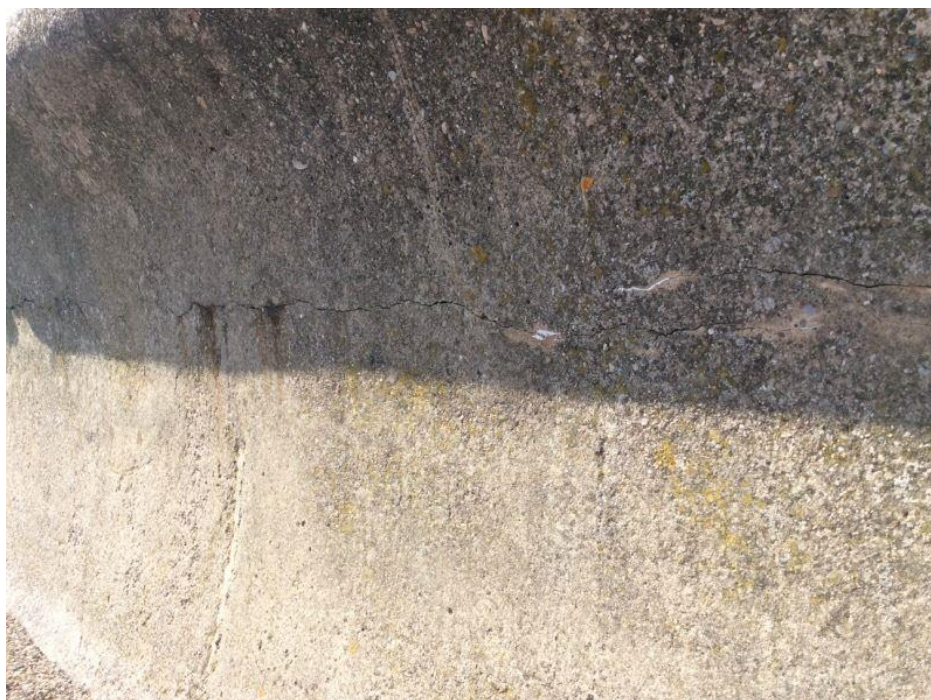
Section C
Splash wall
Defect Ref: D24
Description: D24 - Cracking of concrete
Photo number: 71

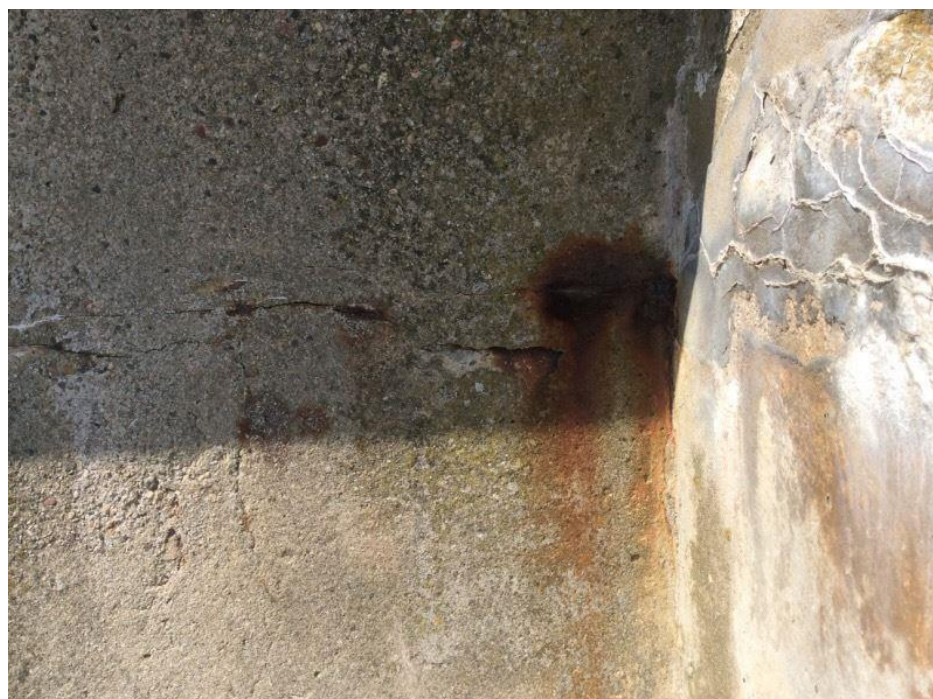
Section C
Splash wall
Defect Ref: D25
Description: D25 -
Corroded reinforcement
Photo number: 72

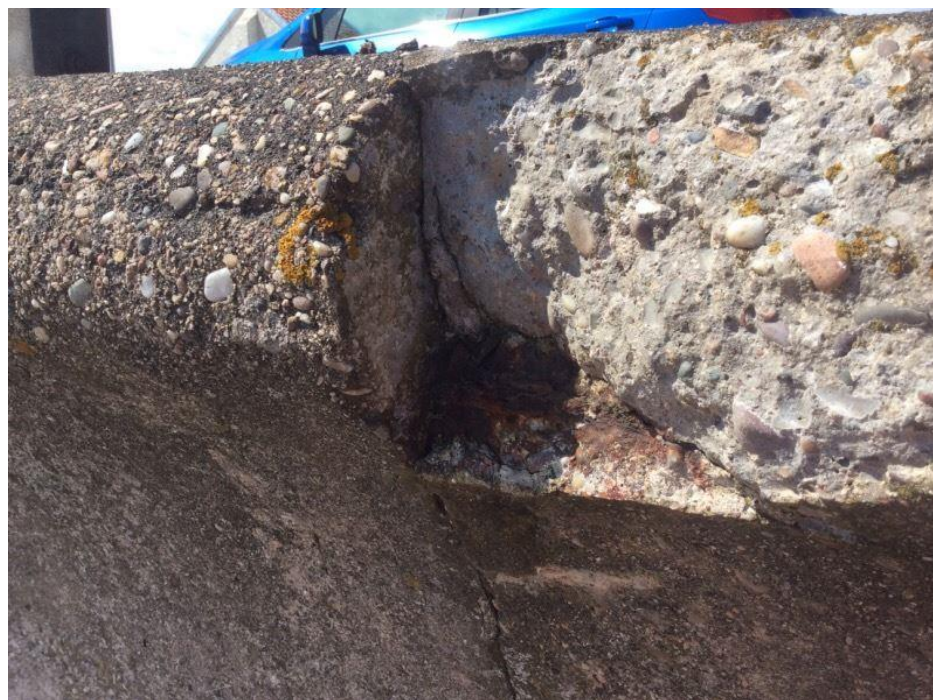
Section C
Splash wall
Defect Ref: D26
Description: D26 -
Chipped concrete
exposing reinforcement
Photo number: 73

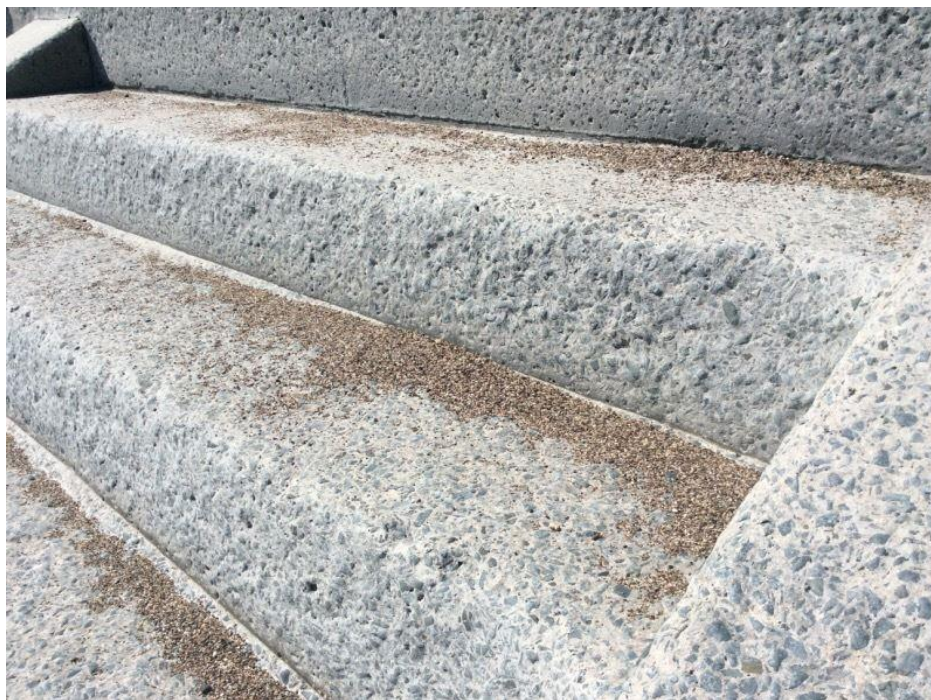
Section C
Splash wall
Defect Ref: D27
Description: D27 -
General abrasion of
steps
Photo number: 74

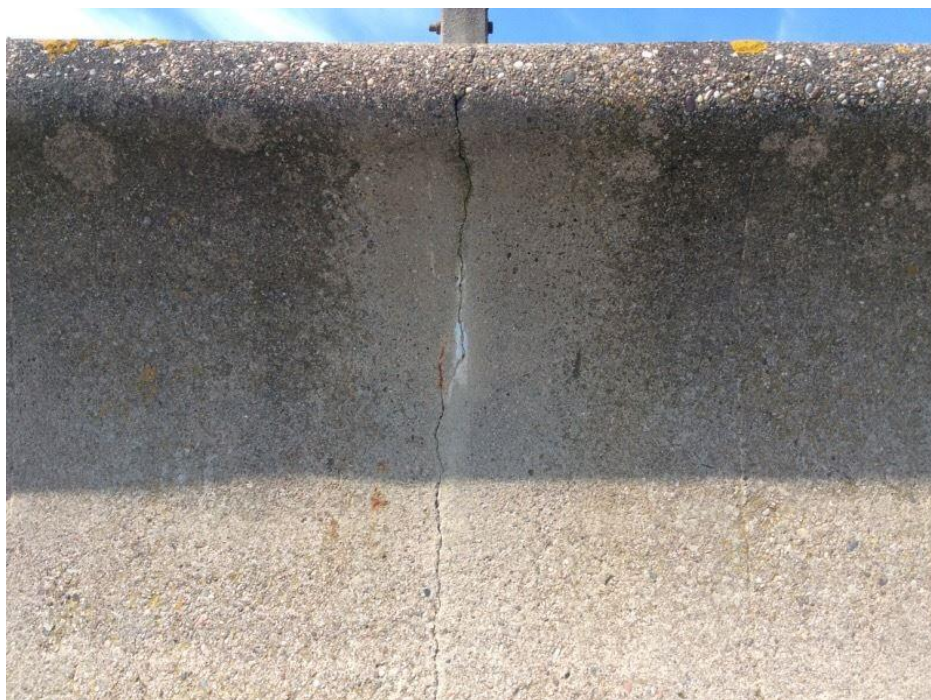
Section C
Splash wall
Defect Ref: D28
Description: D28 -
Vertical crack
Photo number: 75

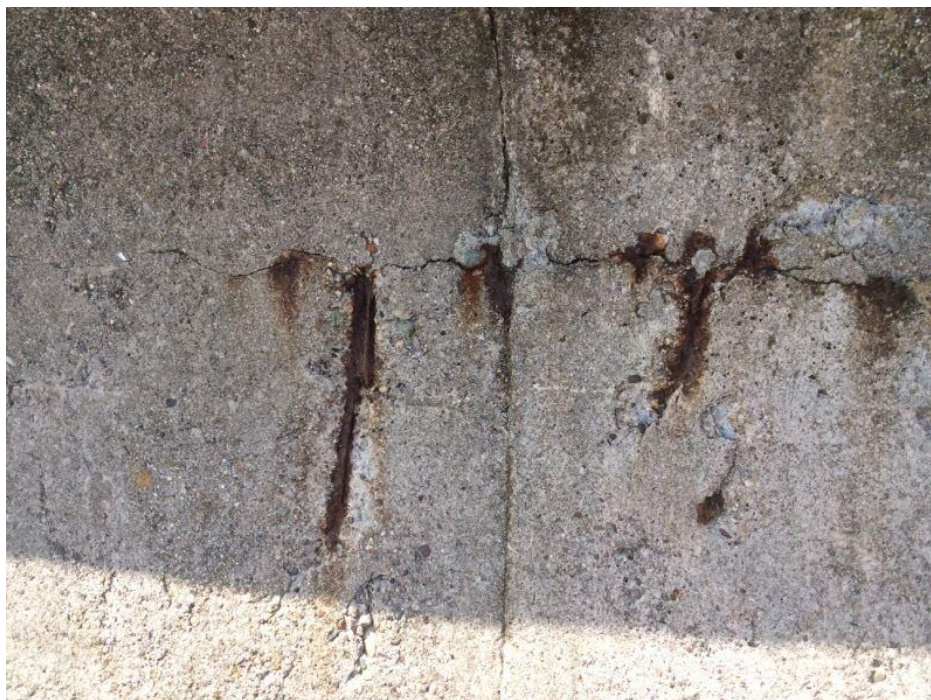
Section C
Splash wall
Defect Ref: D29
Description: D29 -
Exposed corroding
reinforcement
Photo number: 79

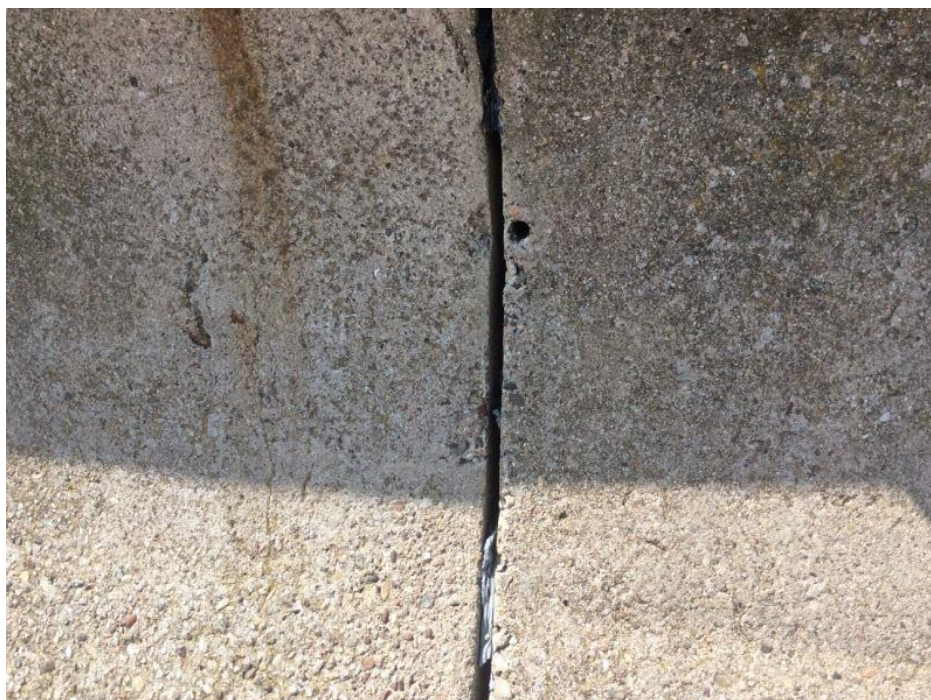
Section C
Splash wall
Defect Ref: D30
Description: D30 - Open
joints
Photo number: 76

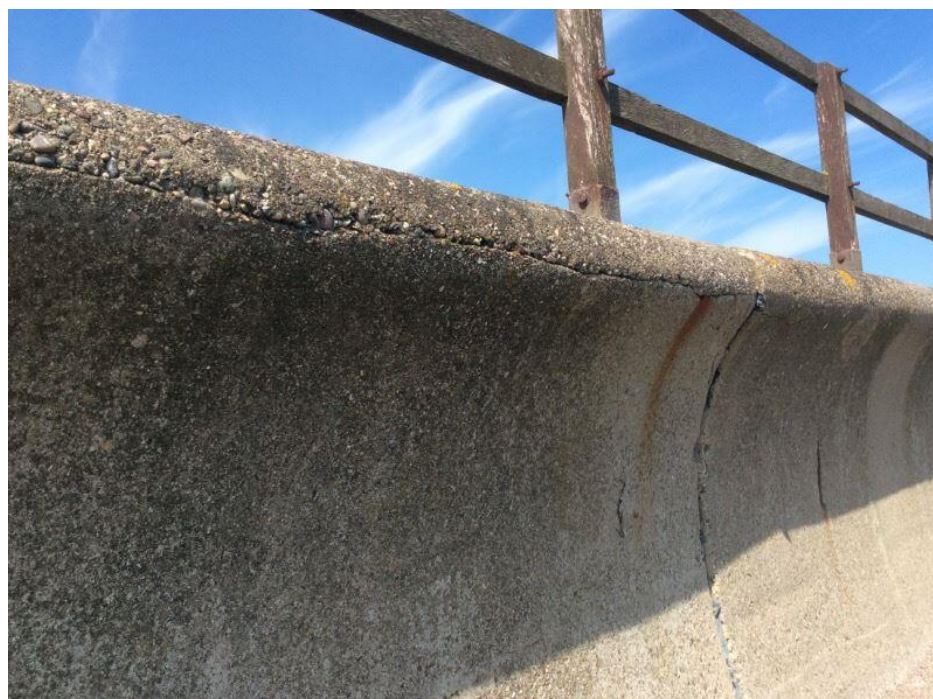
Section C
Splash wall
Defect Ref: D31
Description: D31 -
Cracking in upper radius
of recurve
Photo number: 77

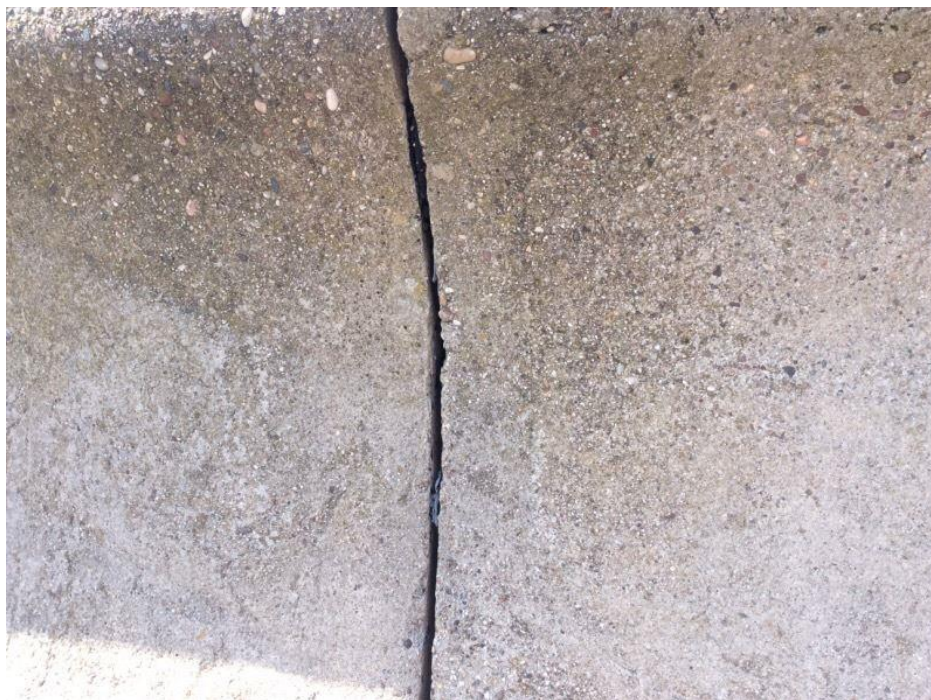
Section C
Splash wall
Defect Ref: D33
Description: D33 - Open joints
Photo number: 80

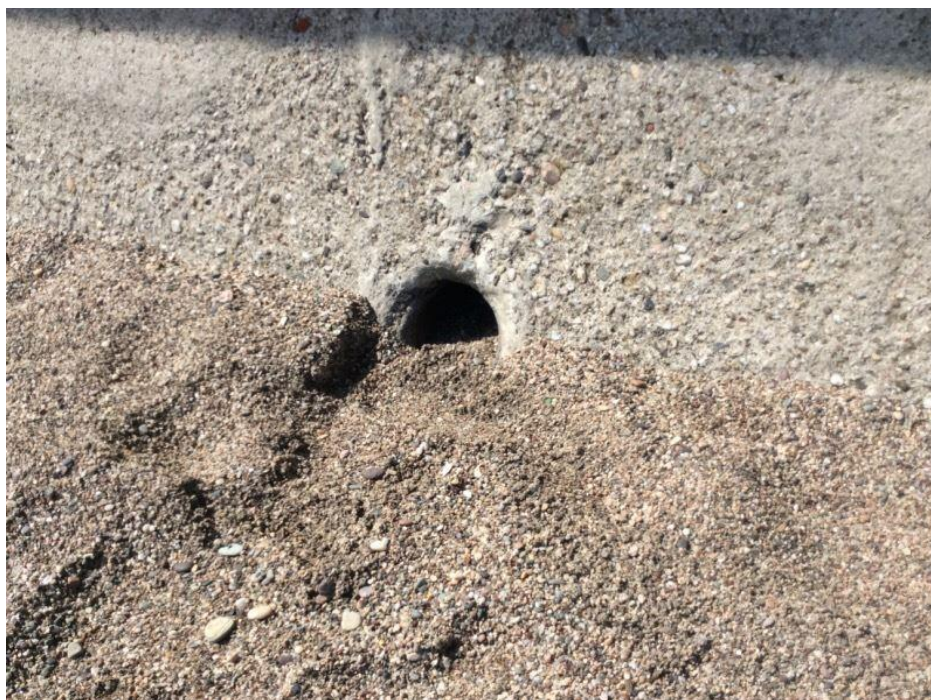
Section C
Splash wall
Defect Ref: D34
Description: D34 - 24 outfalls missing flap valves
Photo number: 81

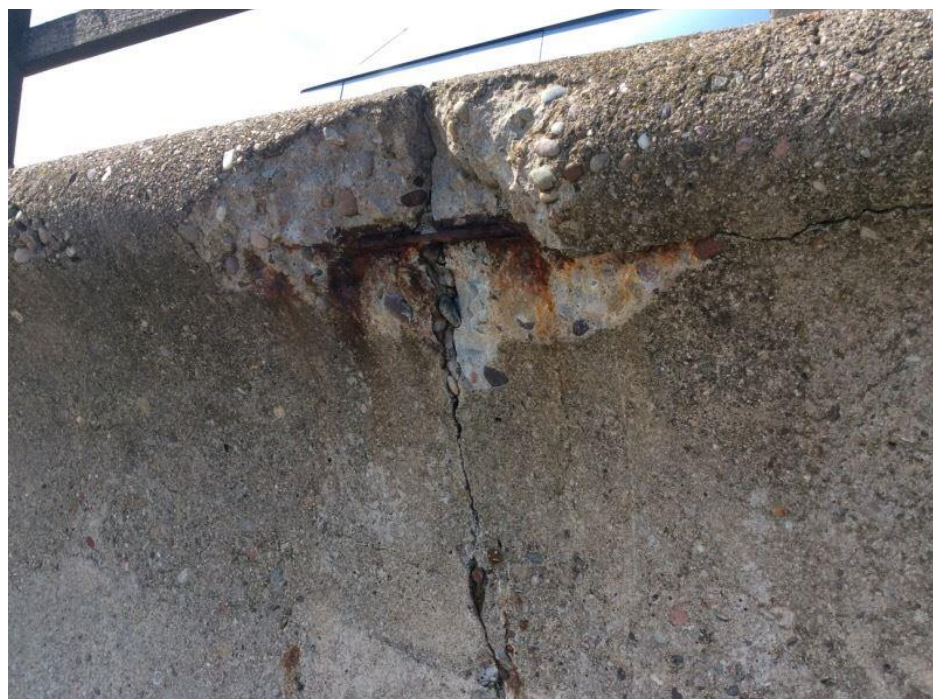
Section C
Splash wall
Defect Ref: D35
Description: D35 - Loss of concrete exposing reinforcement
Photo number: 82

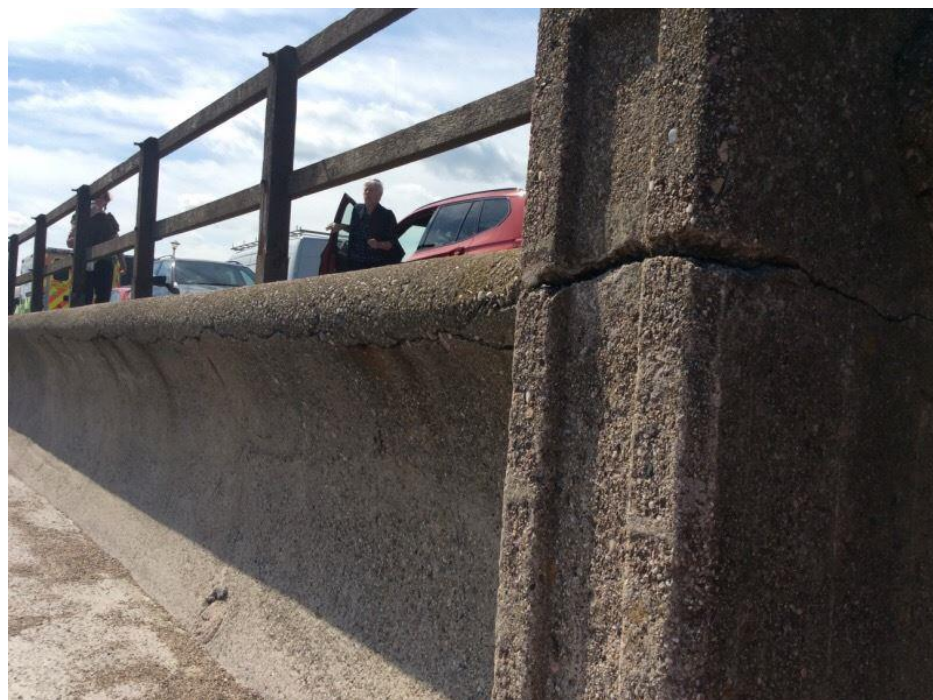
Section C
Splash wall
Defect Ref: D36
Description: D36 - Horizontal crack on sea wall and buttress wall
Photo number: 83

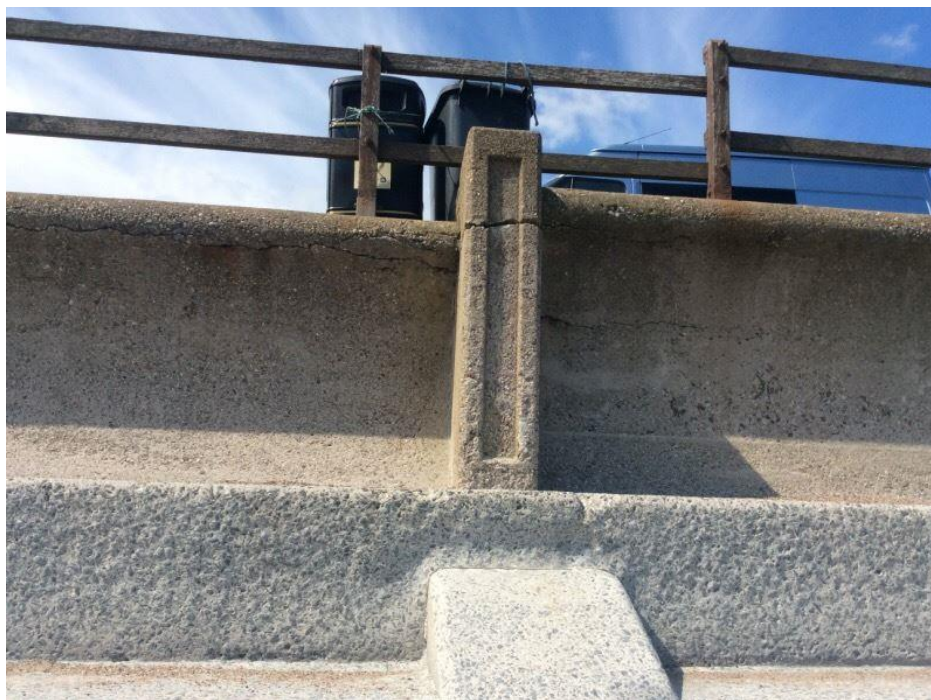
Section C
Splash wall
Defect Ref: D37
Description: D37 -
Difference in crest level
Photo number: 84

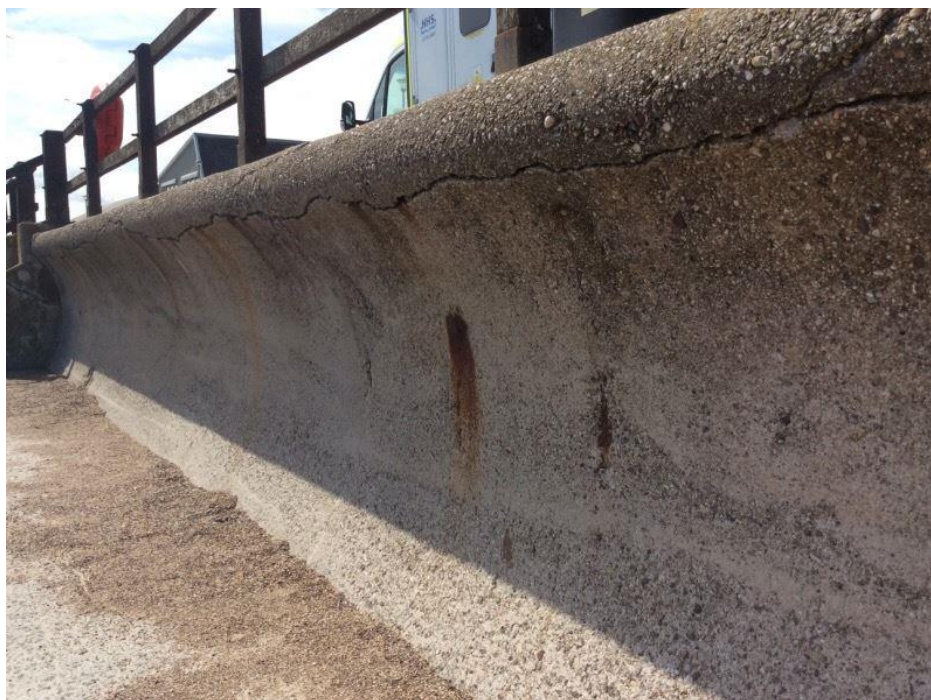
Section C
Splash wall
Defect Ref: D38
Description: D38 - 20m
long cracks
Photo number: 85

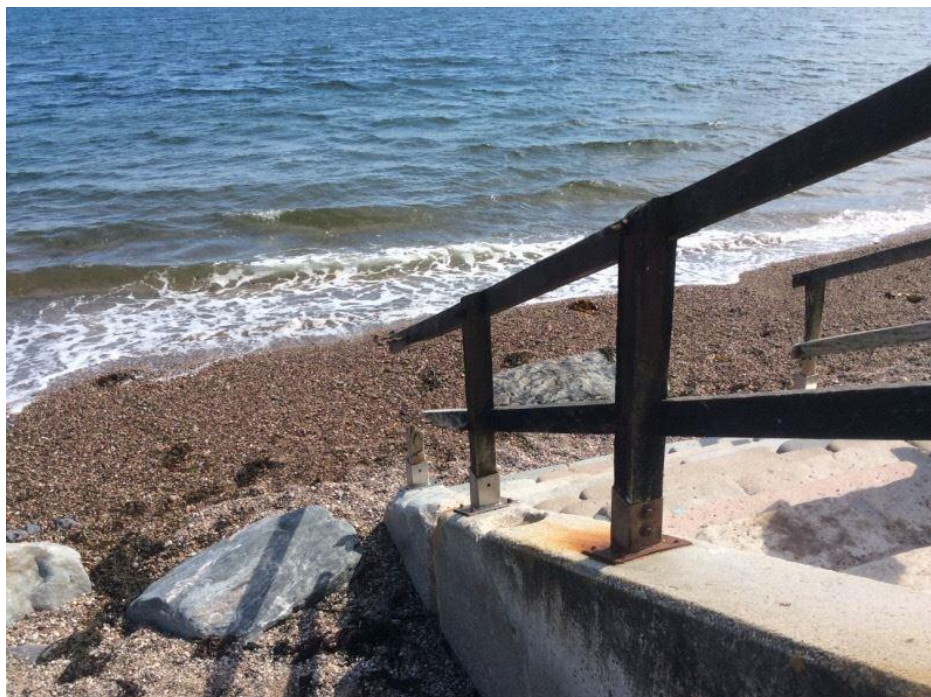
Section C
Splash wall
Defect Ref: D39
Description: D39 -
Handrailing missing
Photo number: 86

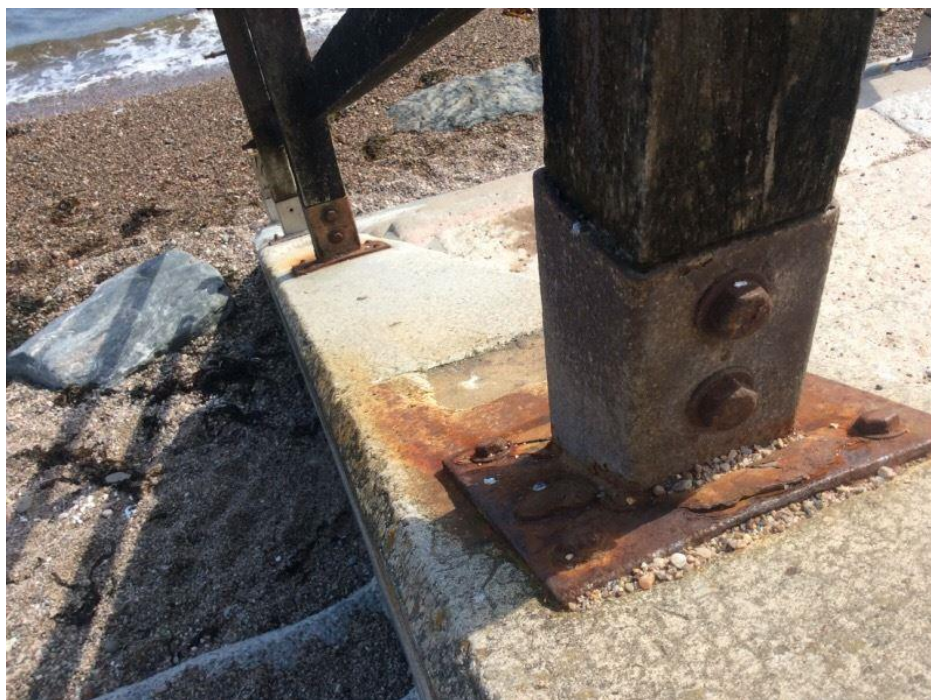
Section C
Splash wall
Defect Ref: D40
Description: D40 -
Corroded handrail
supports
Photo number: 87

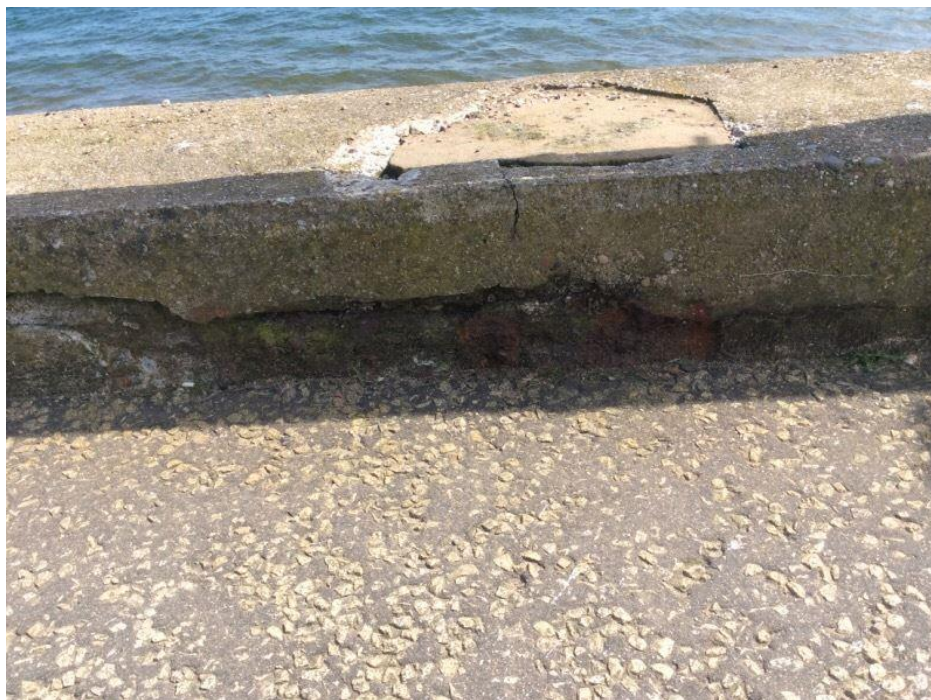
Section C
Splash wall
Defect Ref: D43
Description: D43 -
Cover loss and corroding
reinforcement
Photo number: 90

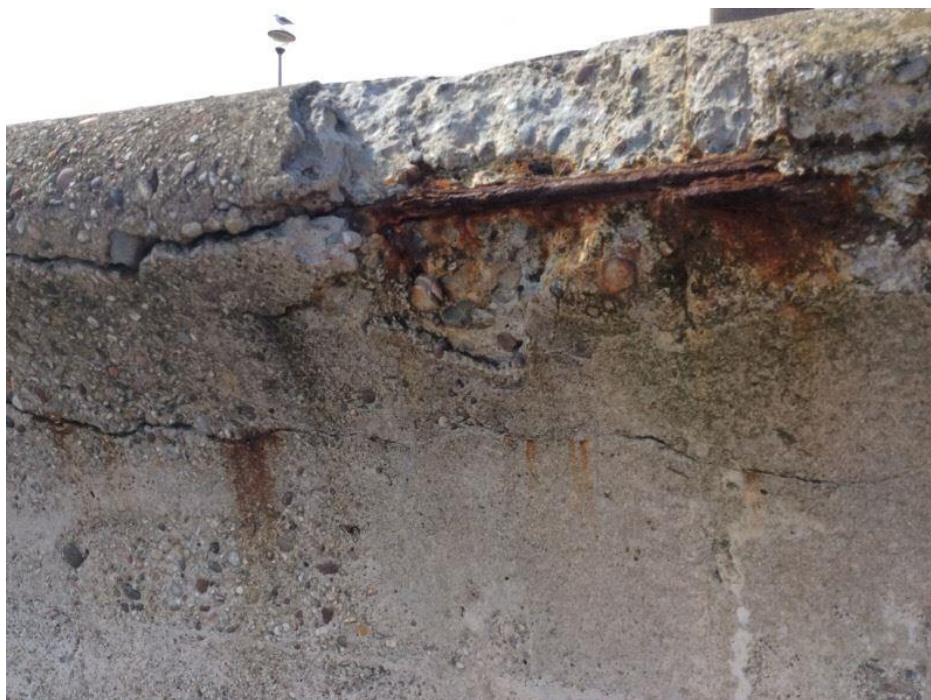
Section C
Splash wall
Defect Ref: D44
Description: D44 -
Crack exposing
corroding reinforcement
Photo number: 91

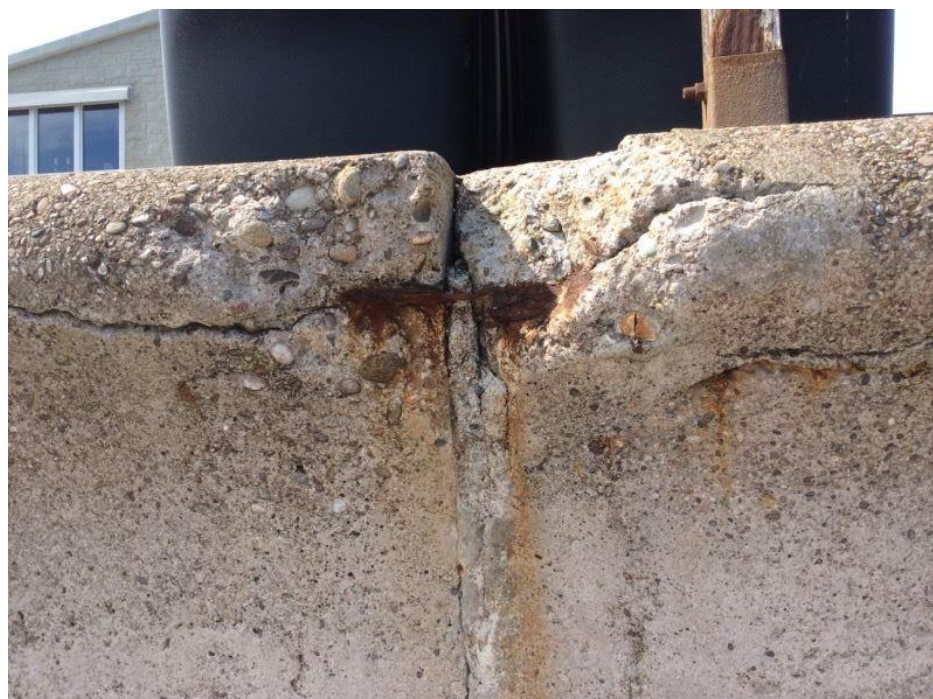
Section C
Splash wall
Defect Ref: D45
Description: D45 -
Chipped concrete
exposing reinforcement
Photo number: 92
