Stonehaven Bay Coastal Flood Protection Study

Final Report

December 2019

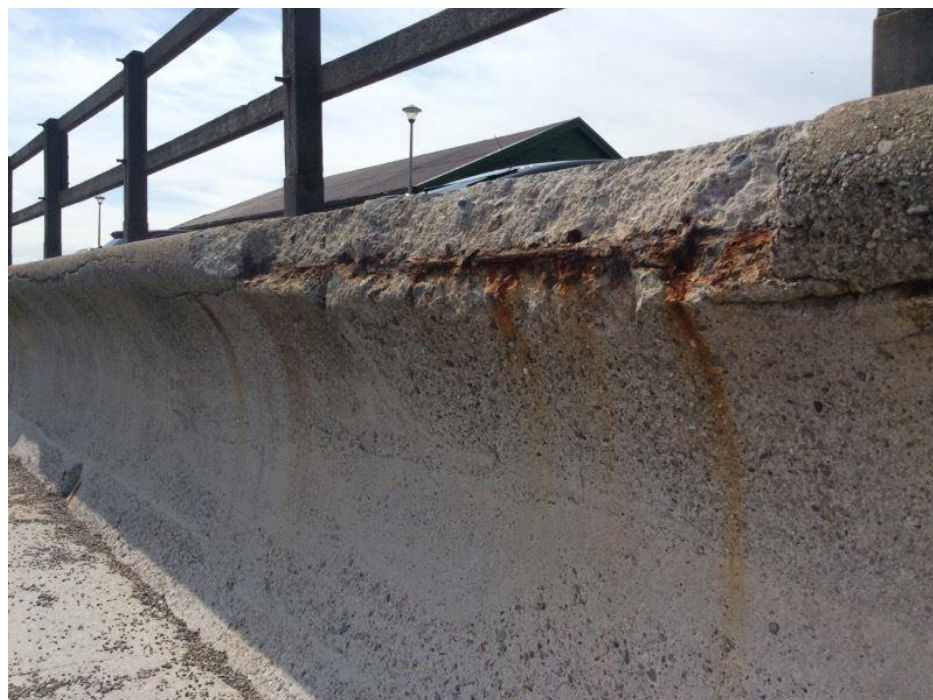
Section C
Splash wall
Defect Ref: D46
Description: D46 -
Chipped concrete
exposing reinforcement
Photo number: 93

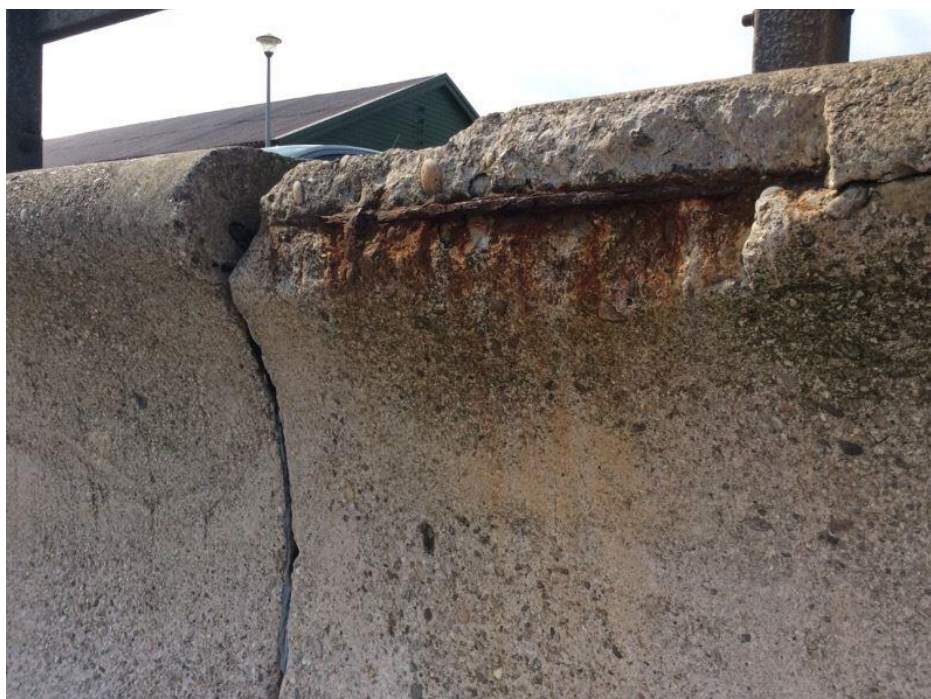
Section C
Splash wall
Defect Ref: D47
Description: D47 -
Chipped concrete
exposing reinforcement
Photo number: 94

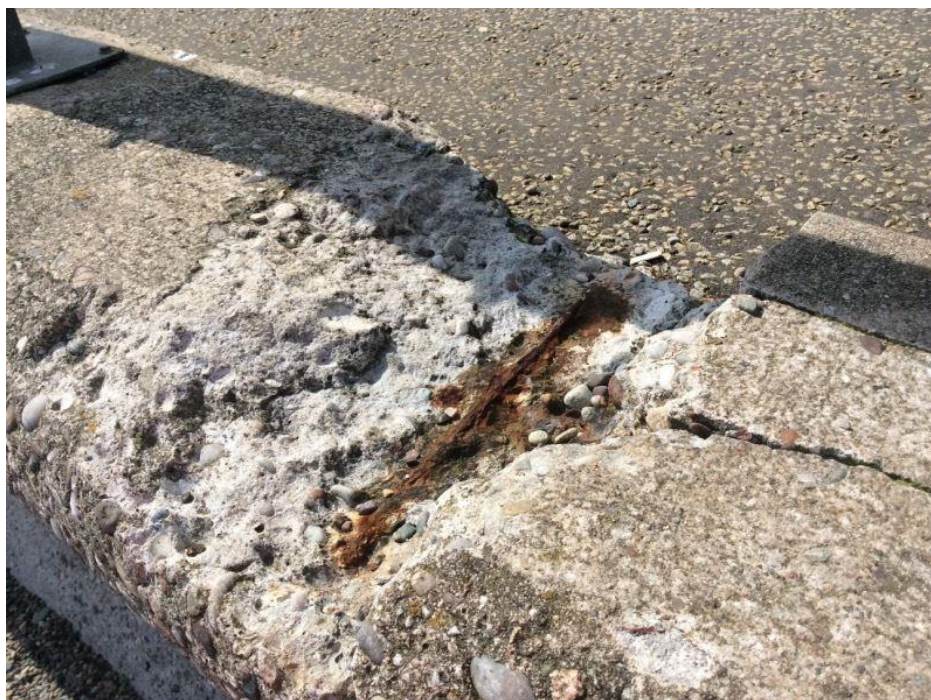
Section C
Splash wall
Defect Ref: D48
Description: D48 -
Chipped concrete
exposing reinforcement
Photo number: 95

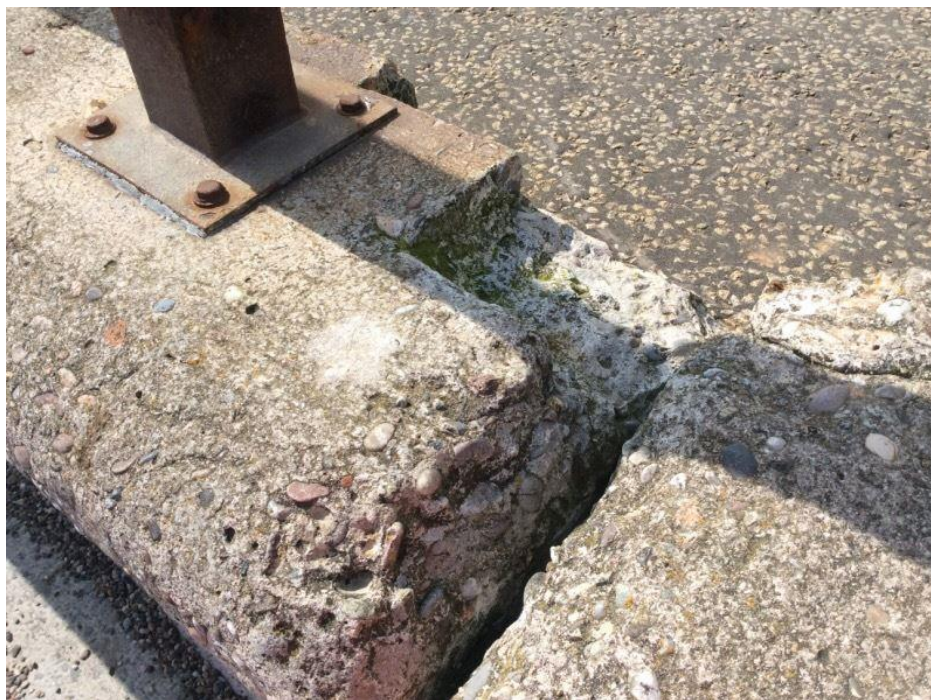
Section C
Splash wall
Defect Ref: D49
Description: D49 -
Damaged concrete on
top of recurve
Photo number: 96

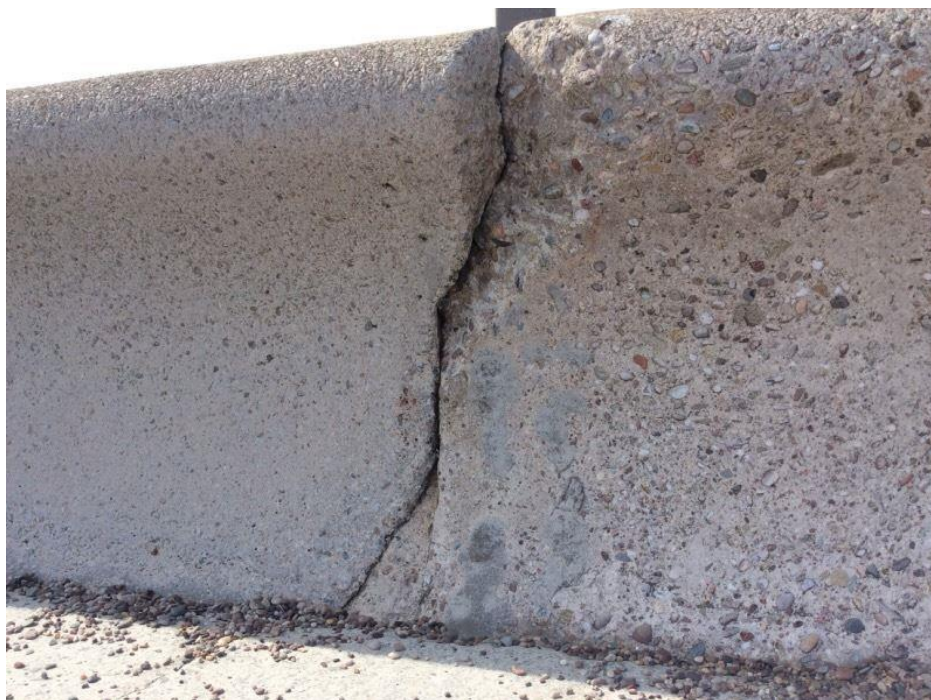
Section C
Splash wall
Defect Ref: D50
Description: D50 -
Vertical crack on recurve
Photo number: 97

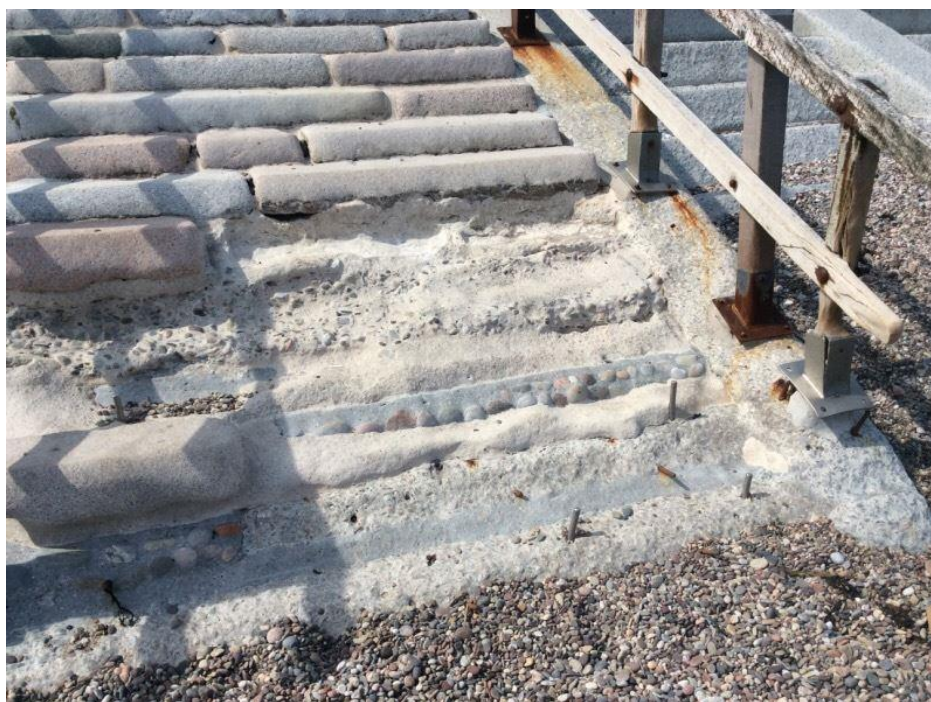
Section C
Splash wall
Defect Ref: D51
Description: D51 - Loss of steps and exposed dowels
Photo number: 98

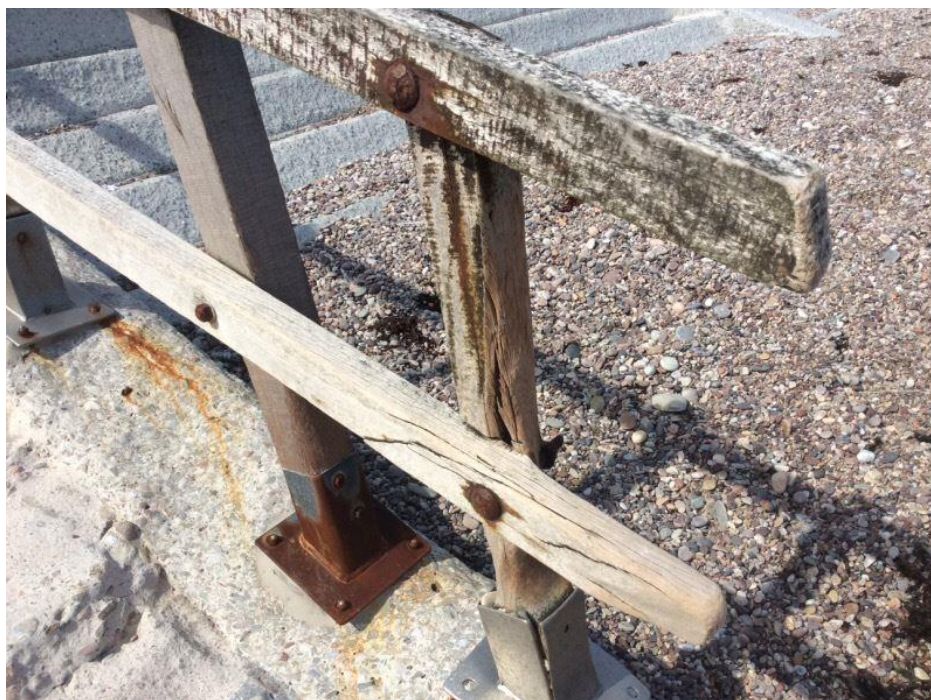
Section C
Splash wall
Defect Ref: D52
Description: D52 - Signs of rot on timber handrailing
Photo number: 99

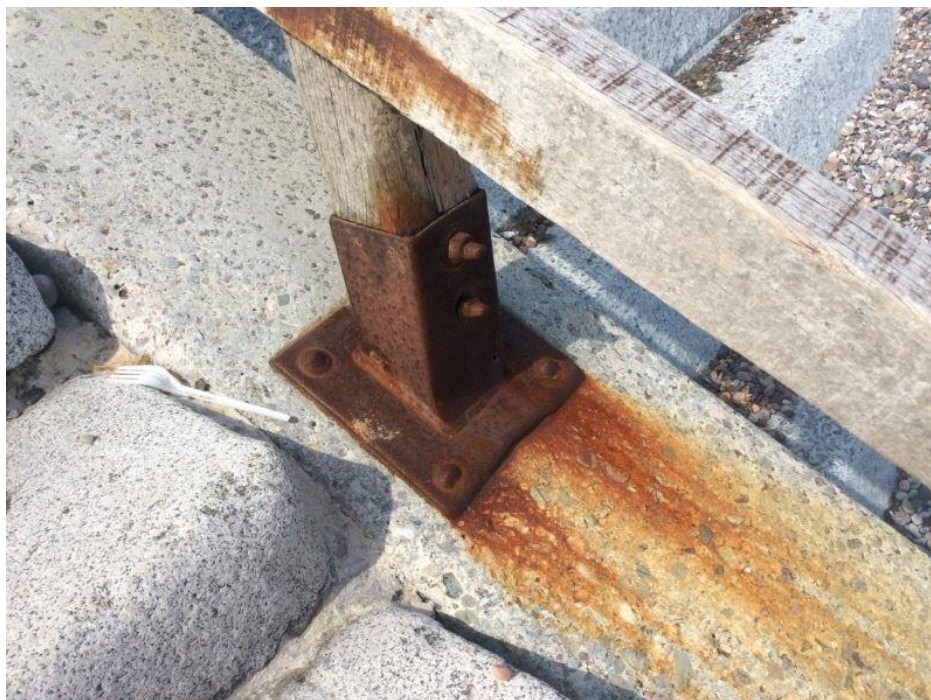
Section C
Splash wall
Defect Ref: D53
Description: D53 -
Corroded handrail
supports
Photo number: 100

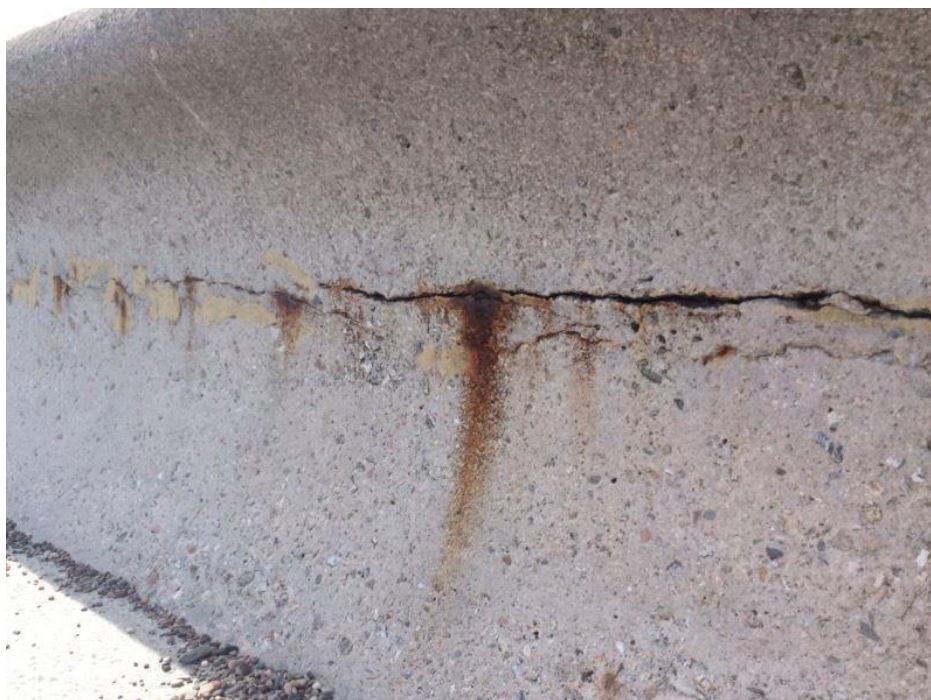
Section C
Splash wall
Defect Ref: D54
Description: D54 -
Horizontal crack in sea
wall
Photo number: 101

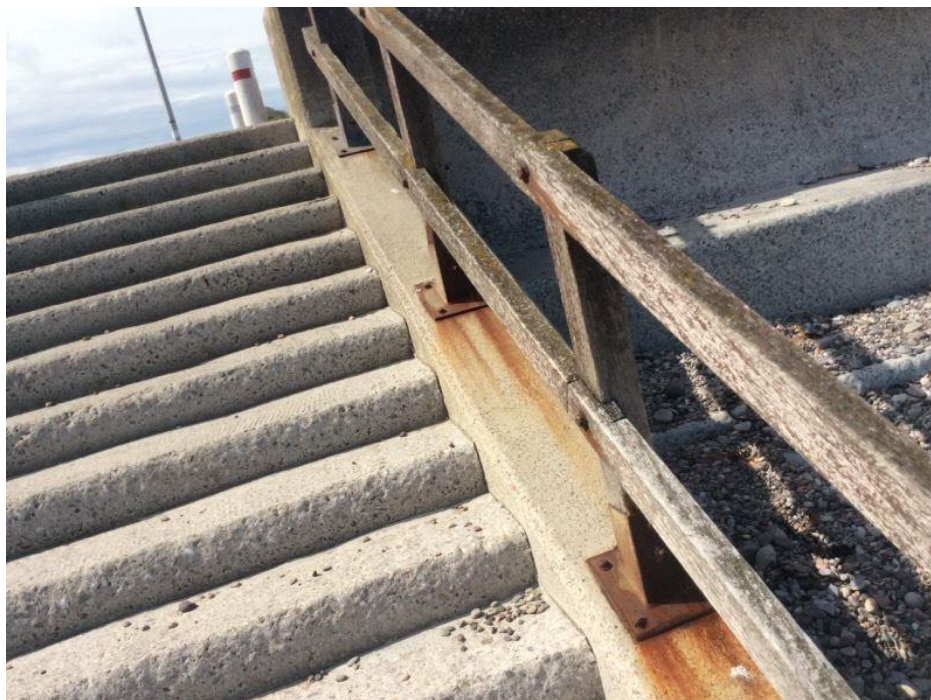
Section C
Exposed face
Defect Ref: D55
Description: D55 -
Corrosion of handrailing
supports
Photo number: 102

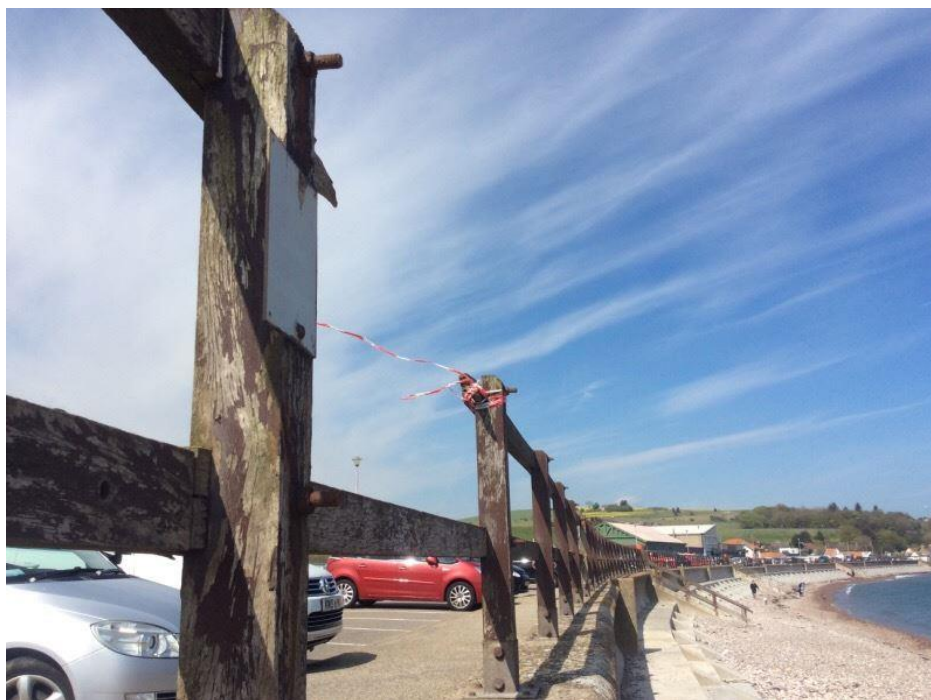
Section C
Splash wall
Defect Ref: D56
Description: D56 -
Missing handrails
Photo number: 103

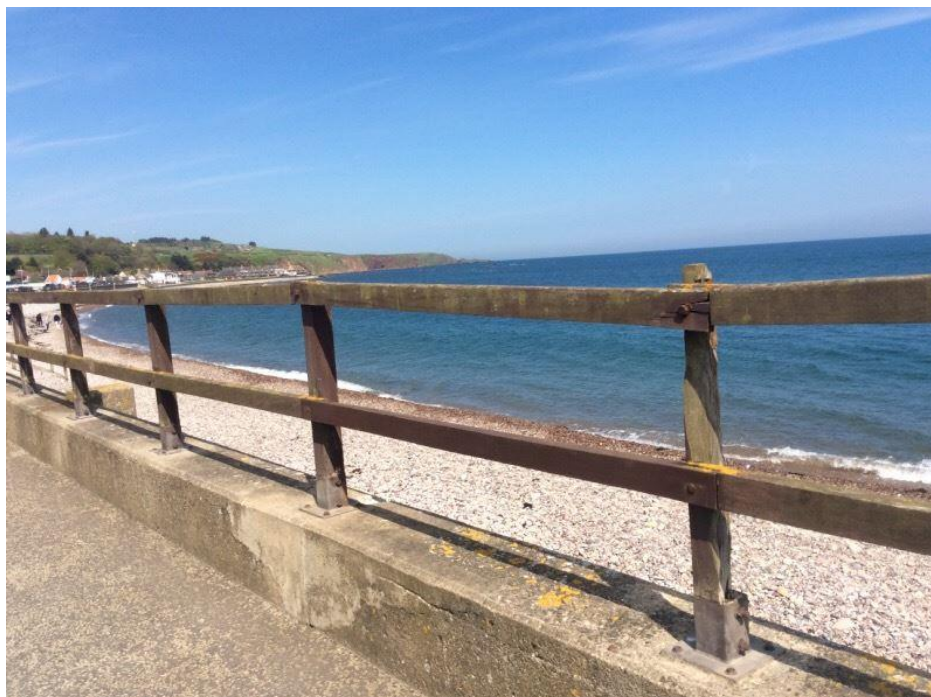
Section C
Splash wall
Defect Ref: D57
Description: D57 -
Distorted handrails
Photo number: 104

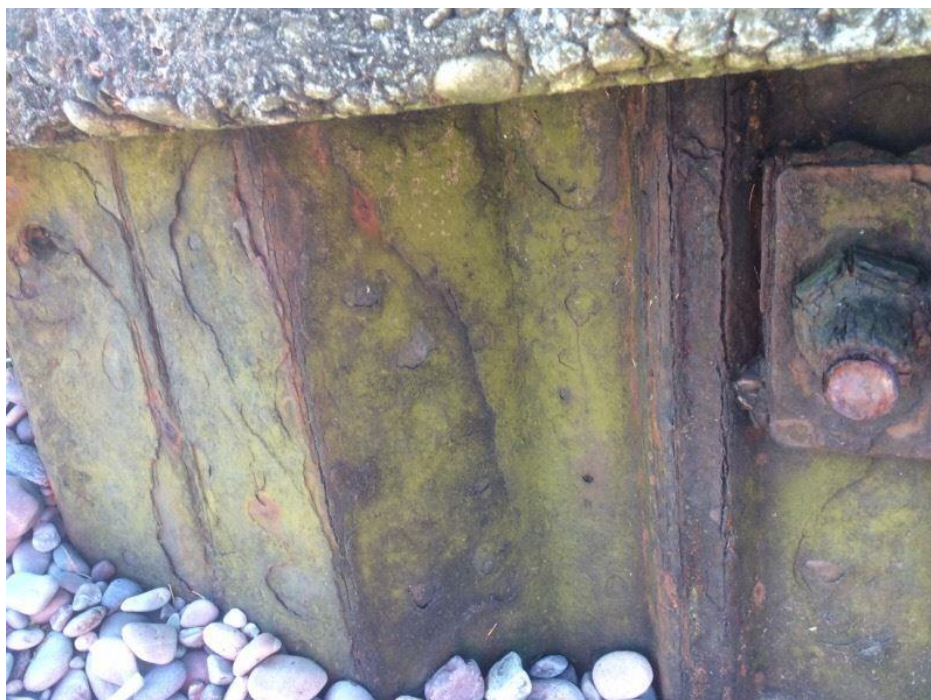
Section D
Piling
Defect Ref: D58
Description: D58 -
Corrosion of piles
Photo number: 105

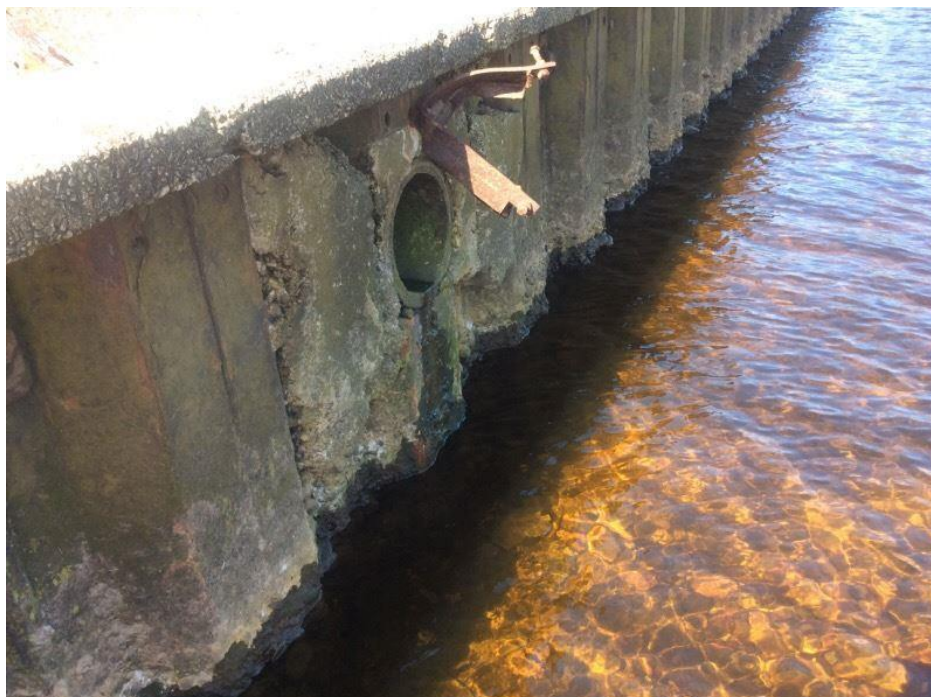
Section D
Piling
Defect Ref: D59
Description: D59 -
Missing flap valve
Photo number: 106

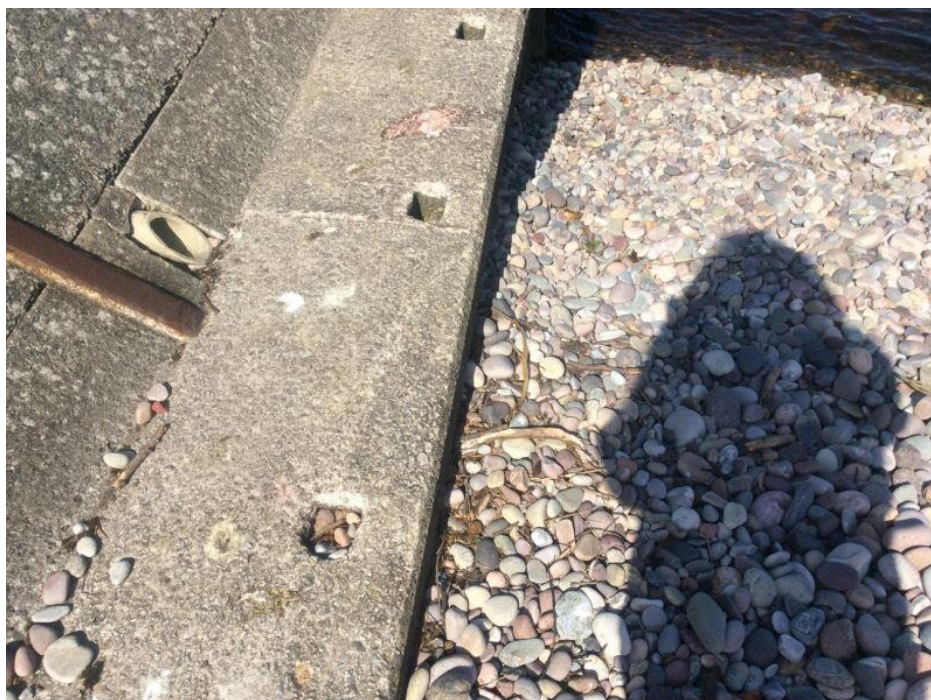
Section D
Channel side
Defect Ref: D60
Description: D60 -
Drainage points blocked
Photo number: 107

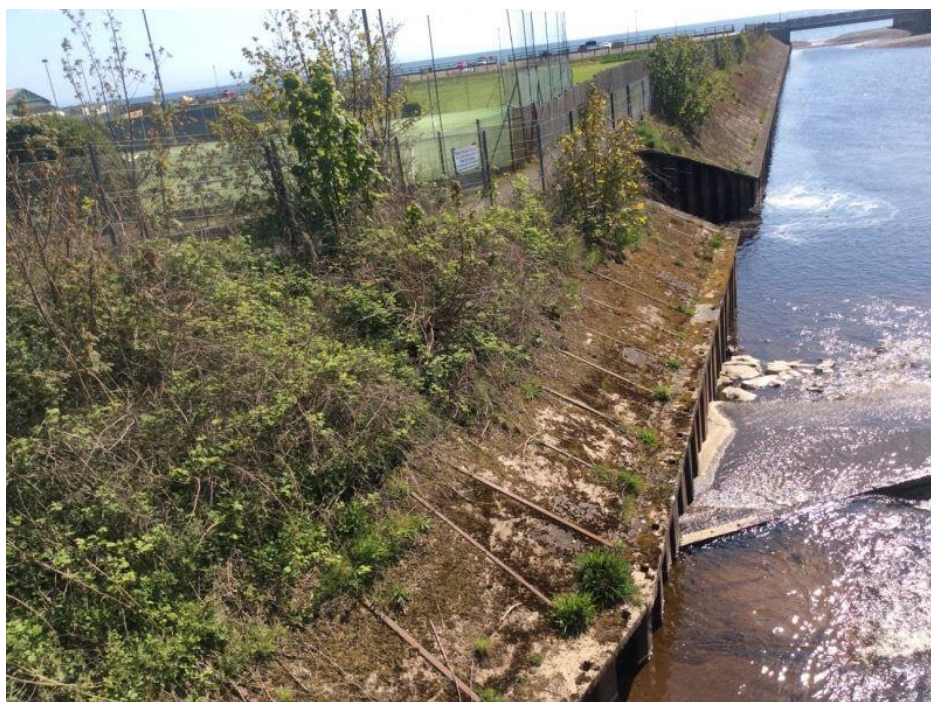
Section D
Channel side
Defect Ref: D61
Description: D61 -
Vegetation growth on top
of concrete
Photo number: 122

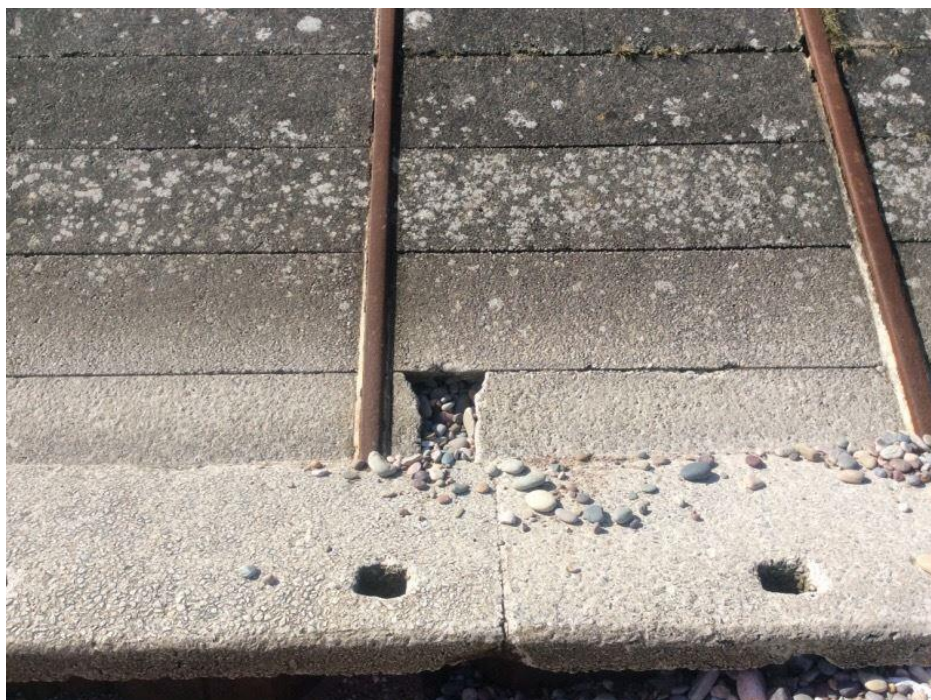
Section D
Channel side
Defect Ref: D62
Description: D62 -
Broken slab, potential for
scour behind protected
face
Photo number: 108

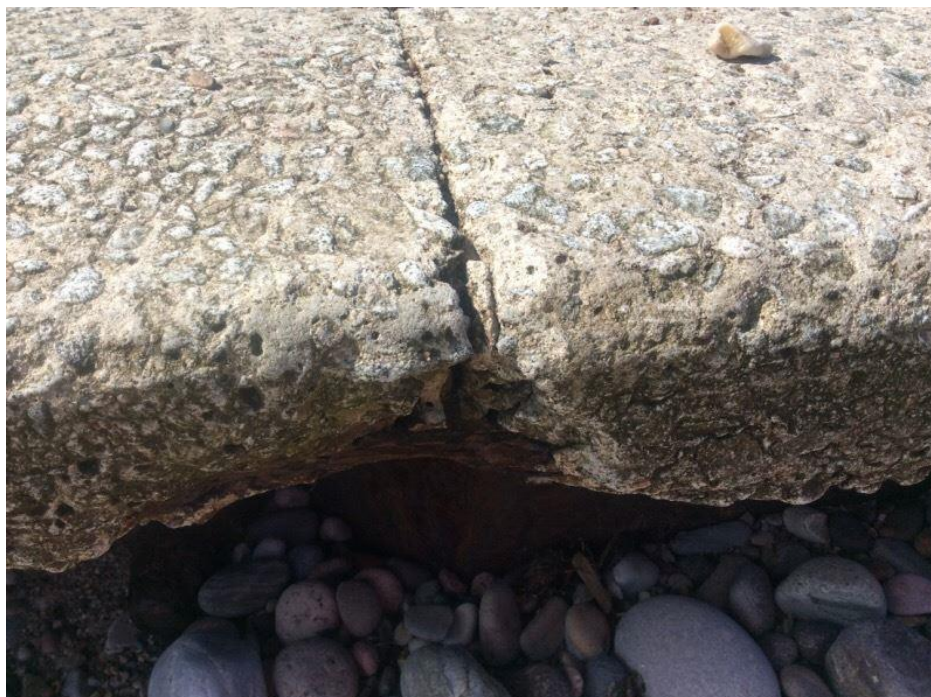
Section D
Piling
Defect Ref: D63
Description: D63 -
Damaged concrete
capping beam exposing
reinforcement
Photo number: 109

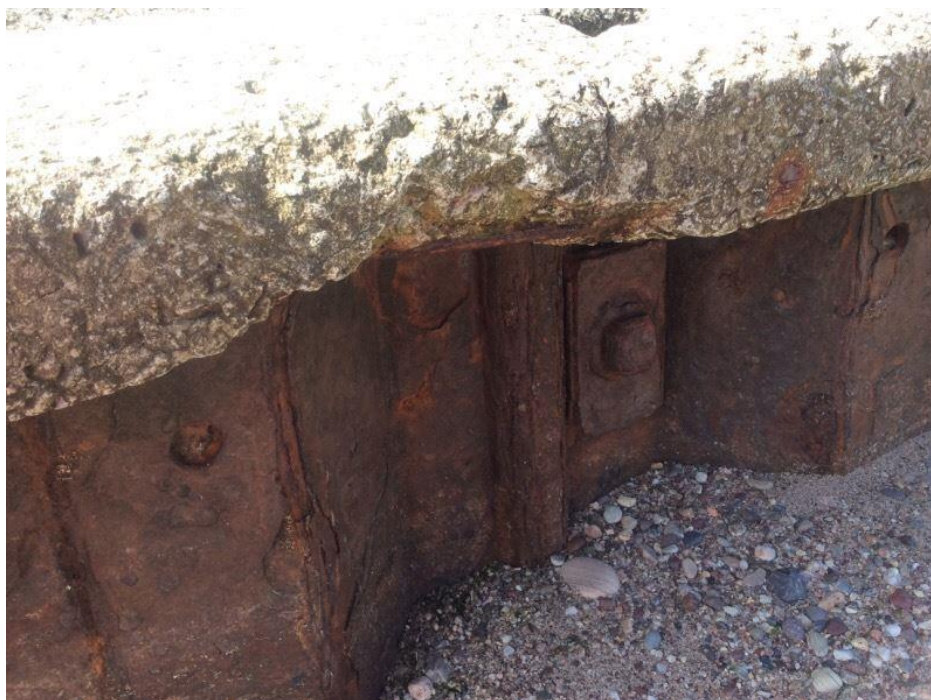
Section D
Piling
Defect Ref: D63
Description: D63 -
Damaged concrete
capping beam exposing
reinforcement
Photo number: 143

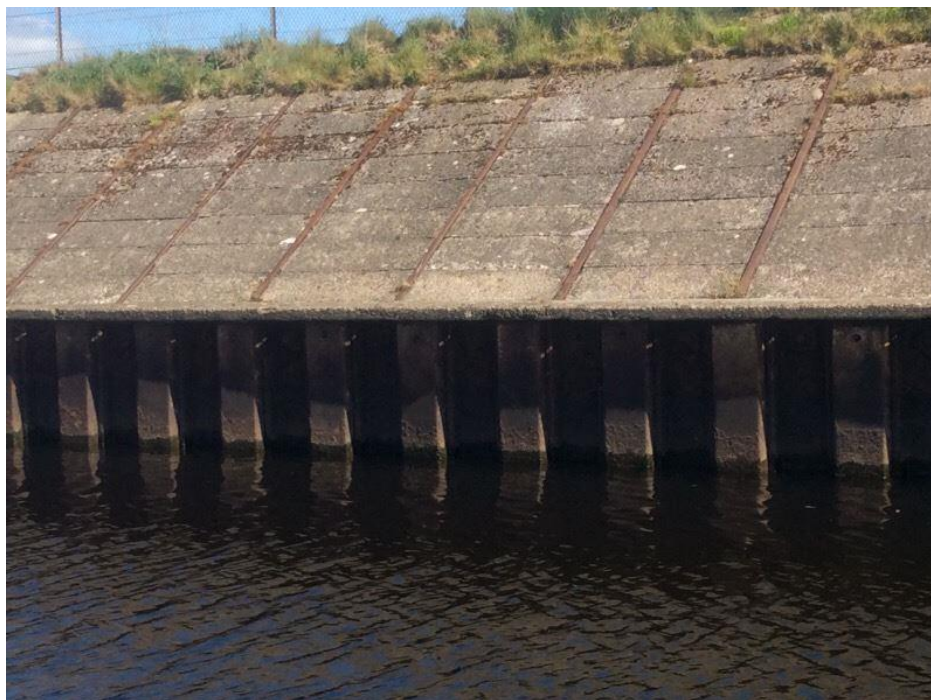
Section D
Piling
Defect Ref: D64
Description: D64 -
Anchor missing,
potentially more than one
Photo number: 110

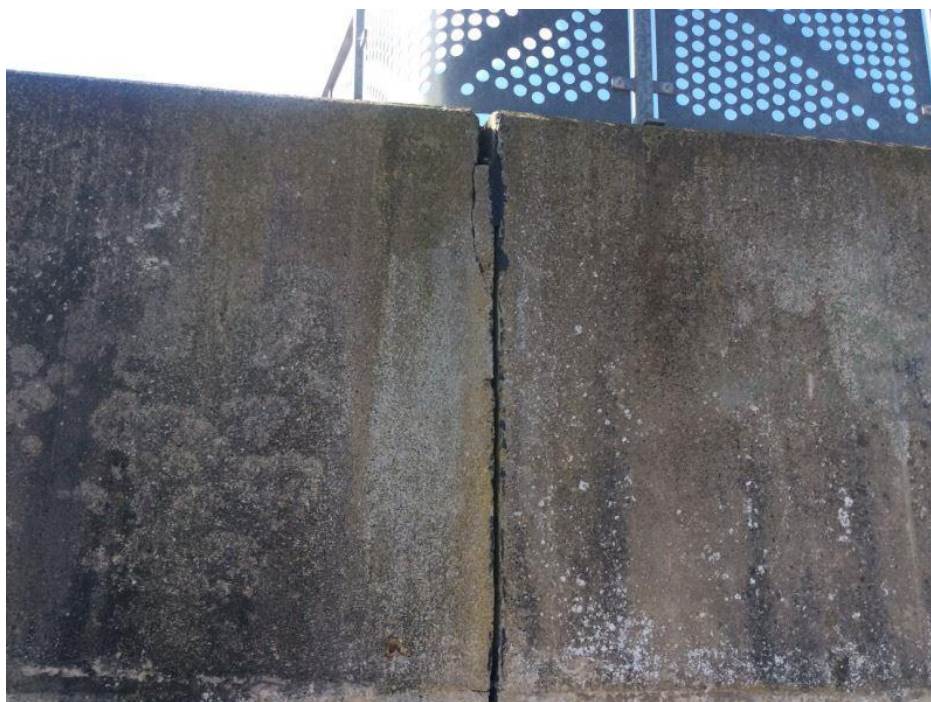
Section D
Exposed face
Defect Ref: D66
Description: D65 -
Cracked and broken
concrete approximately
0.5m
Photo number: 112

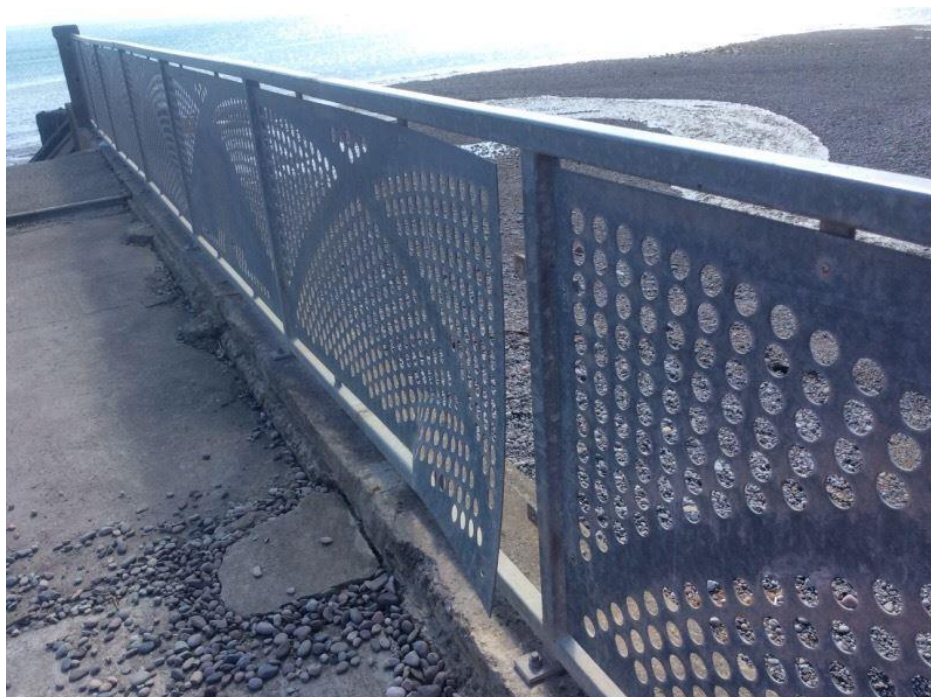
Section D
Exposed face
Defect Ref: D68
Description: D68 -
Broken parapet
Photo number: 114

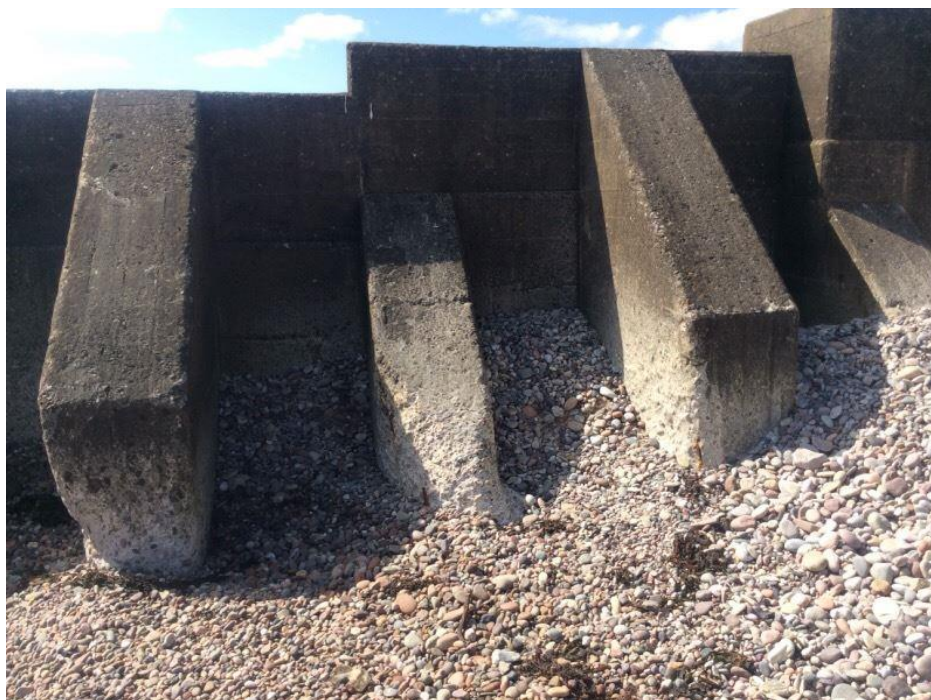
Section D
Exposed face
Defect Ref: D69
Description: D69 -
Abrasion of concrete
exposing reinforcement
Photo number: 115

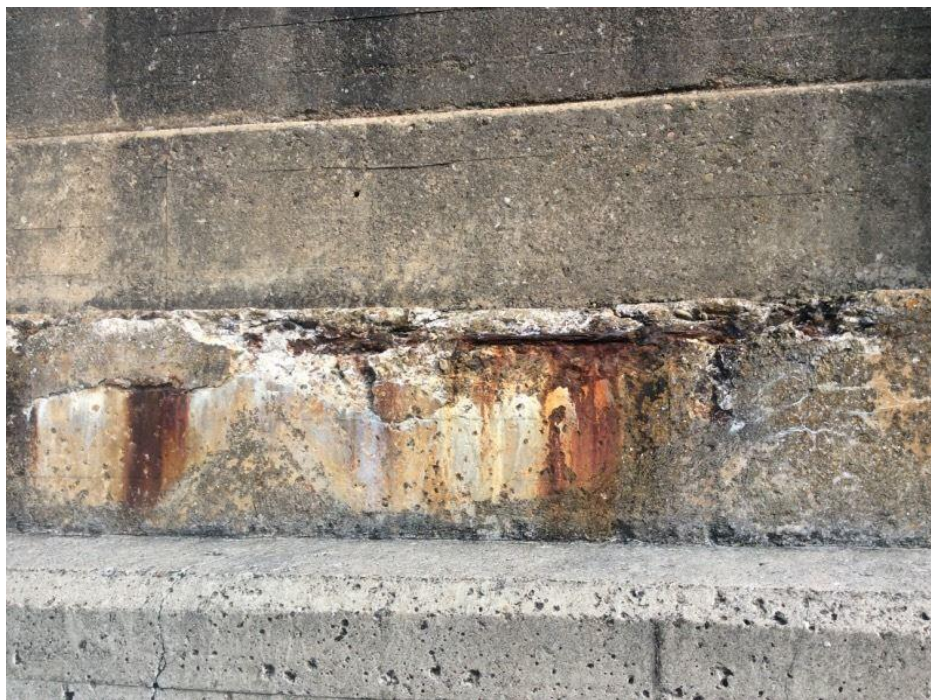
Section D
Exposed face
Defect Ref: D70
Description: D70 -
Damaged concrete
approximately 1.5m long,
exposing heavily
corroded reinforcement
Photo number: 116

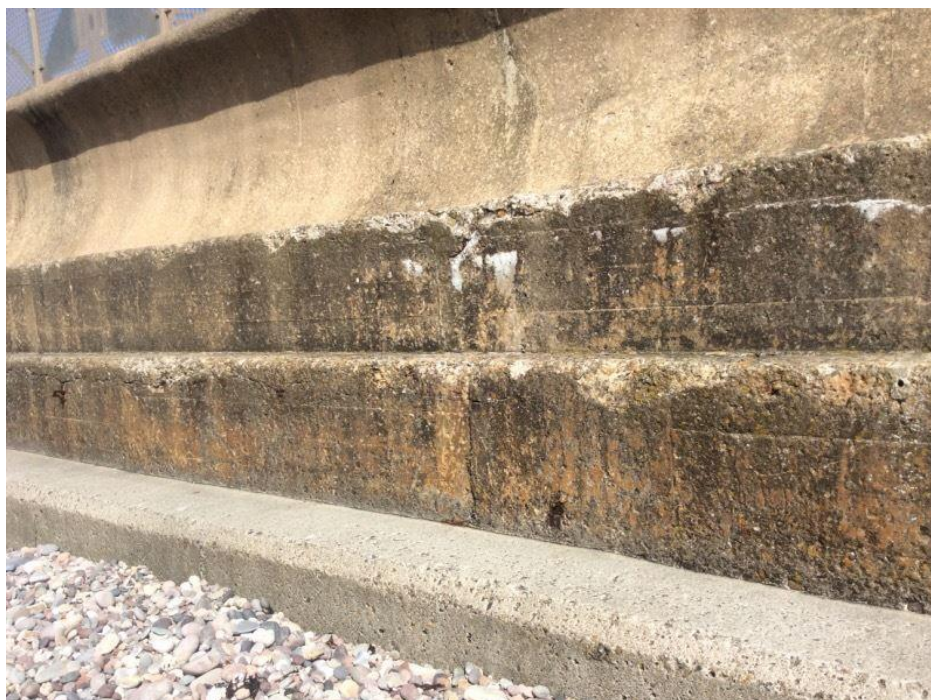
Section D
Exposed face
Defect Ref: D71
Description: D71 -
Chipping concrete and
cracks along the river
face of the wall
Photo number: 117

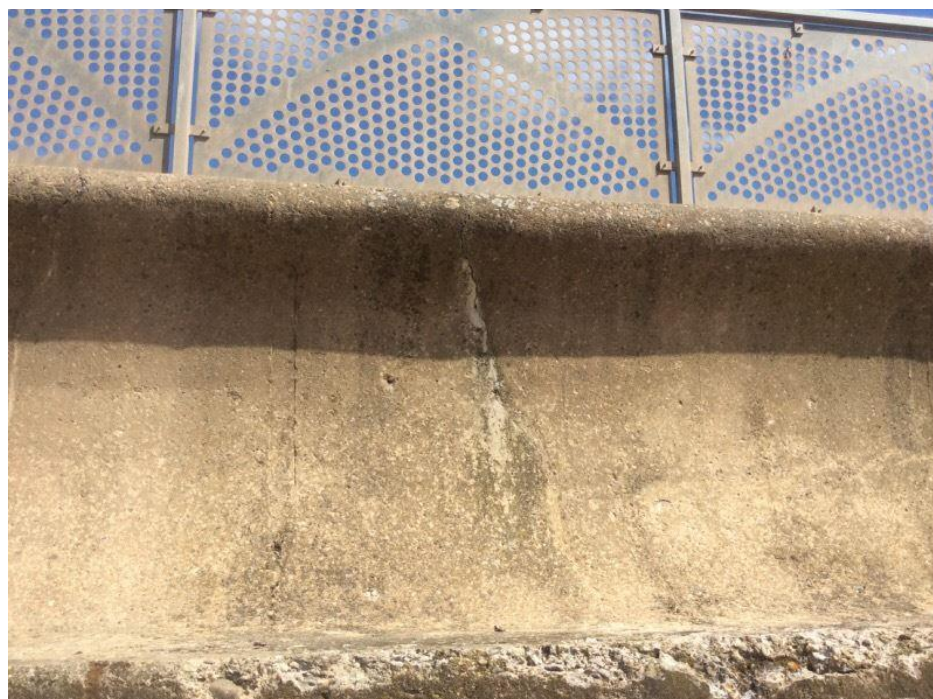
Section D
Exposed face
Defect Ref: D72
Description: D72 -
Vertical crack on recurve
approximately 1m long
Photo number: 118

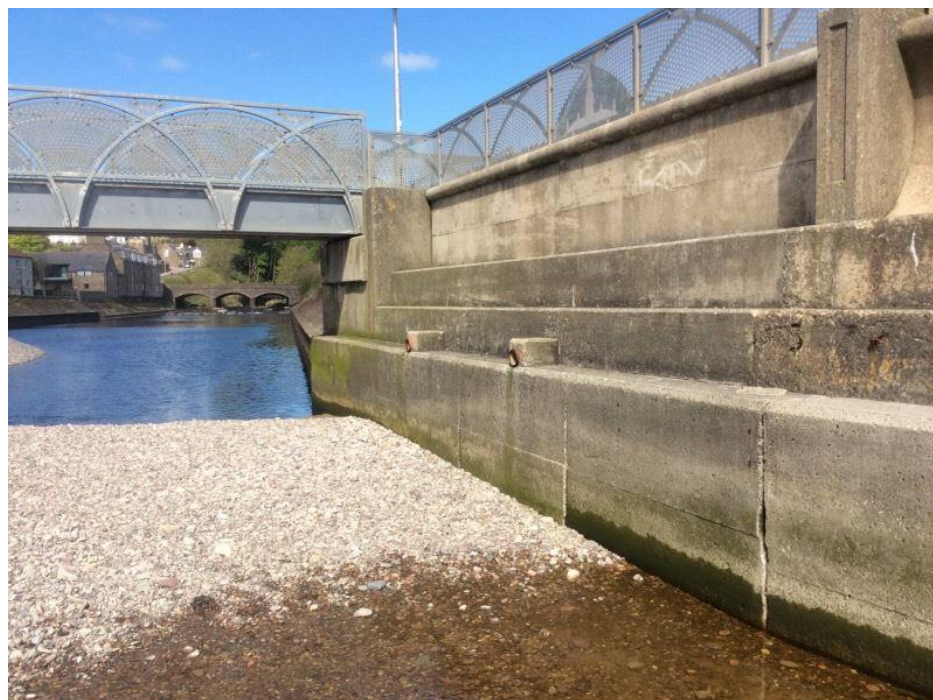
Section D
Exposed face
Defect Ref: D73
Description: D73 -Flap
valves missing
Photo number: 119

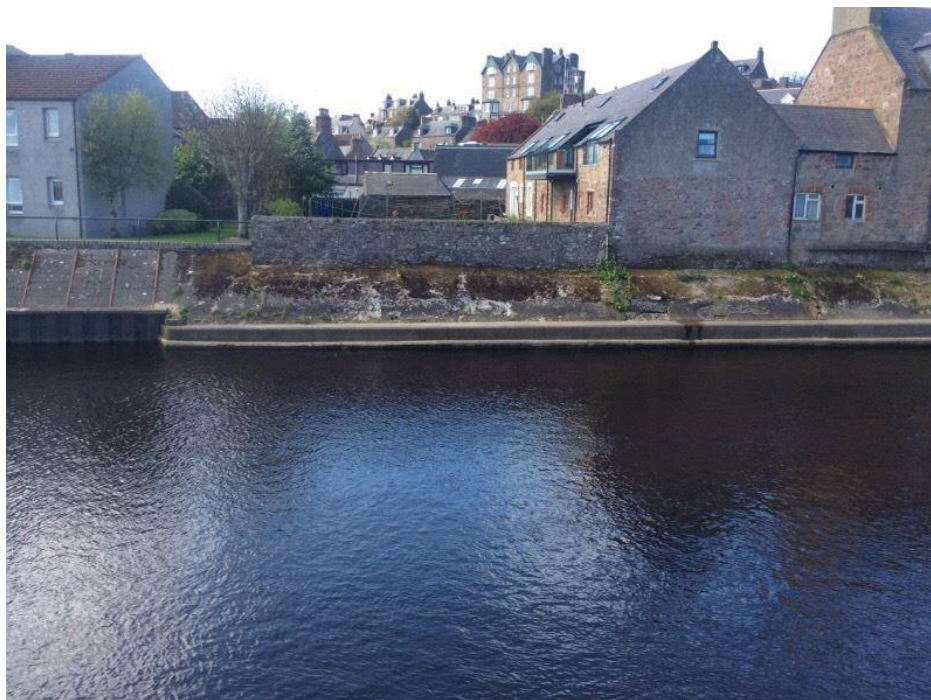
Section D
Channel side
Defect Ref: D74
Description: D74 -
Delaminating concrete
repairs
Photo number: 120

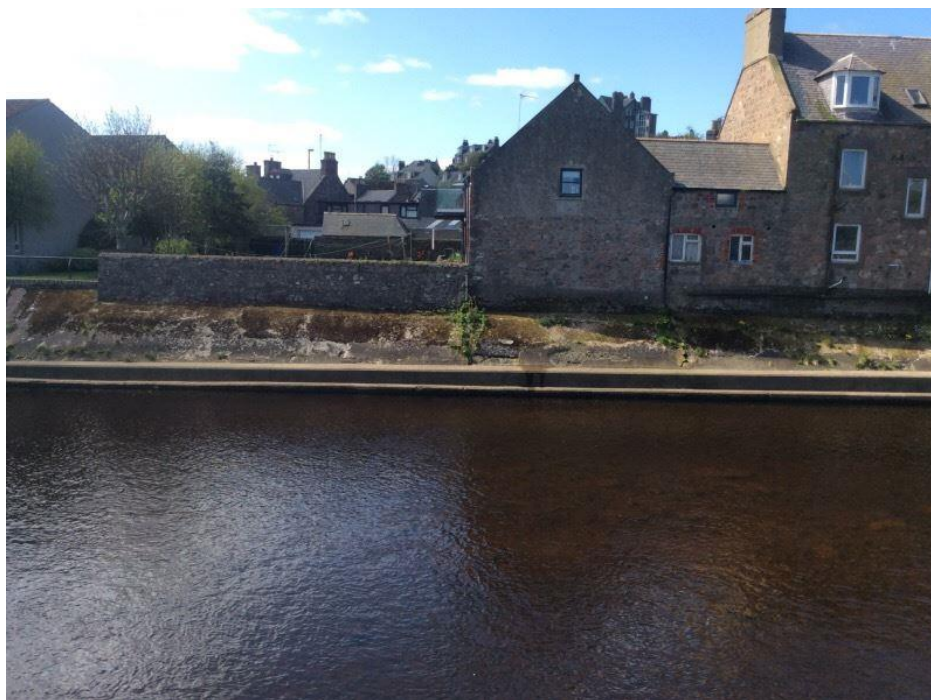
Section D
Channel side
Defect Ref: D75
Description: D75 -
Horizontal crack - poor
protection of upper
concrete slope
Photo number: 121

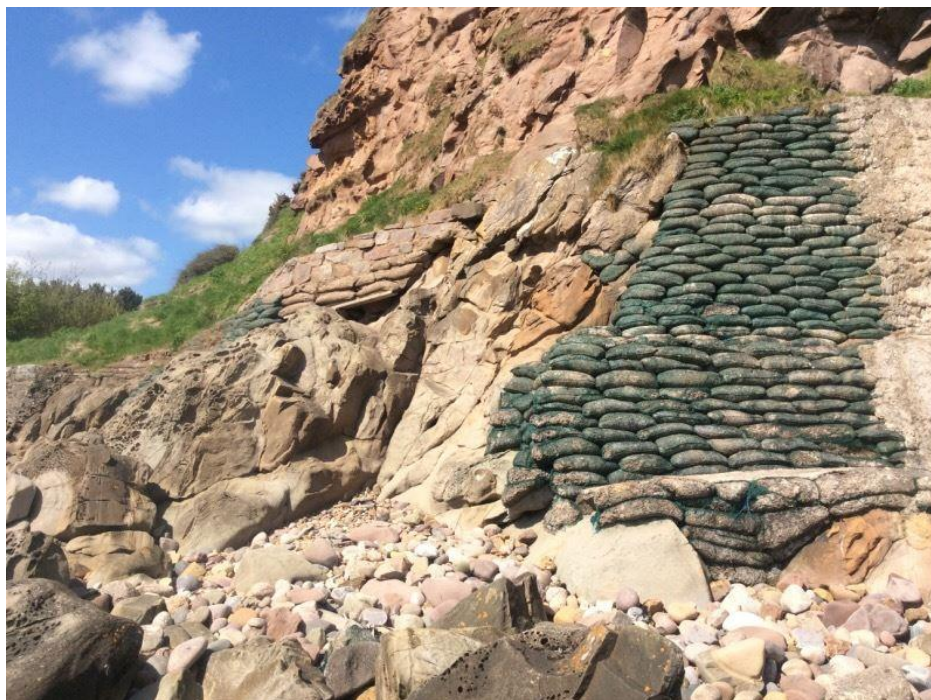
Section A
Exposed face
Defect Ref: D76
Description: D76 -
Improper design / repairs
Photo number: 123

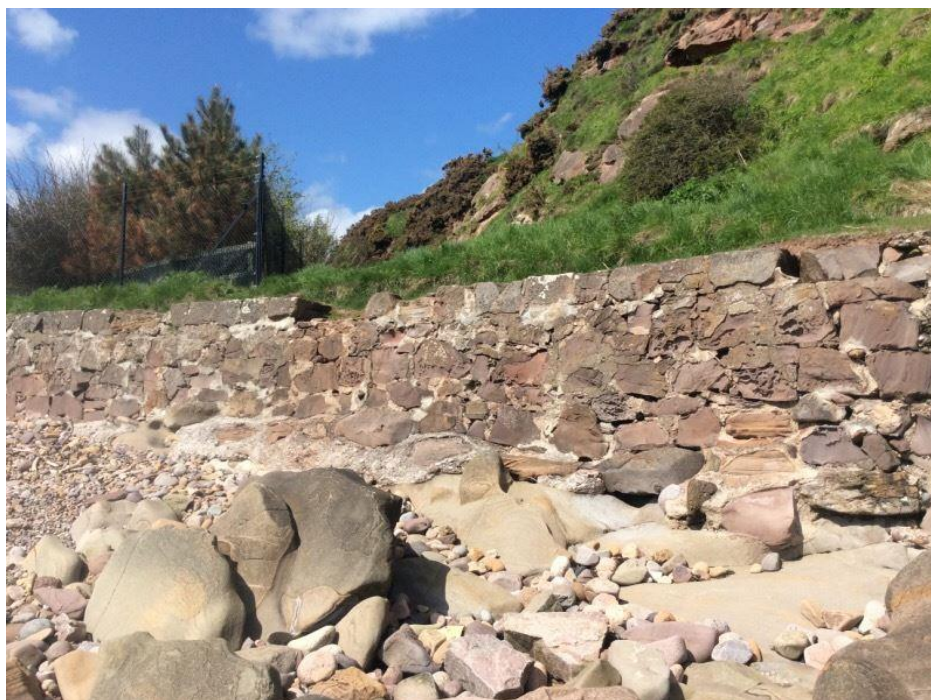
Section A
Exposed face
Defect Ref: D77
Description: D77 -
Missing blockwork
Photo number: 124

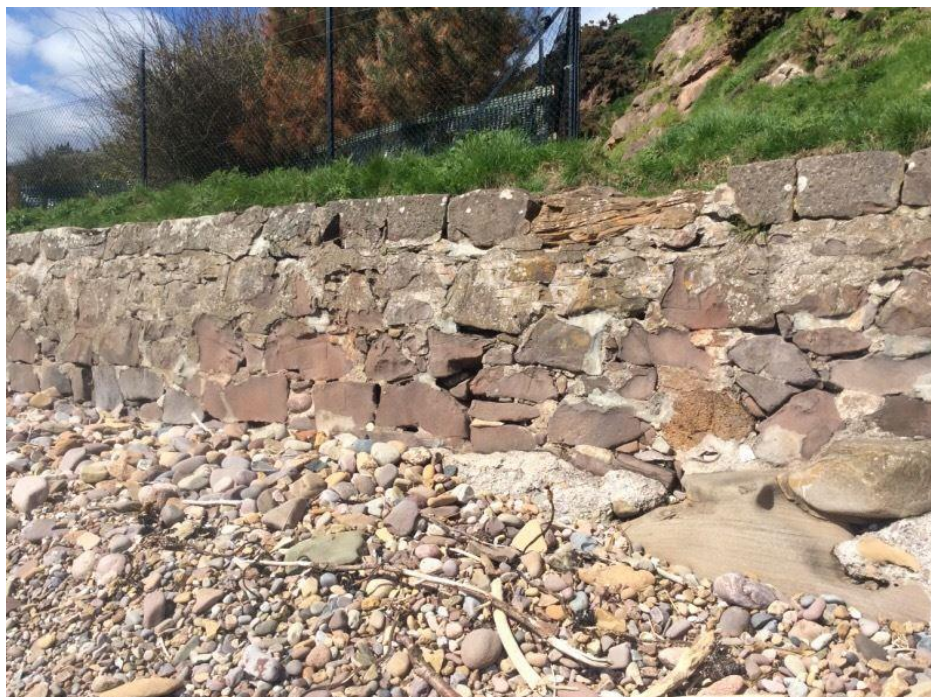
Section A
Exposed face
Defect Ref: D78
Description: D78 - Open joints
Photo number: 125

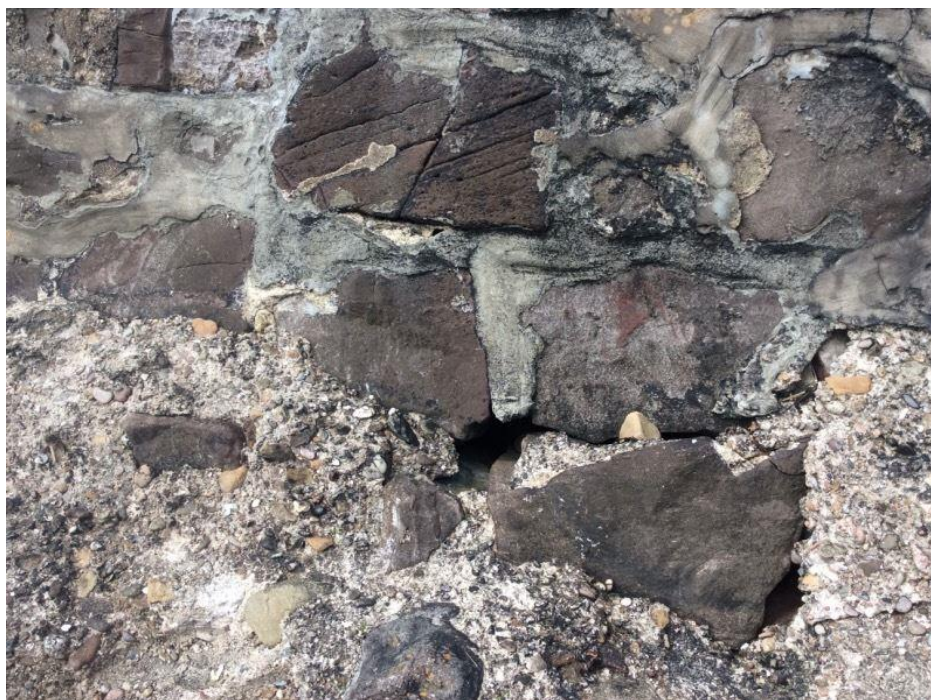
Section A
Exposed face
Defect Ref: D79
Description: Voiding behind blockwork.
Photo number: 126

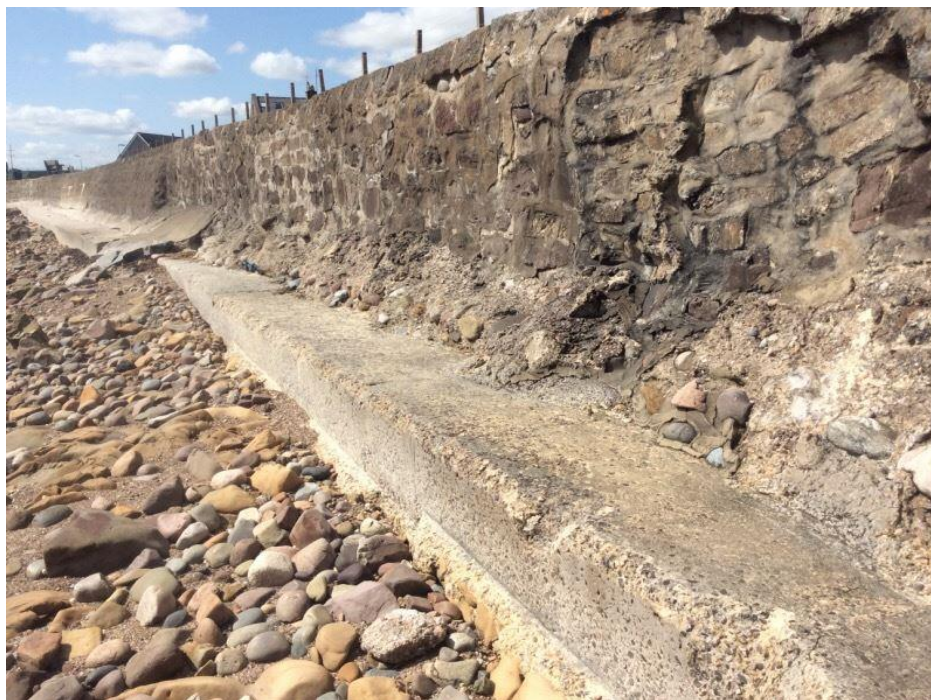
Section A
Exposed face
Defect Ref: D80
Description: D80 -
Dilapidated concrete
repairs
Photo number: 127
