Stonehaven Bay Coastal Flood Protection Study

Final Report

December 2019

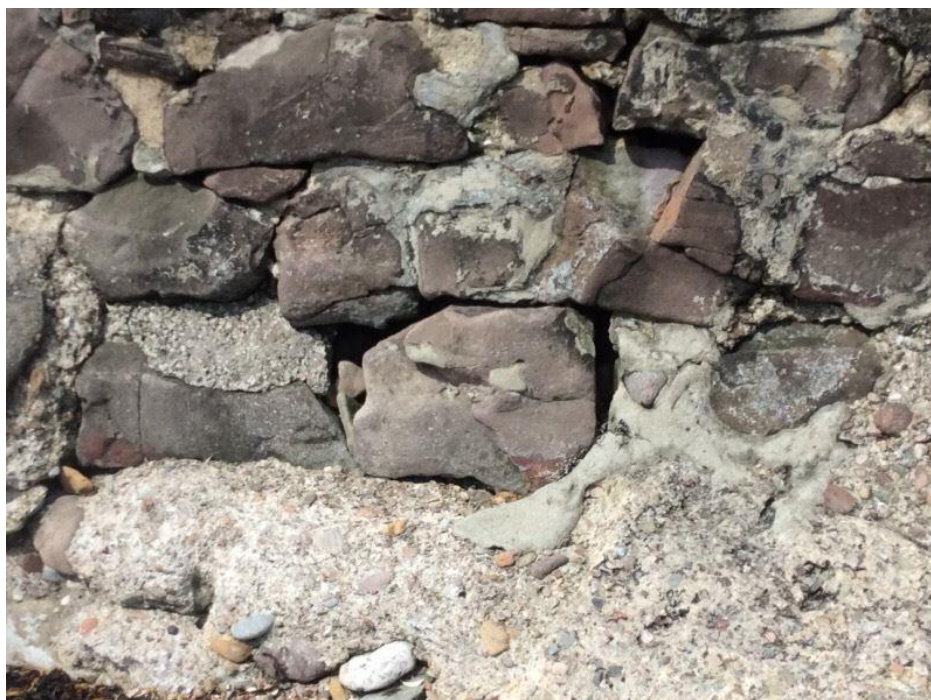
Section A
Exposed face
Defect Ref: D81
Description: D81 -
Voiding around
blockwork
Photo number: 128

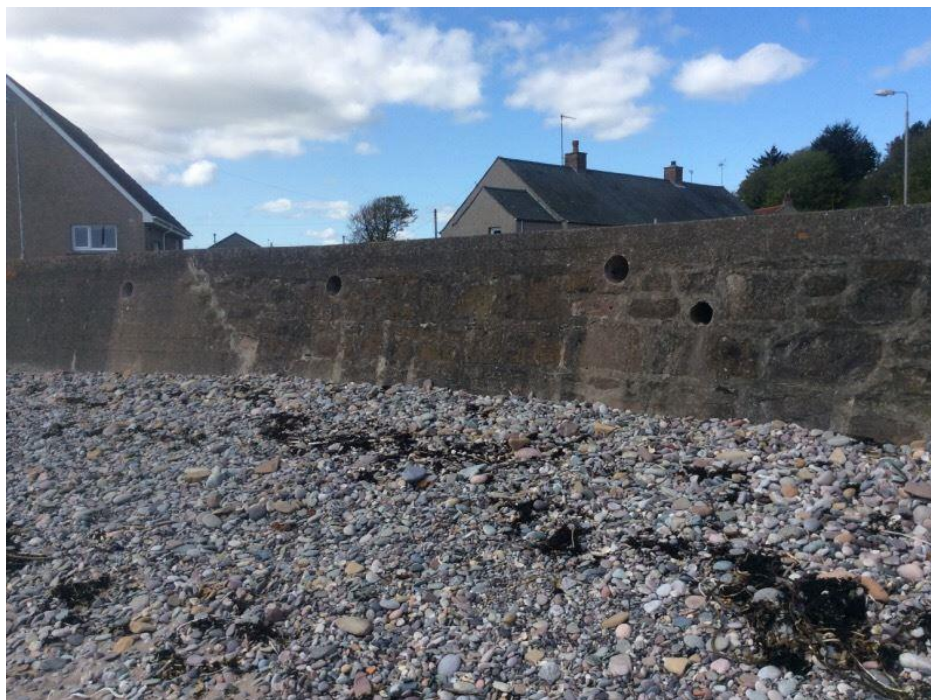
Section A
Exposed face
Defect Ref: D82
Description: D82 -
Missing flap valves
Photo number: 129

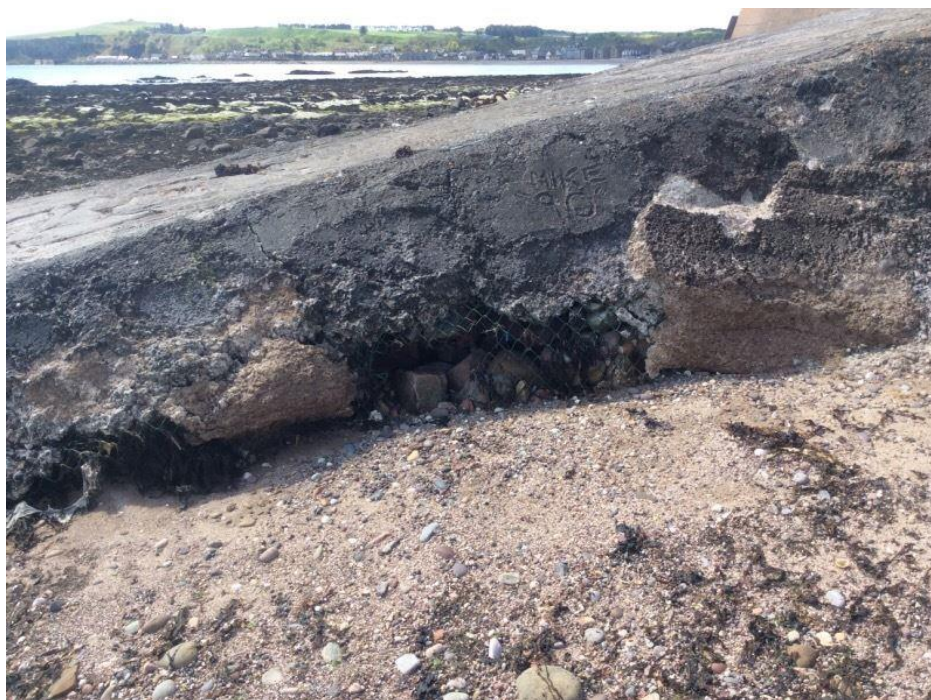
Section A
Access strip
Defect Ref: D83
Description: D84 -
Undermined slipway
Photo number: 130

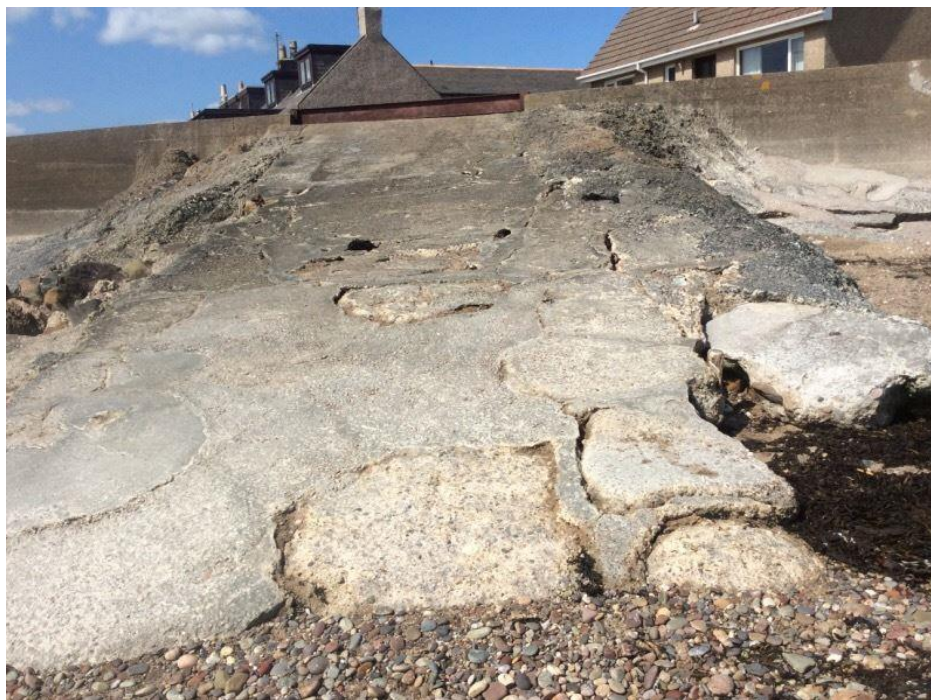
Section A
Access strip
Defect Ref: D83
Description: D83 -
Holes on top of the
slipway
Photo number: 144

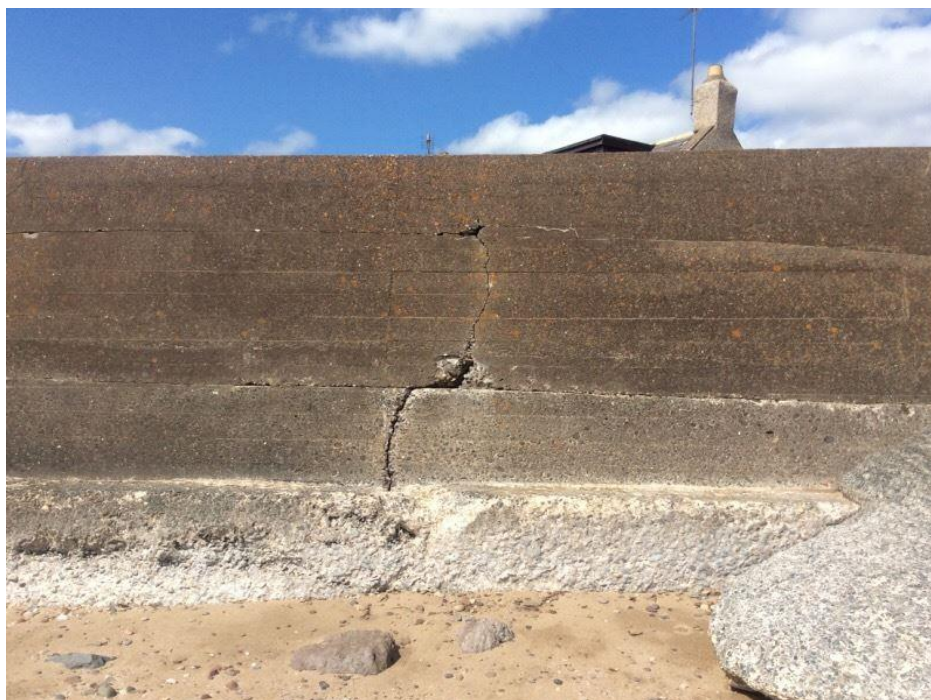
Section A
Exposed face
Defect Ref: D84
Description: D84 -
Cracking of concrete
Photo number: 131

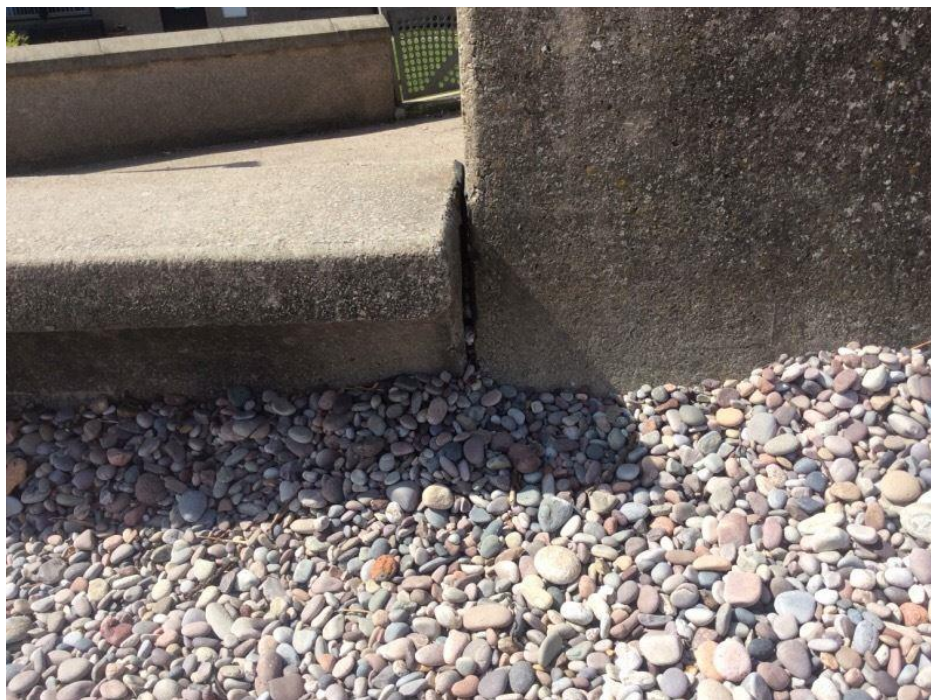
Section E
Exposed face
Defect Ref: D88
Description: D88 - Open joints
Photo number: 132

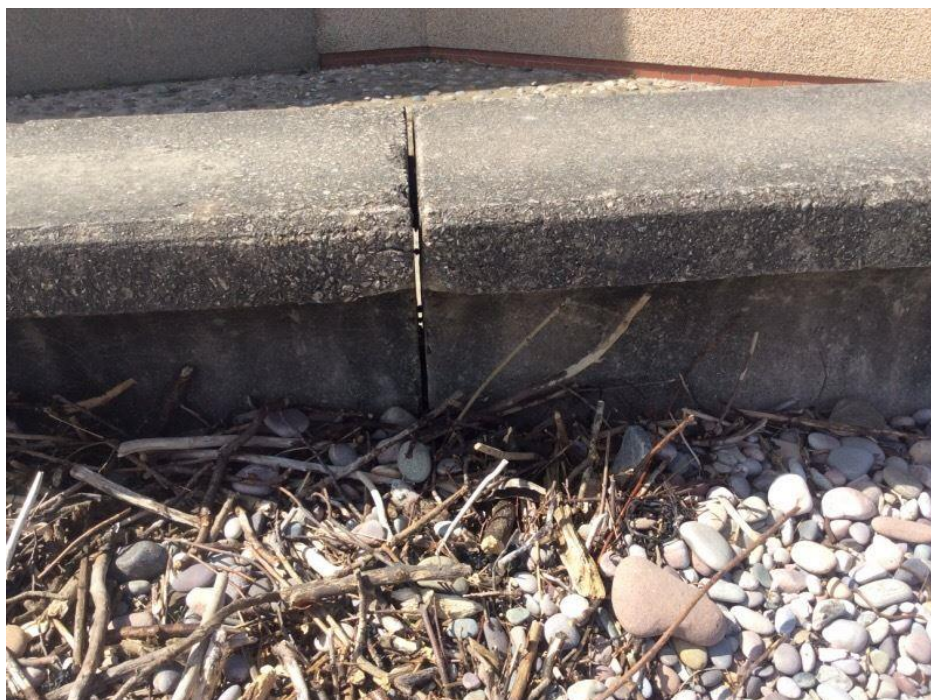
Section E
Exposed face
Defect Ref: D88
Description: D88 - Open joints
Photo number: 146

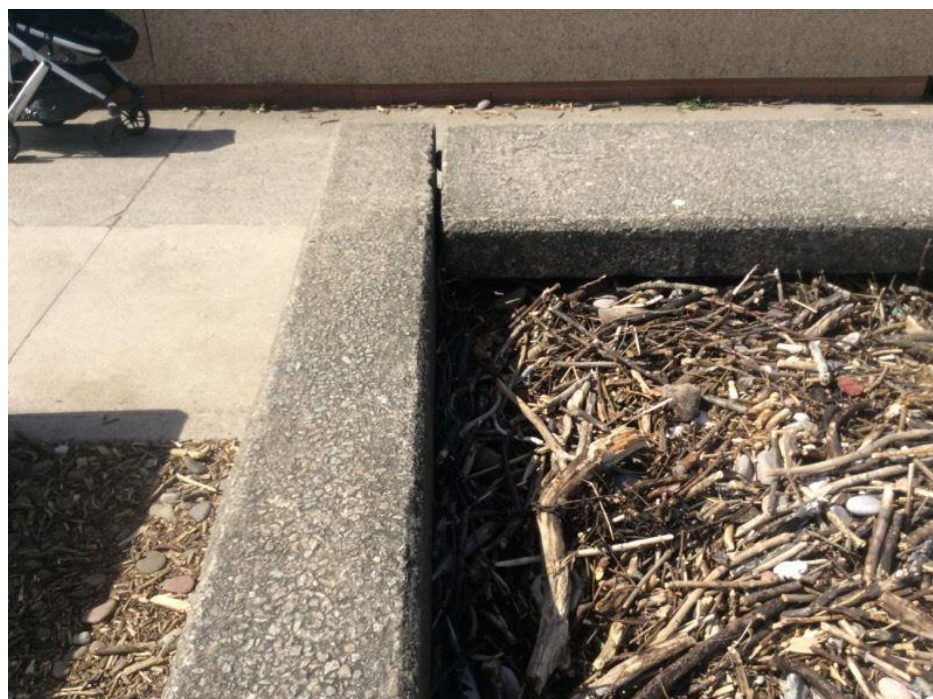
Section E
Exposed face
Defect Ref: D88
Description: D88 - Open joints
Photo number: 150

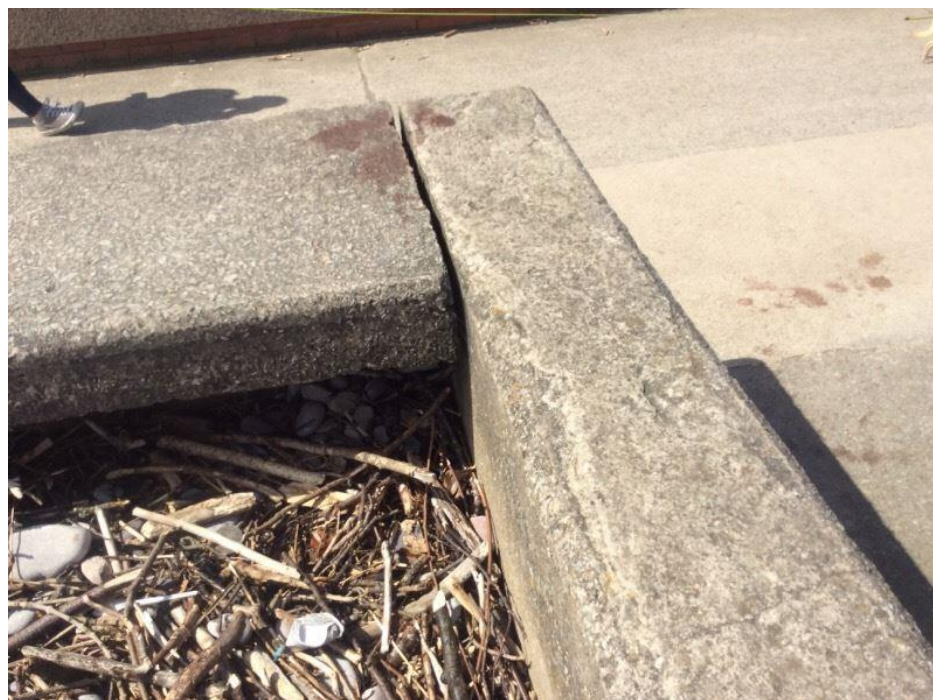
Section E
Exposed face
Defect Ref: D88
Description: D88 - Open joints
Photo number: 154

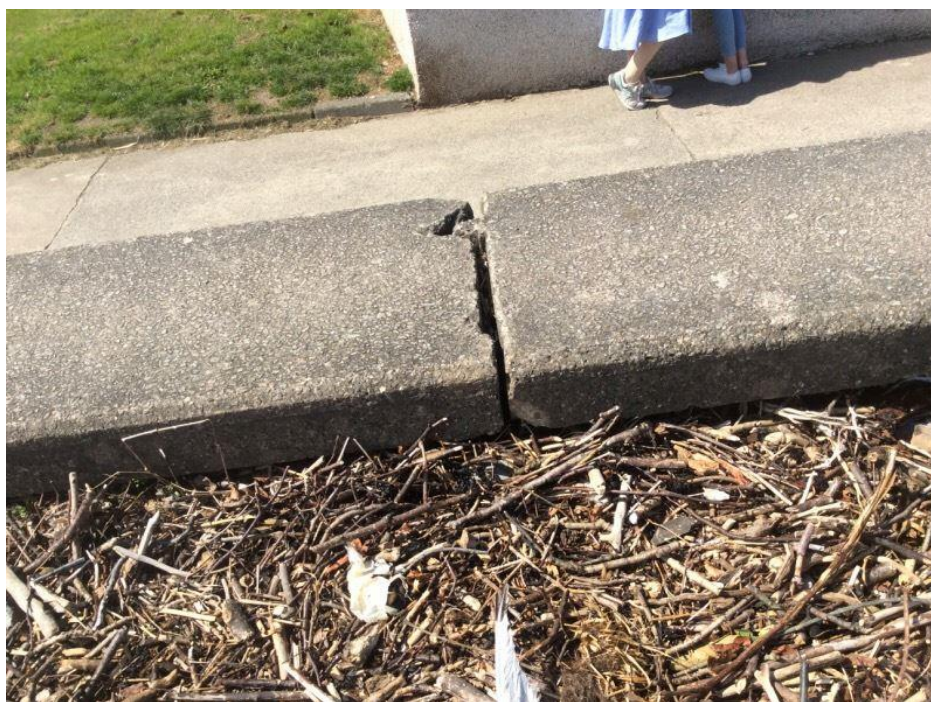
Section E
Exposed face
Defect Ref: D88
Description: D88 - Open
joints
Photo number: 158

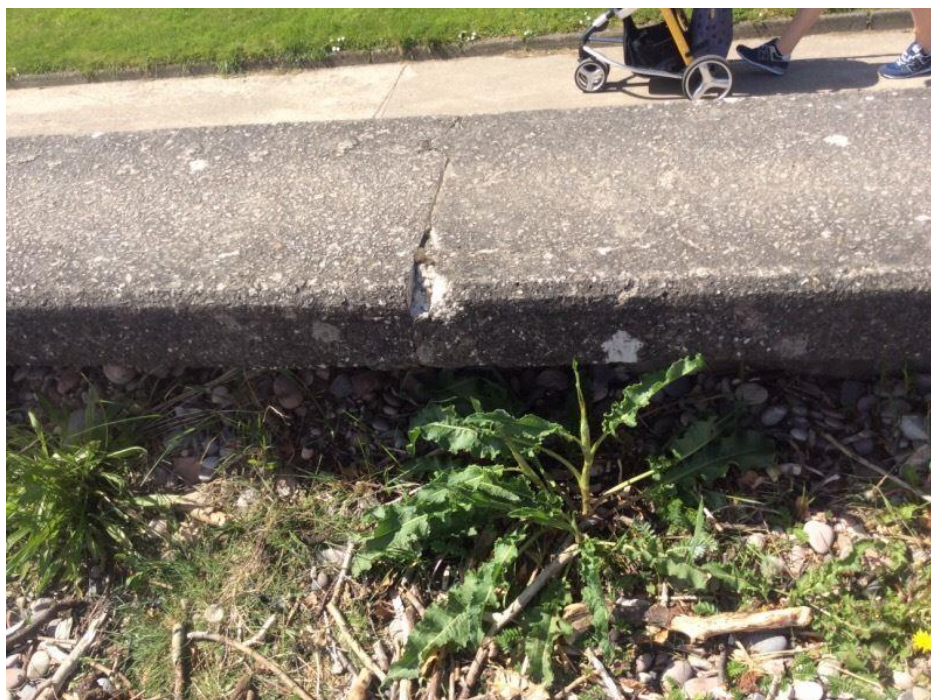
Section E
Exposed face
Defect Ref: D88
Description: D88 - Open
joints
Photo number: 161

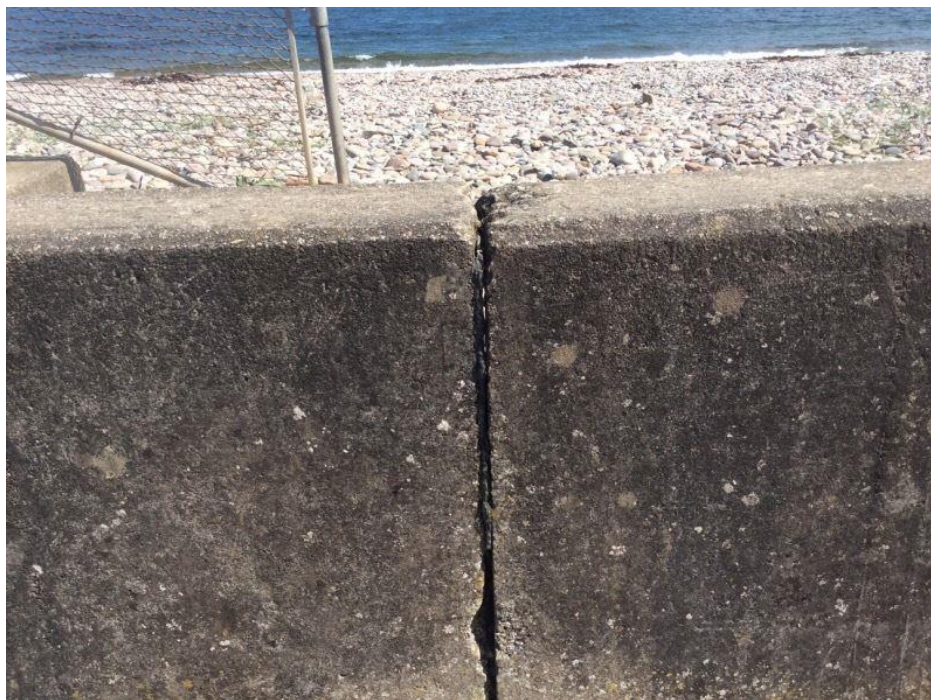
Section E
Exposed face
Defect Ref: D88
Description: D88 - Open
joints
Photo number: 163

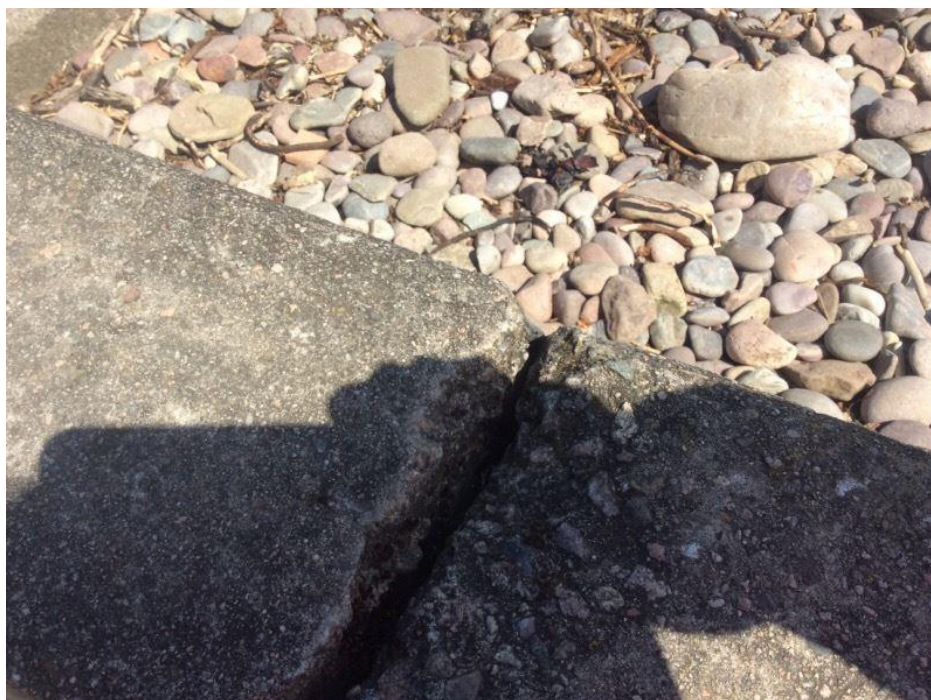
Section E
Exposed face
Defect Ref: D88
Description: D88 - Open
joints
Photo number: 165

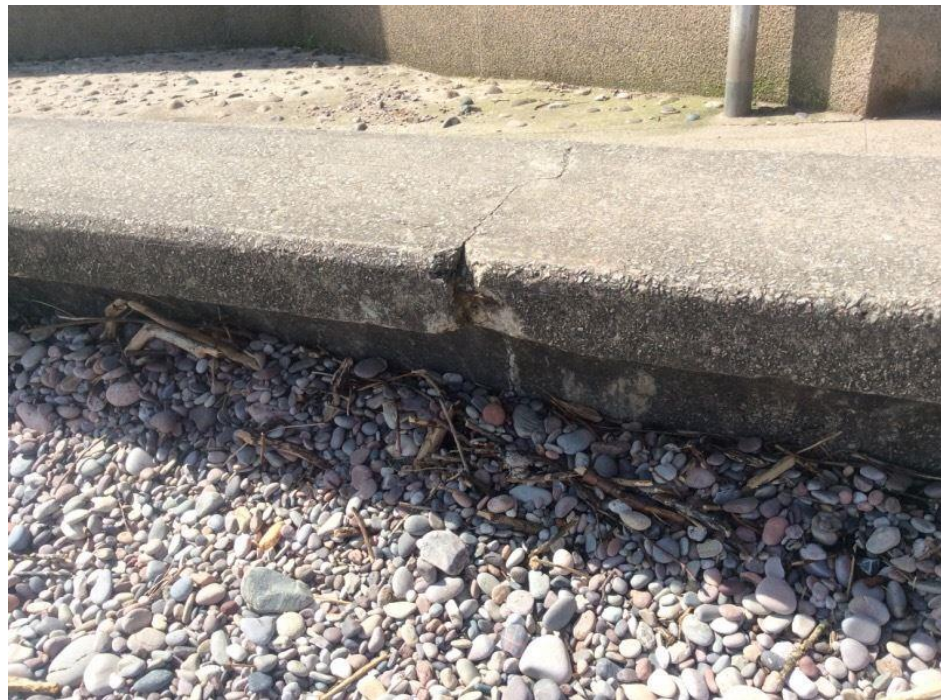
Section E
Exposed face
Defect Ref: D89
Description: D89 -
Chipped concrete by
expansion joint with
exposure of
reinforcement
Photo number: 133

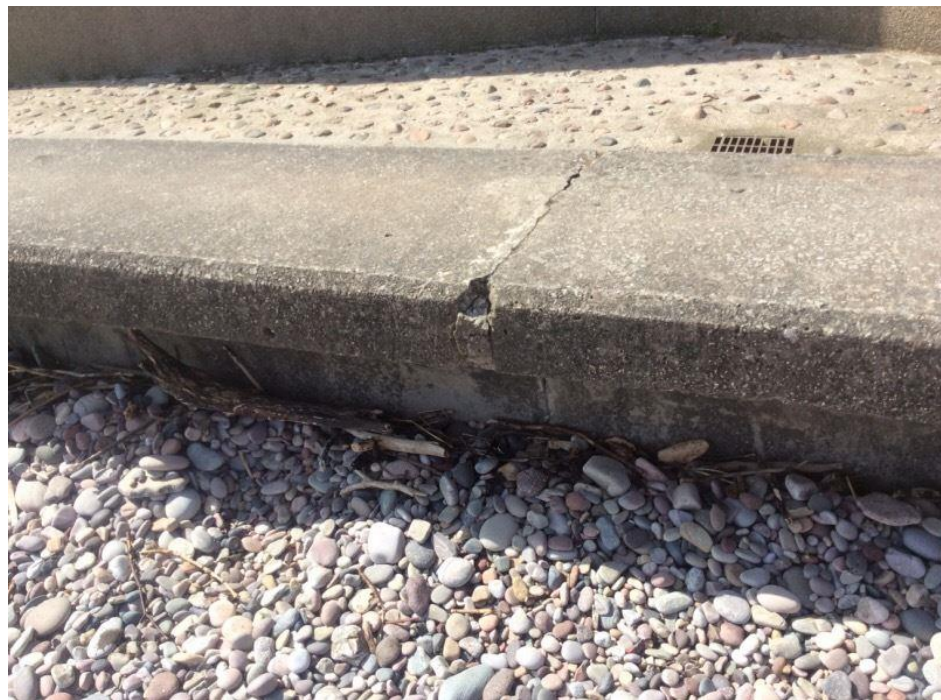
Section E
Exposed face
Defect Ref: D89
Description: D89 -
Chipped concrete by
expansion joint with
exposure of
reinforcement
Photo number: 145

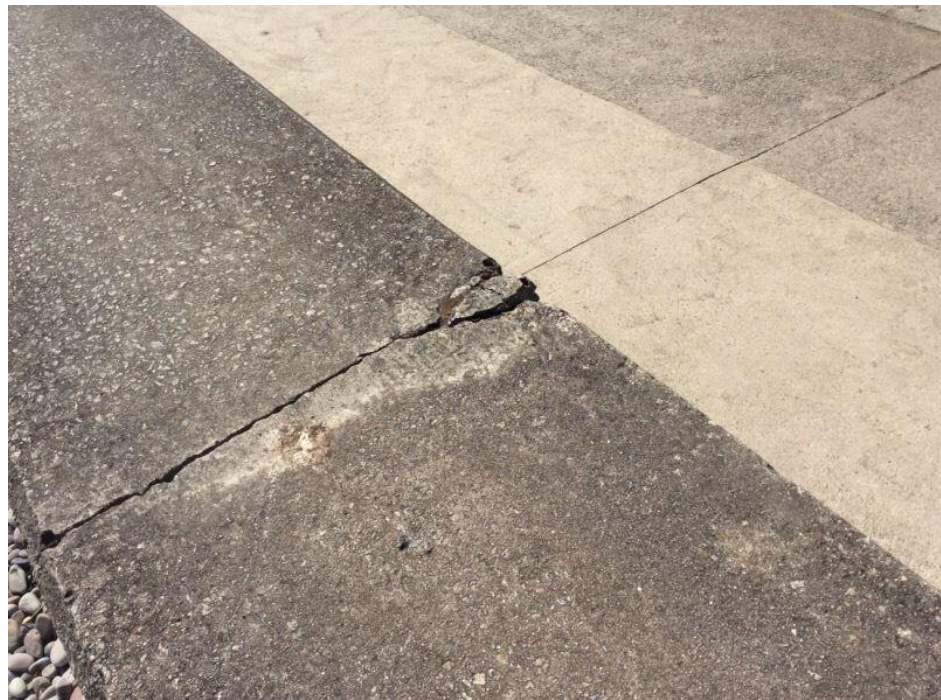
Section E
Exposed face
Defect Ref: D89
Description: D89 -
Chipped concrete by
expansion joint with
exposure of
reinforcement
Photo number: 149

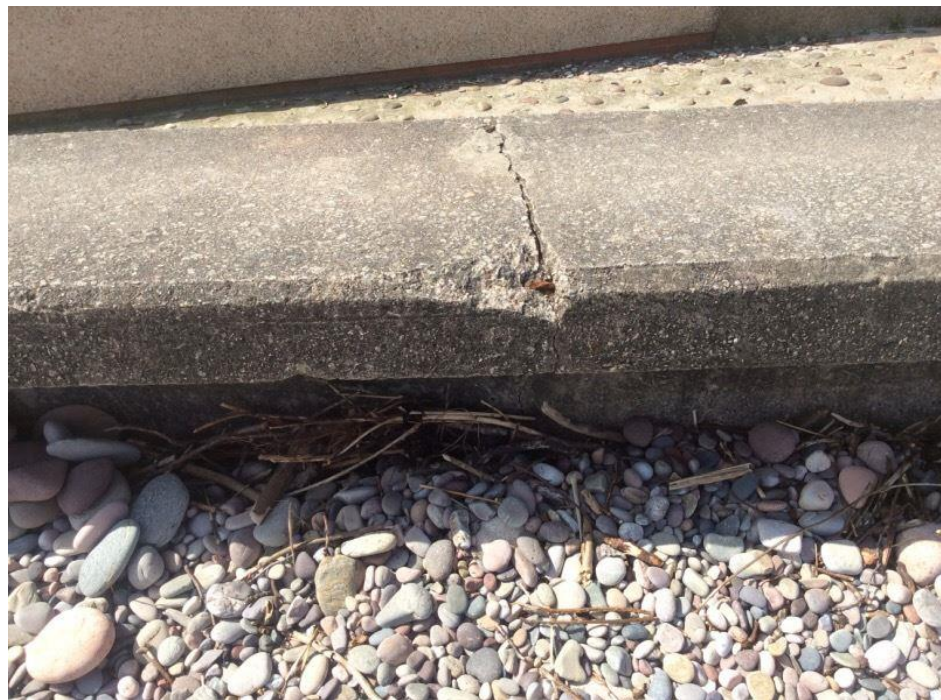
Section E
Exposed face
Defect Ref: D89
Description: D89 -
Chipped concrete by
expansion joint with
exposure of
reinforcement
Photo number: 153

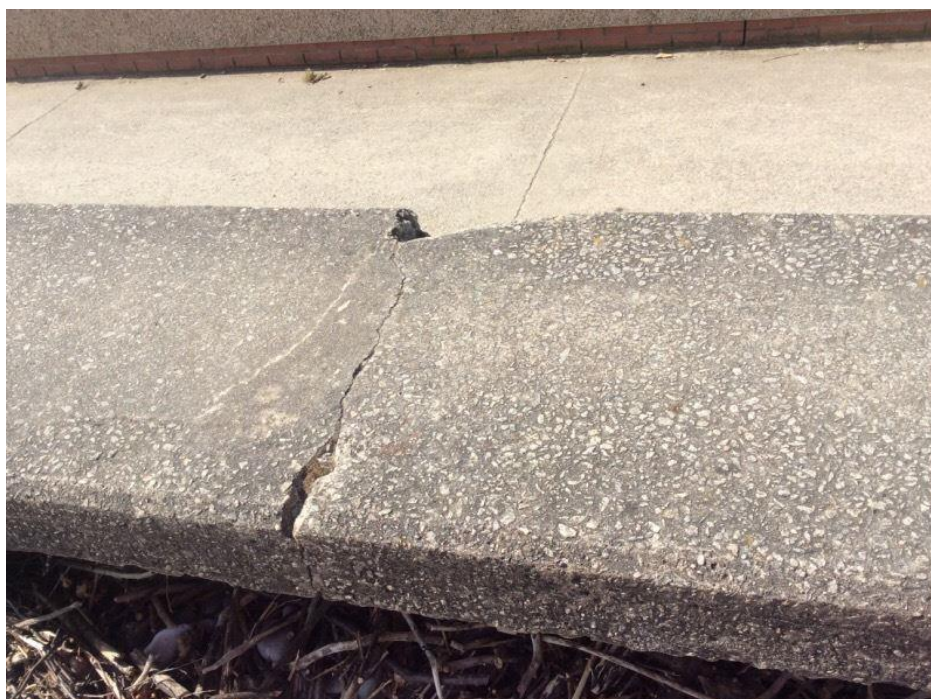
Section E
Exposed face
Defect Ref: D89
Description: D89 -
Chipped concrete by
expansion joint with
exposure of
reinforcement
Photo number: 157

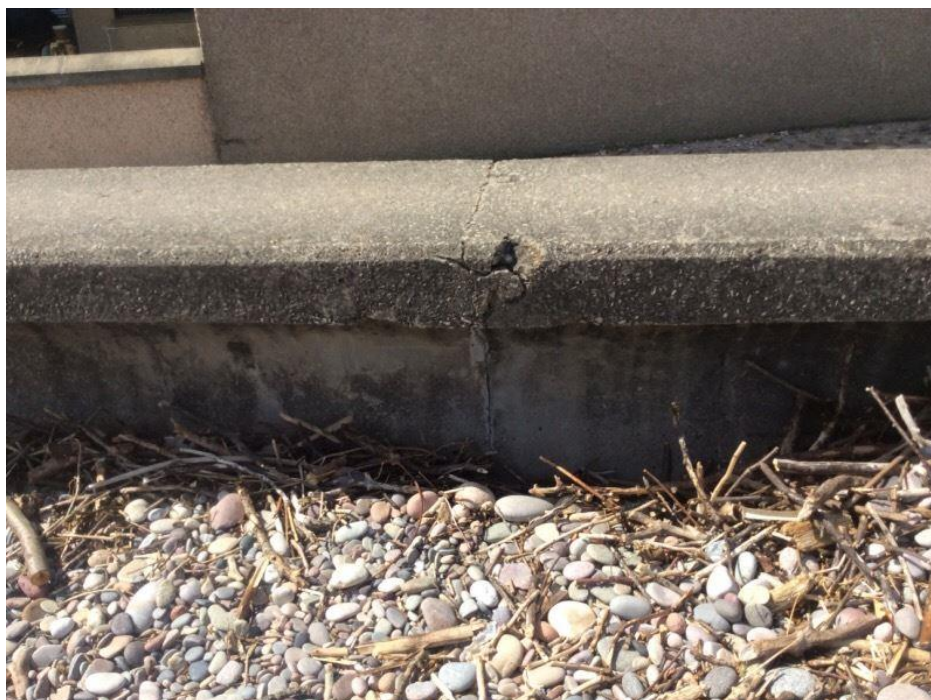
Section E
Exposed face
Defect Ref: D89
Description: D89 -
Chipped concrete by
expansion joint with
exposure of
reinforcement
Photo number: 160

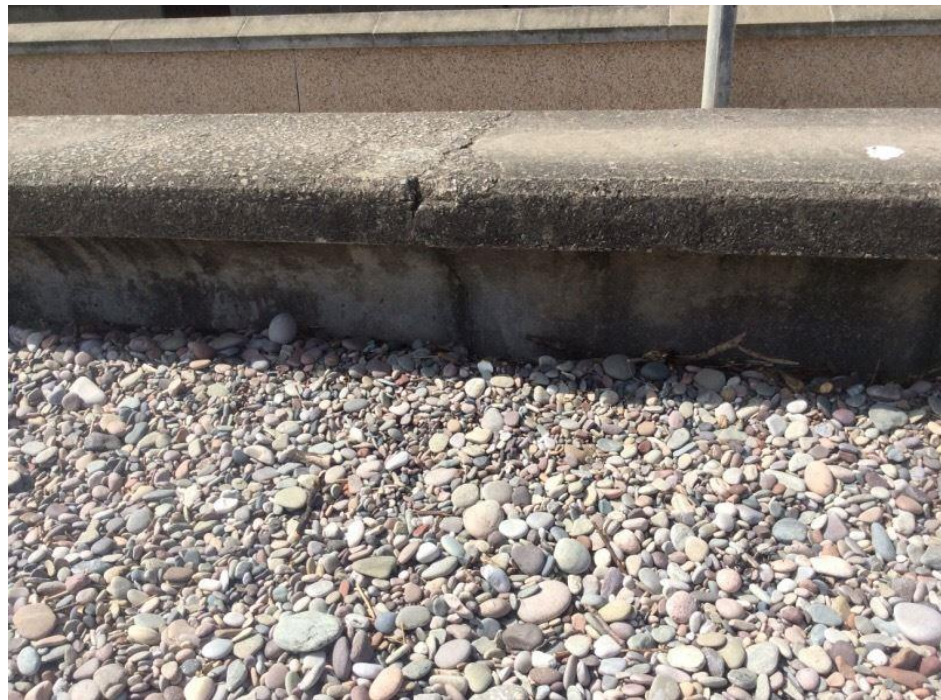
Section E
Exposed face
Defect Ref: D89
Description: D89 -
Chipped concrete by
expansion joint with
exposure of
reinforcement
Photo number: 162

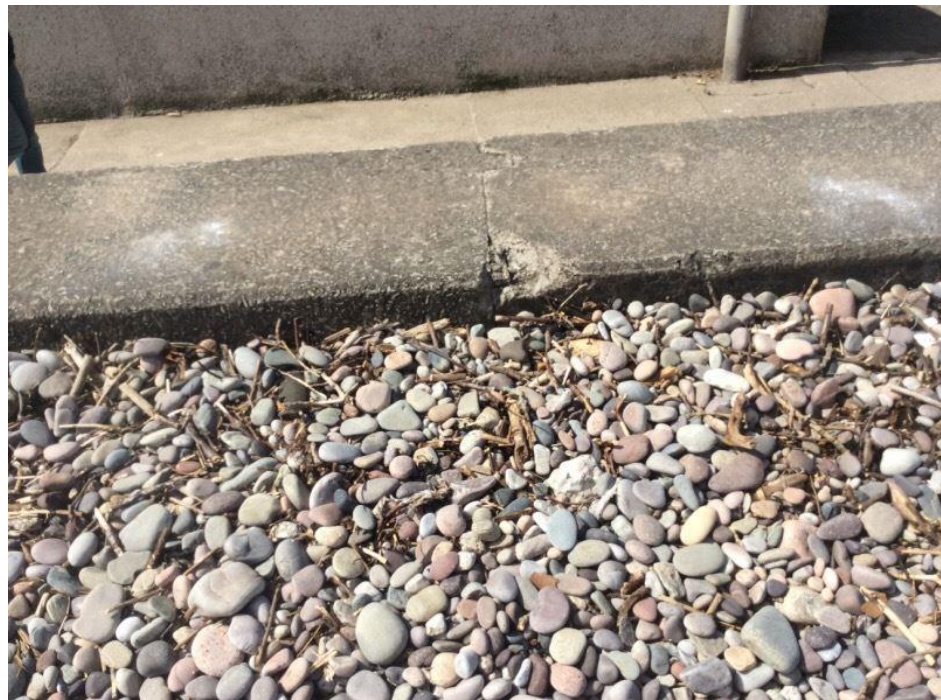
Section E
Exposed face
Defect Ref: D89
Description: D89 -
Chipped concrete by
expansion joint with
exposure of
reinforcement
Photo number: 166

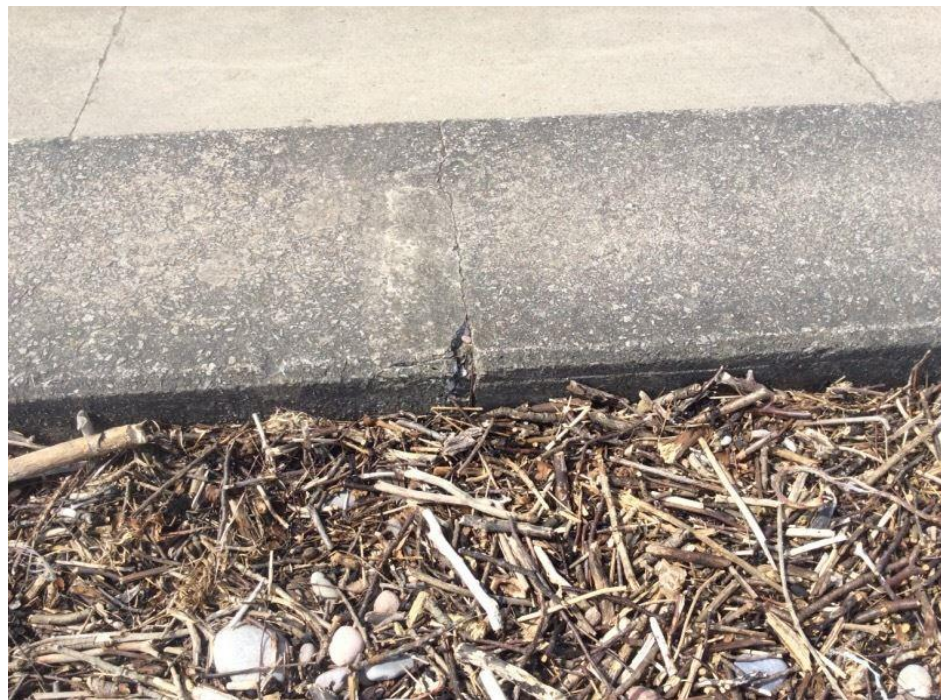
Section E
Exposed face
Defect Ref: D89
Description: D89 -
Chipped concrete by
expansion joint with
exposure of
reinforcement
Photo number: 167

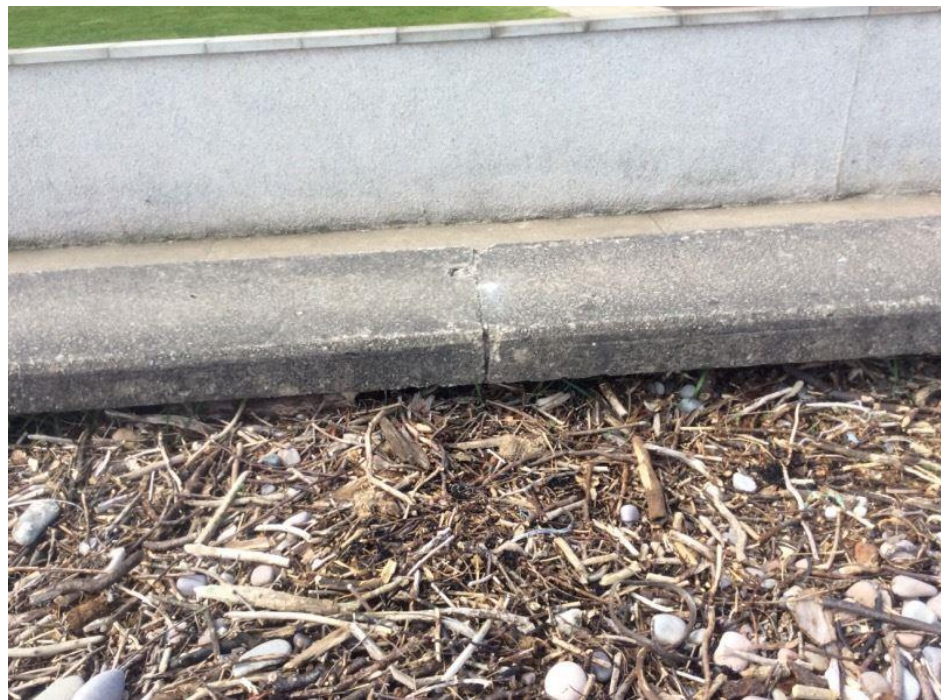
Section E
Exposed face
Defect Ref: D89
Description: D89 -
Chipped concrete by
expansion joint with
exposure of
reinforcement
Photo number: 169

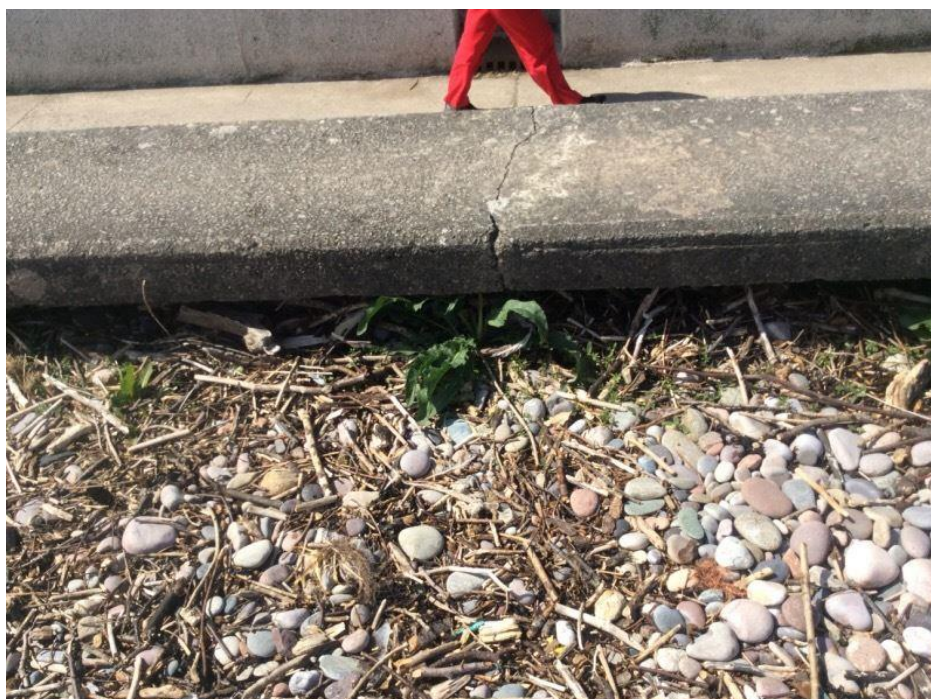
Section E
Exposed face
Defect Ref: D89
Description: D89 -
Chipped concrete by
expansion joint with
exposure of
reinforcement
Photo number: 170

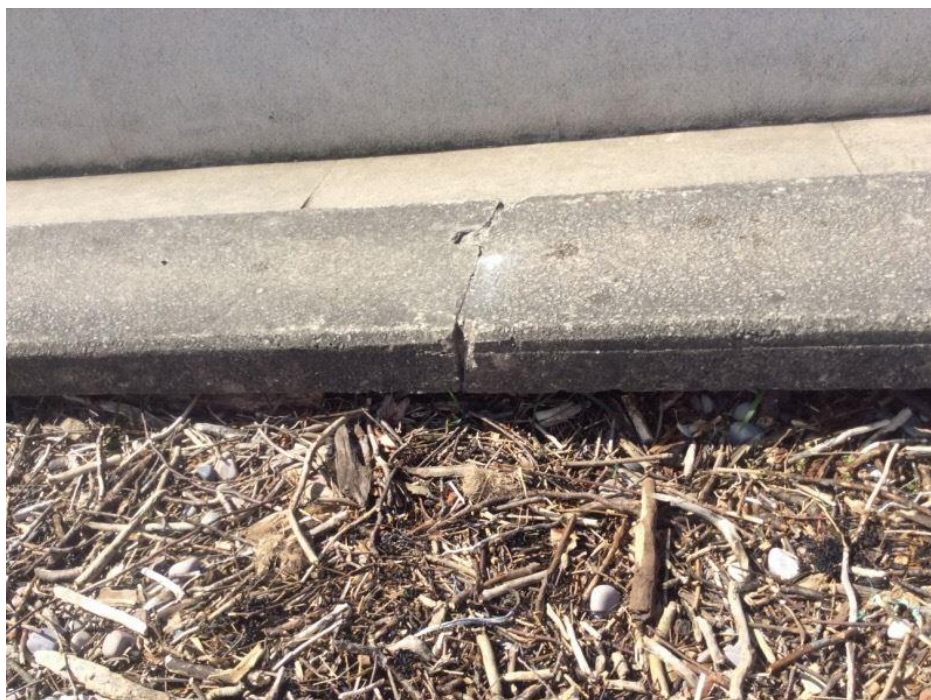
Section E
Exposed face
Defect Ref: D89
Description: D89 -
Chipped concrete by
expansion joint with
exposure of
reinforcement
Photo number: 171

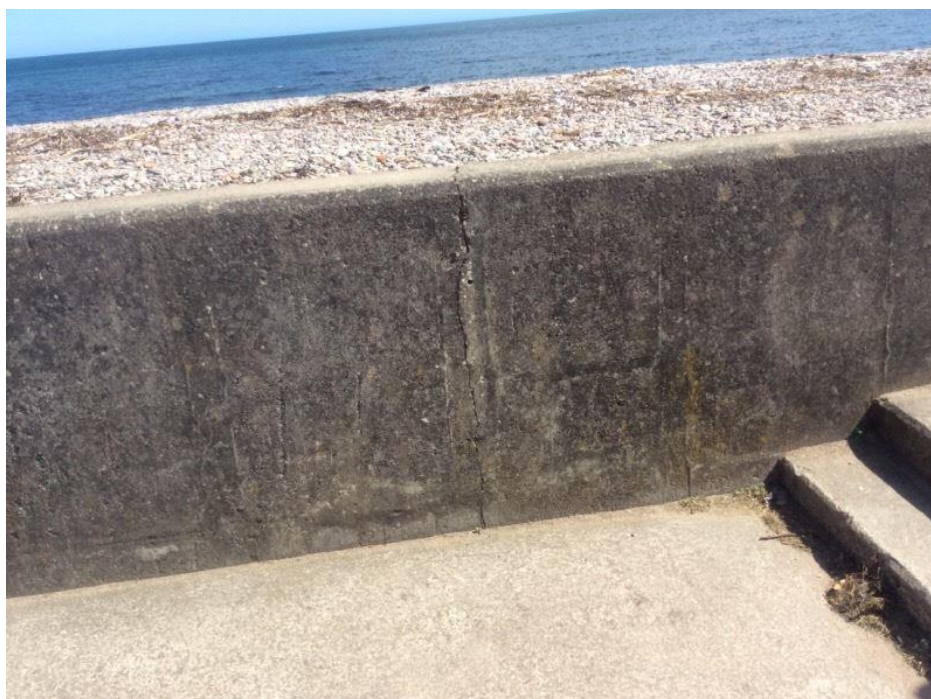
Section E
Exposed face
Defect Ref: D89
Description: D89 -
Chipped concrete by
expansion joint with
exposure of
reinforcement
Photo number: 172

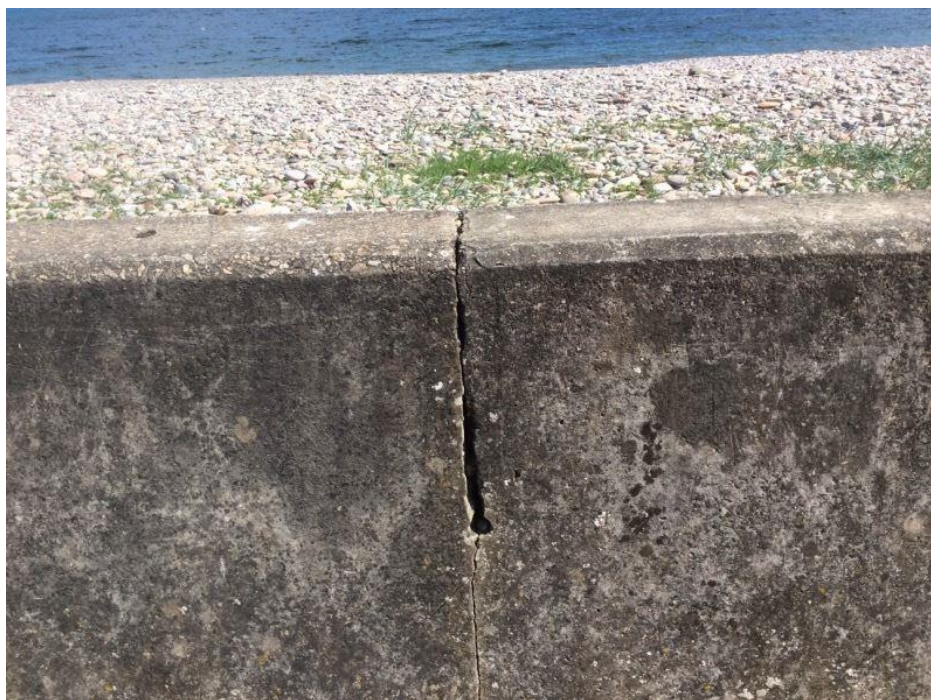
Section E
Exposed face
Defect Ref: D89
Description: D89 -
Chipped concrete by
expansion joint with
exposure of
reinforcement
Photo number: 173

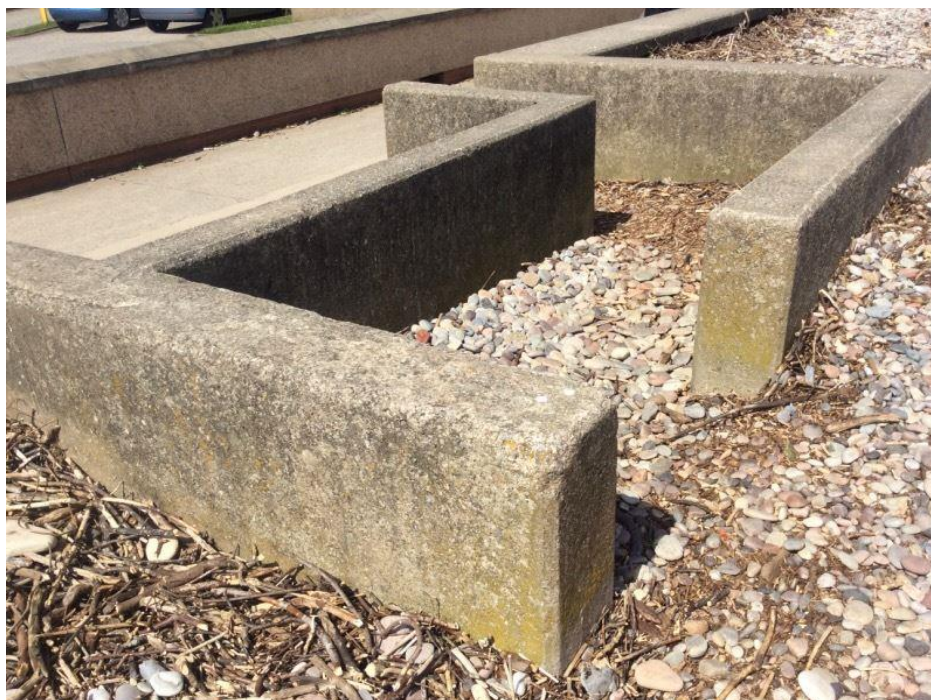
Section E
Exposed face
Defect Ref: D90
Description: D90 -
Flood gate possibly
needed
Photo number: 134

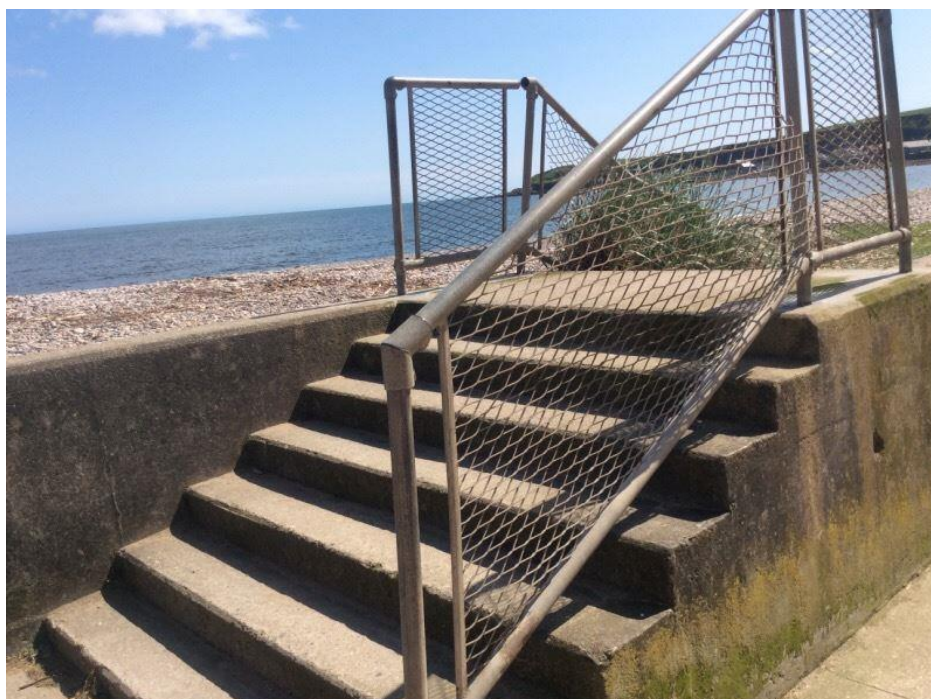
Section E
Exposed face
Defect Ref: D91
Description: D91 -
Distortion of parapet
Photo number: 135

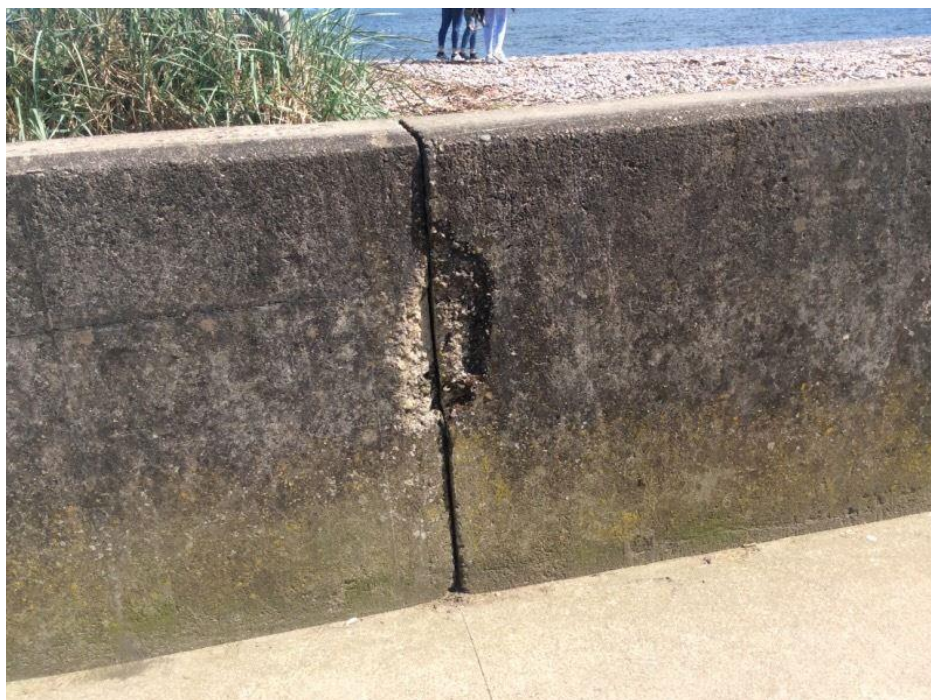
Section E
Exposed face
Defect Ref: D92
Description: D92 -
Chipped concrete by the
expansion joint
approximately 0.4x0.2m
Photo number: 136

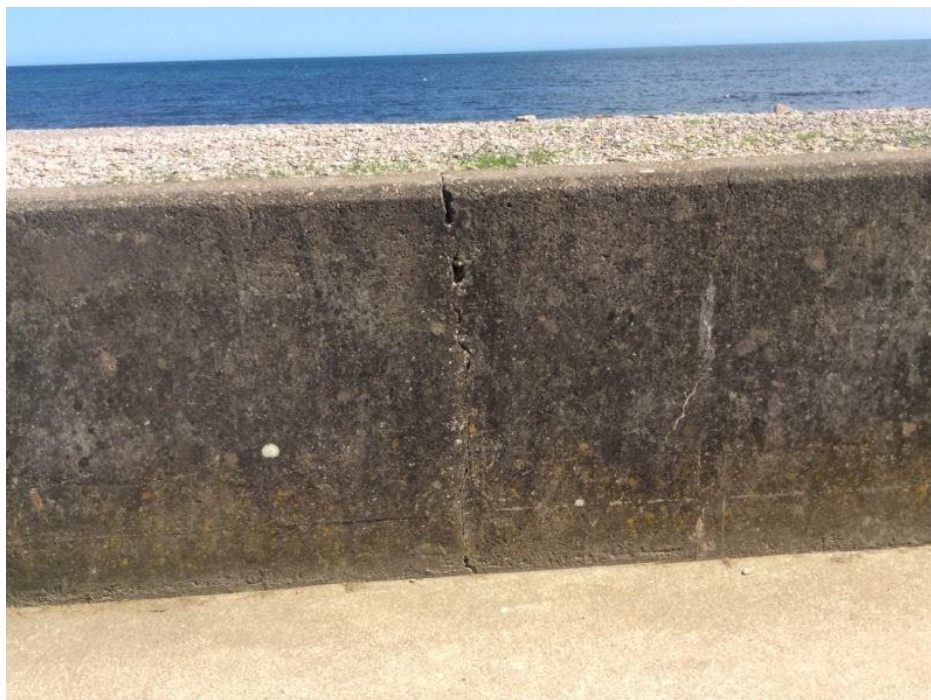
Section E
Exposed face
Defect Ref: D93
Description: D93 -
Vertical crack in concrete
Photo number: 137

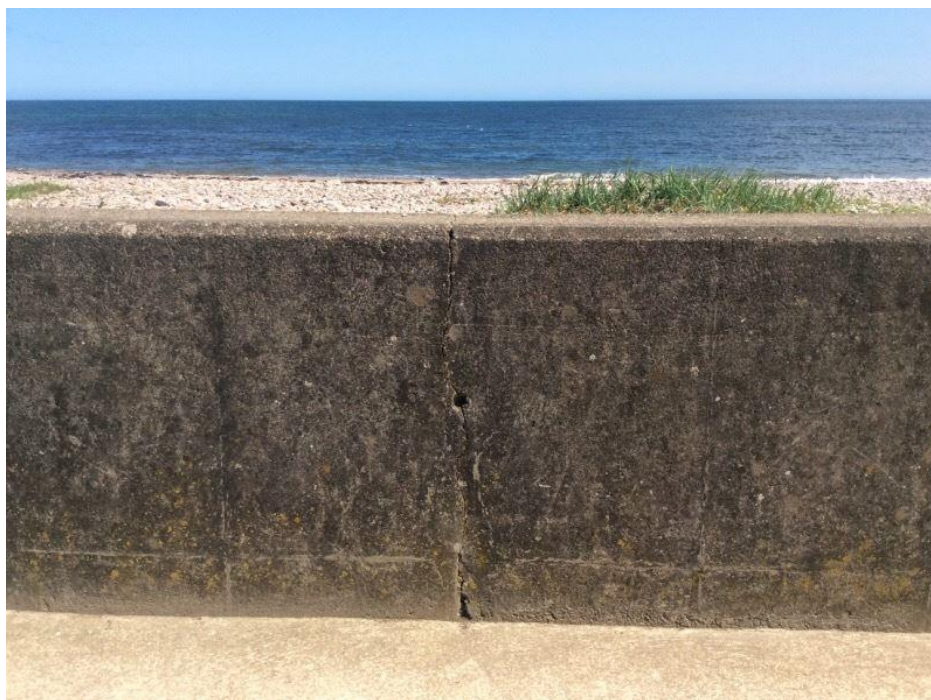
Section E
Exposed face
Defect Ref: D93
Description: D93 -
Vertical crack in concrete
Photo number: 147

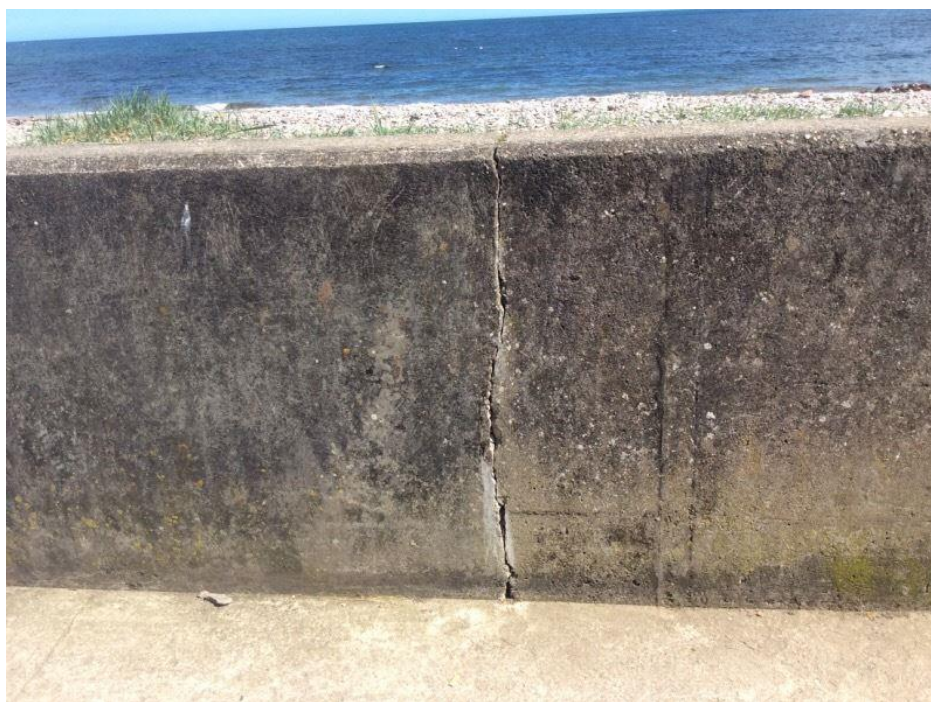
Section E
Exposed face
Defect Ref: D93
Description: D93 -
Vertical crack in concrete
Photo number: 151

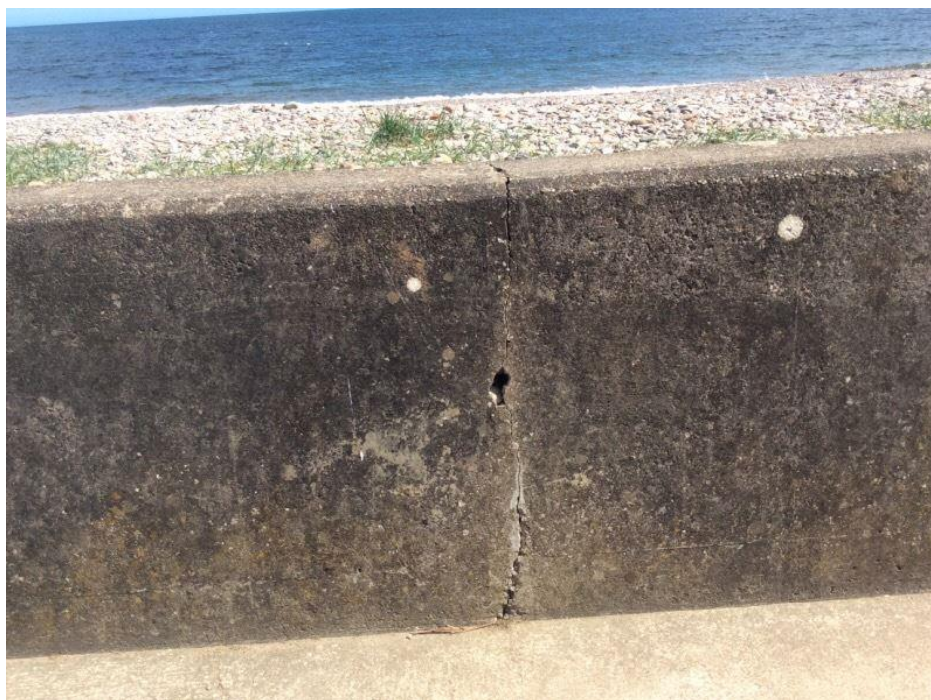
Section E
Exposed face
Defect Ref: D93
Description: D93 -
Vertical crack in concrete
Photo number: 155
