Stonehaven Bay Coastal Flood Protection Study

Final Report

December 2019

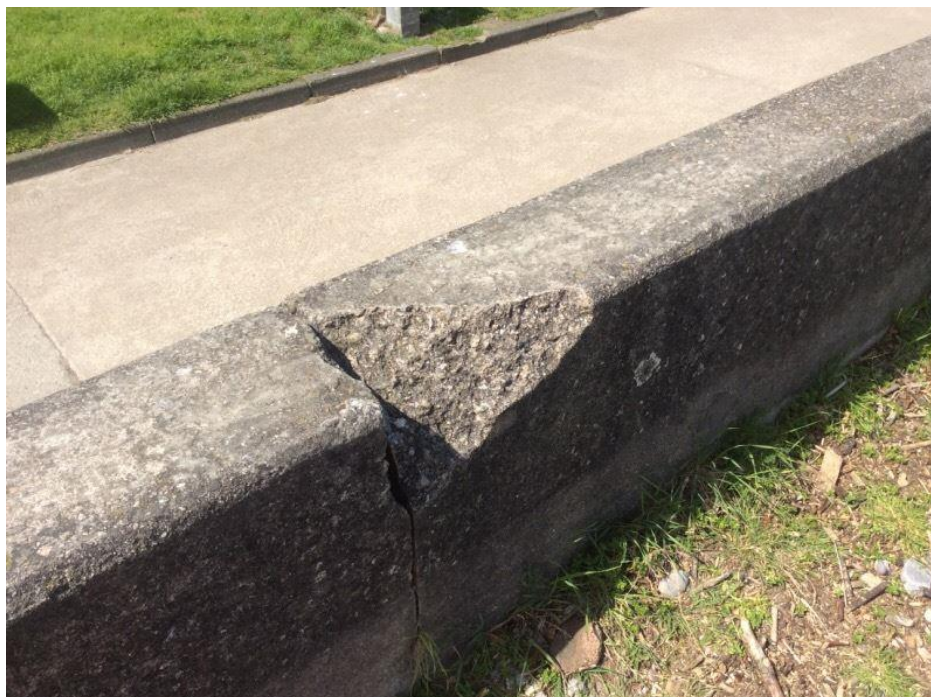
Section E
Exposed face
Defect Ref: D94
Description: D94 -
Damaged concrete
Photo number: 138

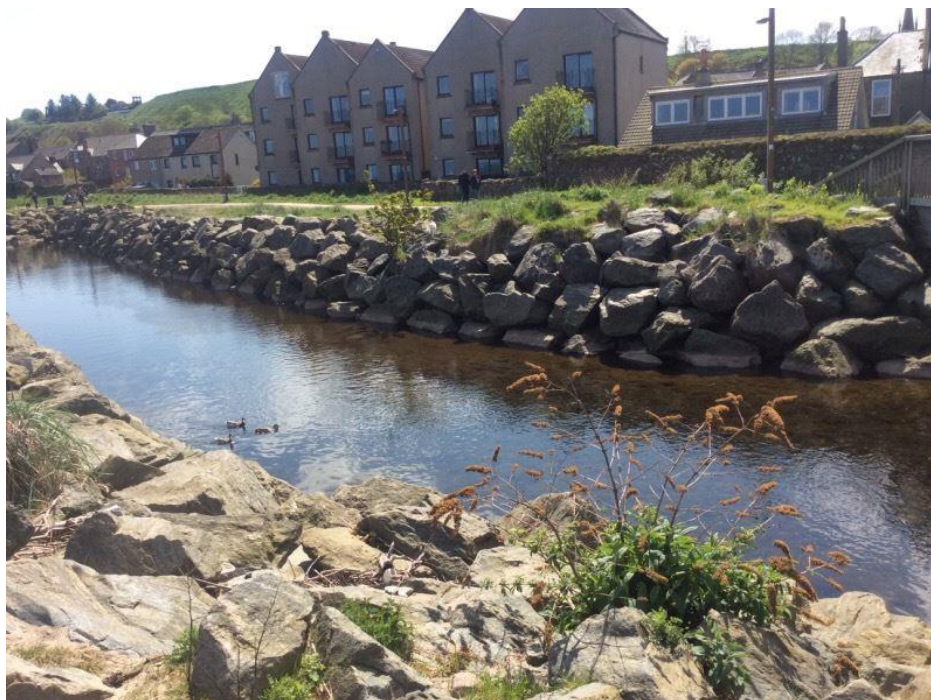
Section F
Rock armour
Defect Ref: D95
Description: D95 -
Overly steep rock armour
profile
Photo number: 139

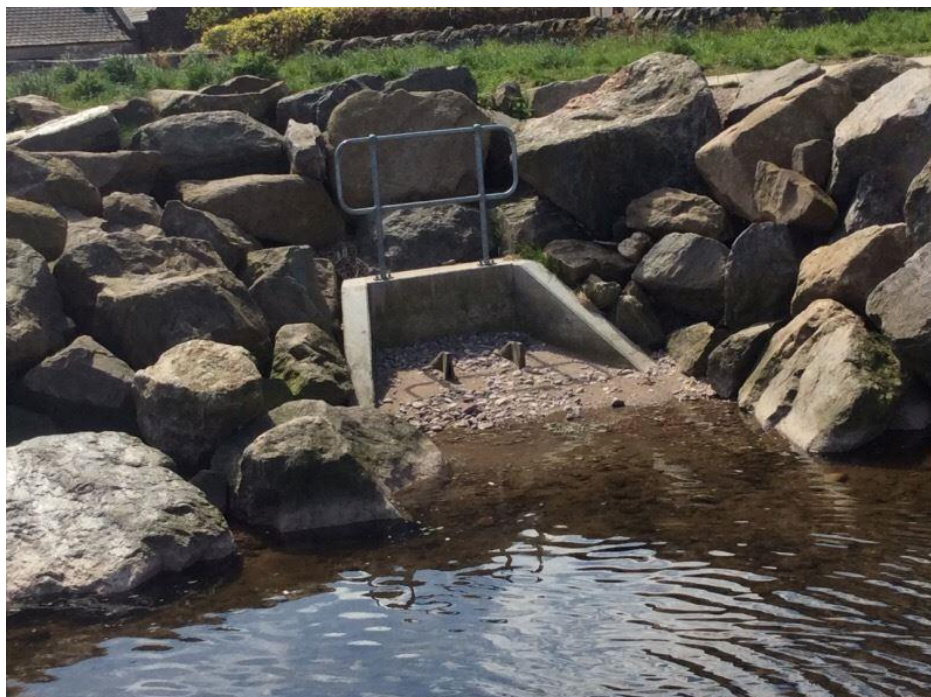
Section F
Rock armour
Defect Ref: D96
Description: D96 -
Duckbill valves blocked
up
Photo number: 140

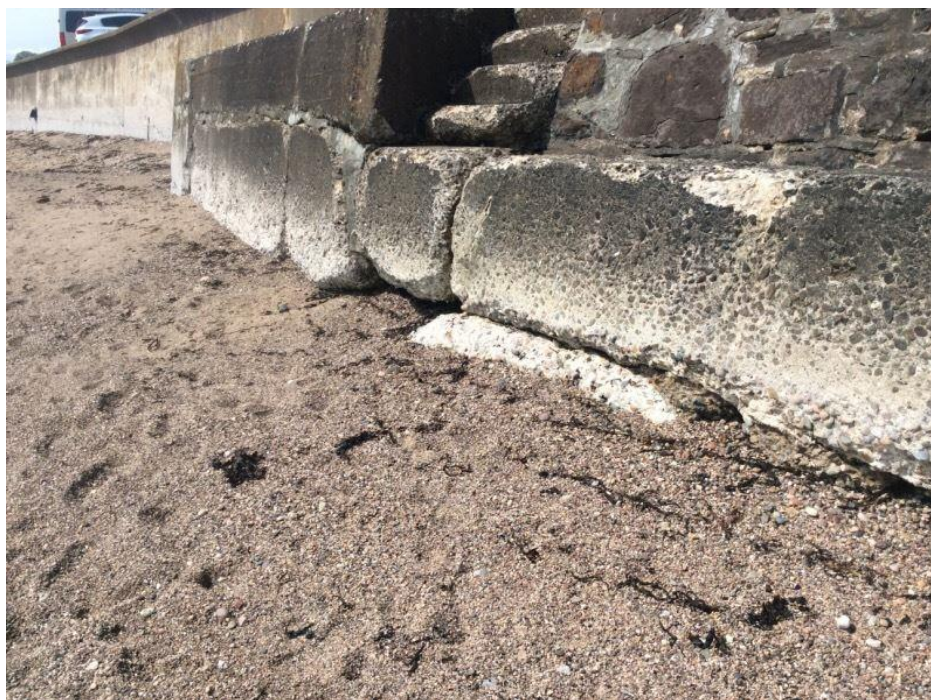
Section A
Seaward toe
Defect Ref: D97
Description: D97 - Poor
protection of the toe
Photo number: 141

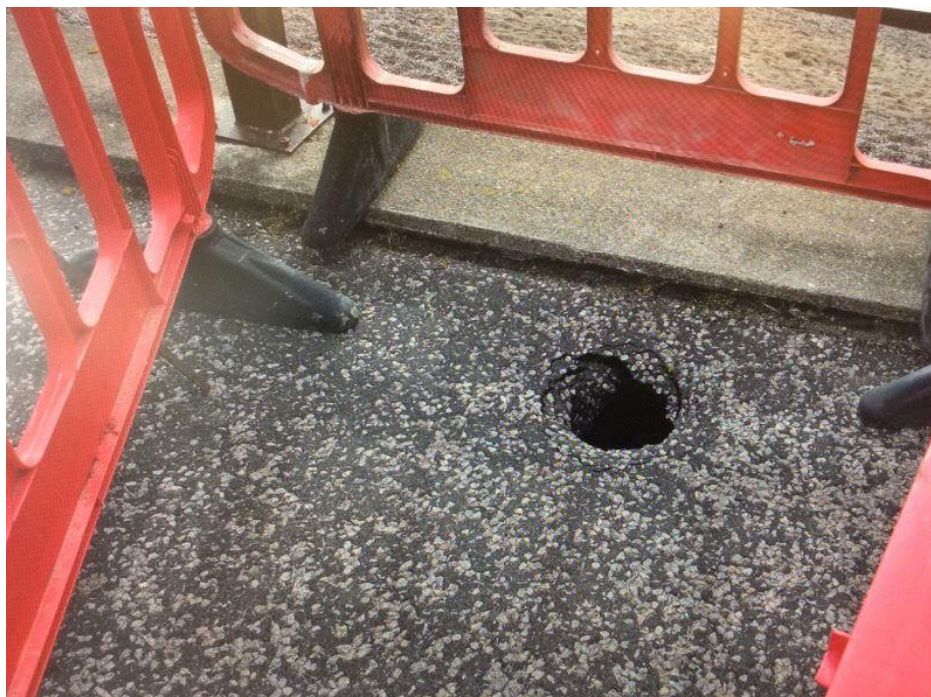
Photo number: 142

Description: Sinkhole in crest (observed following initial inspection)

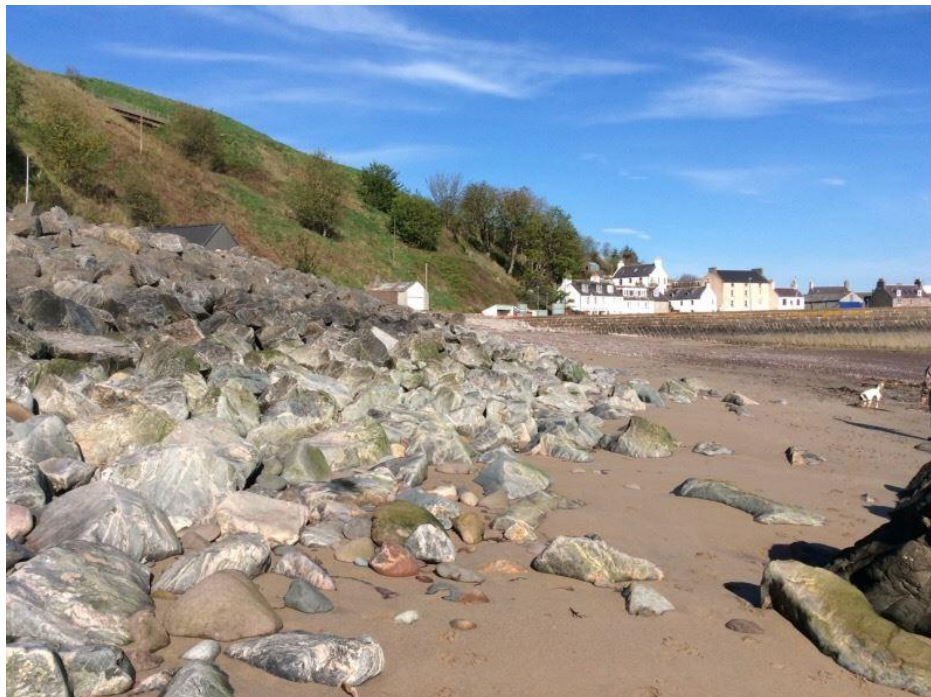
Photo number: 1

Description: Viewer Section A (looking northwest).
Asset Type: Defence
Sub Type: Embankment
Elements: Rock armour, access strip and splash wall.

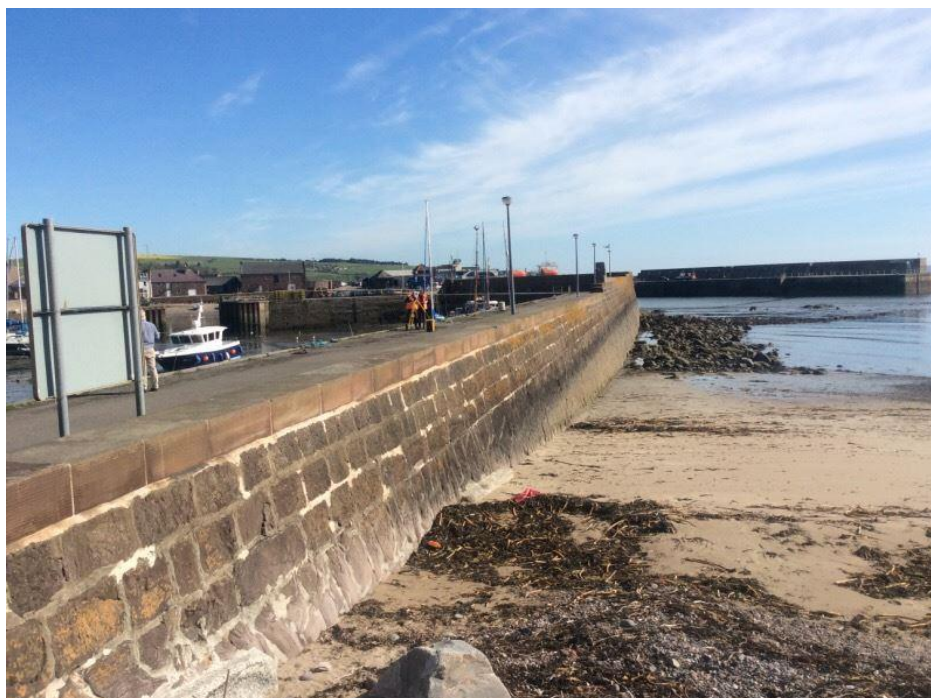
Photo number: 2

Description: View of Section B (looking north)
Asset Type: Defence
Sub Type: Quay
Elements: Seaward face, Quay face, capping, piling, deck.

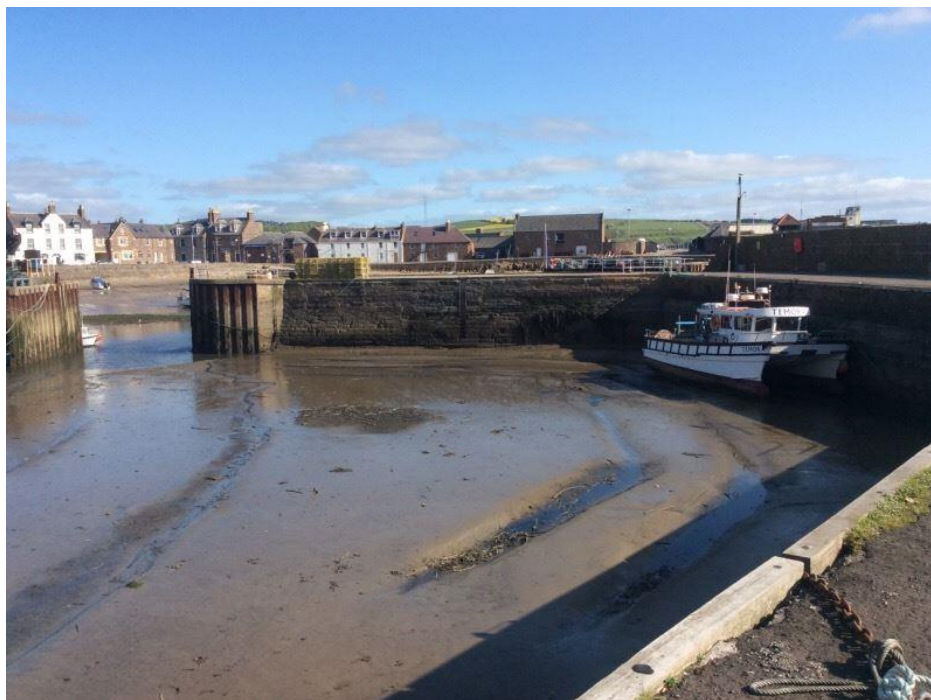
Description: View of
Section B
(looking north)
Asset Type: Defence
Sub Type: Quay
Elements: Seaward face,
Quay face, capping,
piling, deck.
Photo number: 10

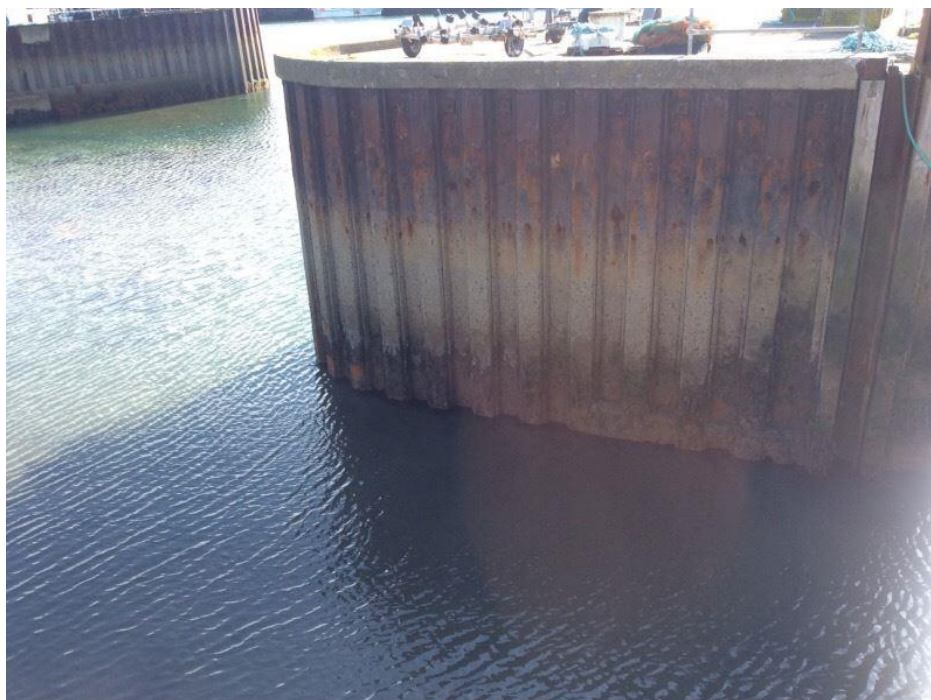
Description: View of
Section B
(looking north)
Asset Type: Defence
Sub Type: Quay
Elements: Seaward face,
Quay face, capping,
piling, deck.
Photo number: 12

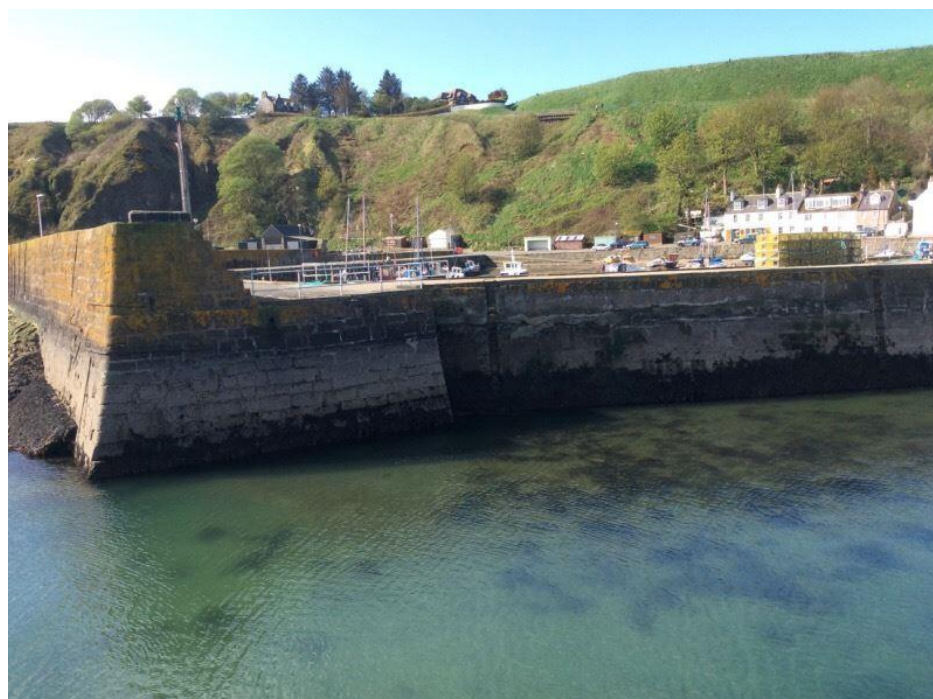
Description: View of Section B (looking north)
Asset Type: Defence
Sub Type: Quay
Elements: Seaward face, Quay face, capping, piling, deck.
Photo number: 14

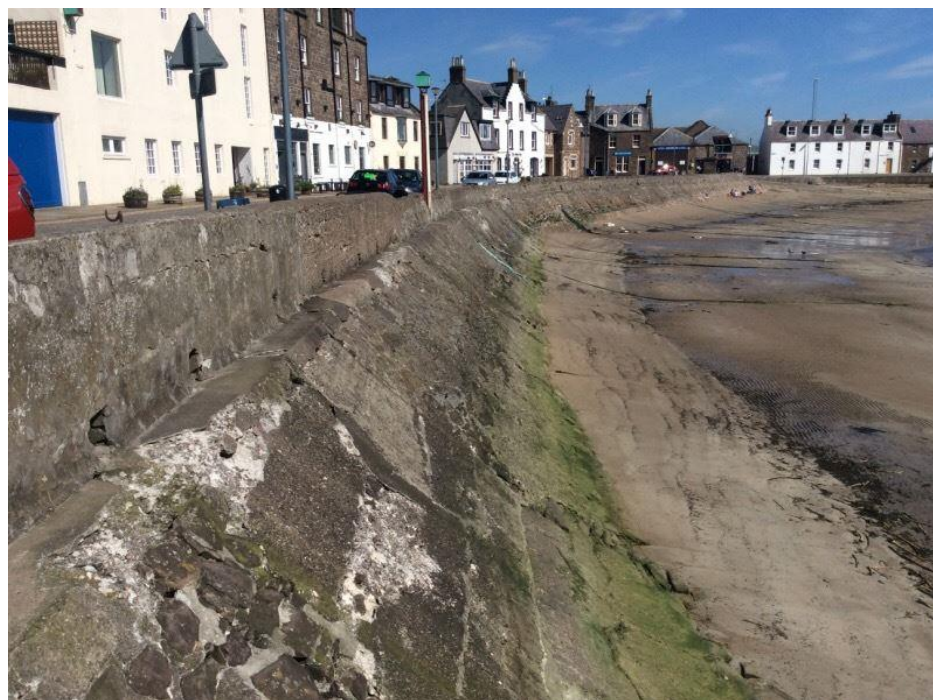
Description: View of Section C (looking north)
Asset Type: Defence
Sub Type: Wall
Elements: Access strip, exposed face, capping wall.
Photo number: 4

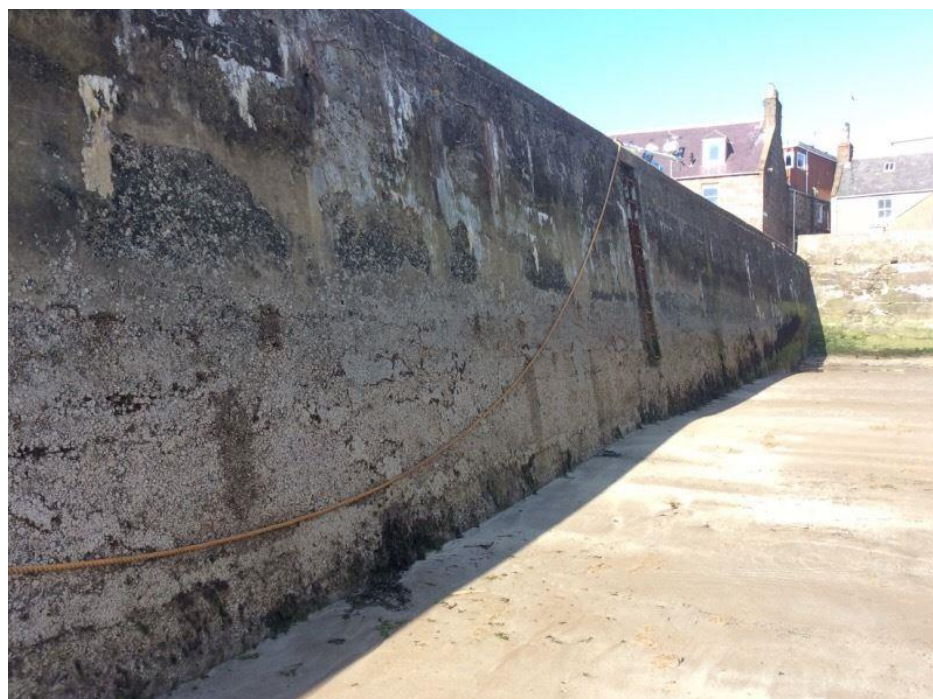
Description: View of Section D (looking west)
Asset Type: Defence
Sub Type: Quay
Elements: Sheet piling, quay face, deck.
Photo number: 13

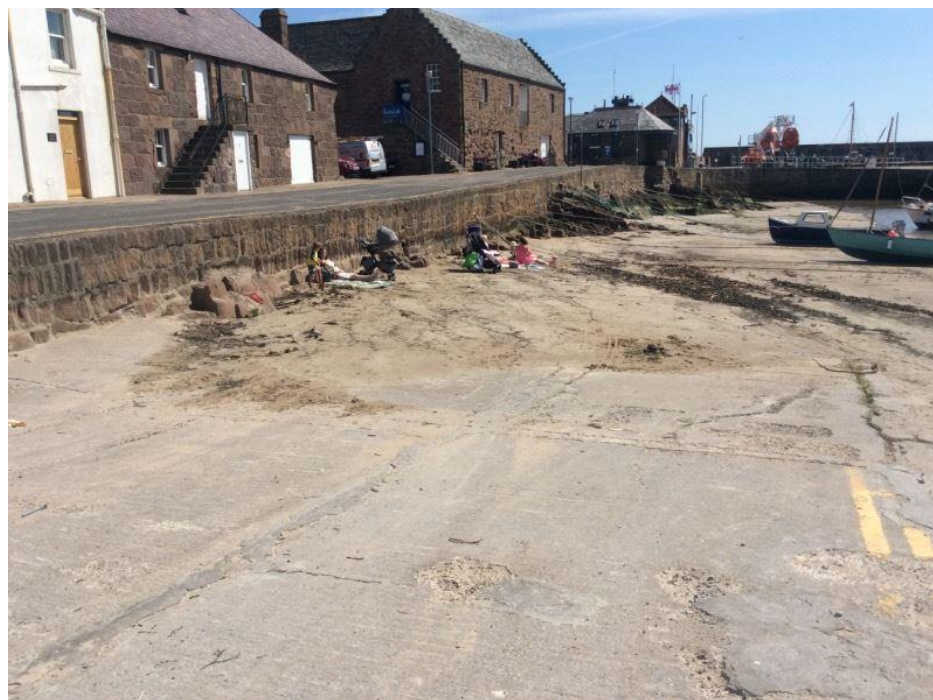
Description: View of Section E (looking north)
Asset Type: Defence
Sub Type: Wall
Elements: Access strip, exposed face.
Photo number: 5

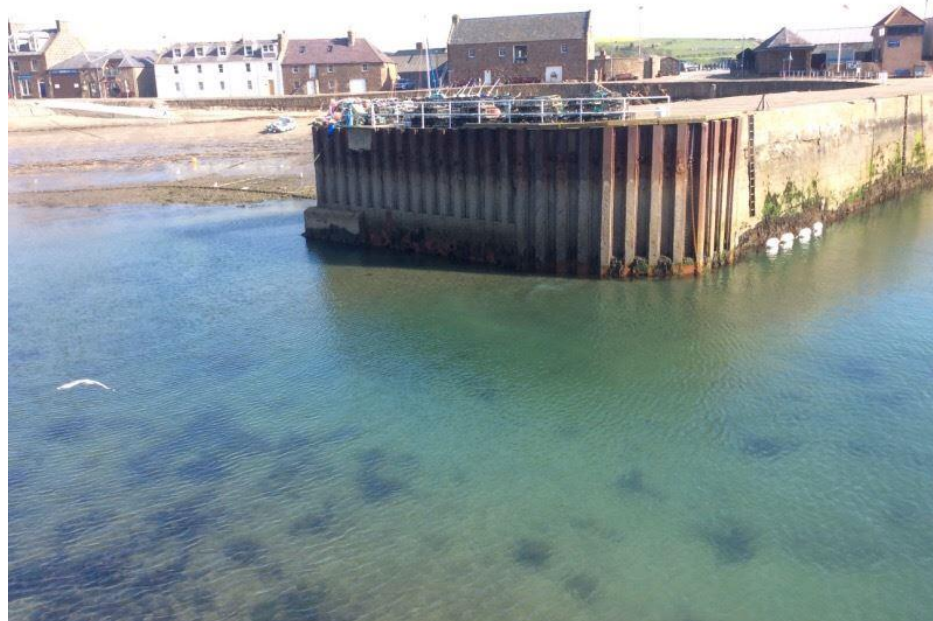
Photo number: 7

Description: View of
Section F

Elements: Quay face,
deck, sheet piling.

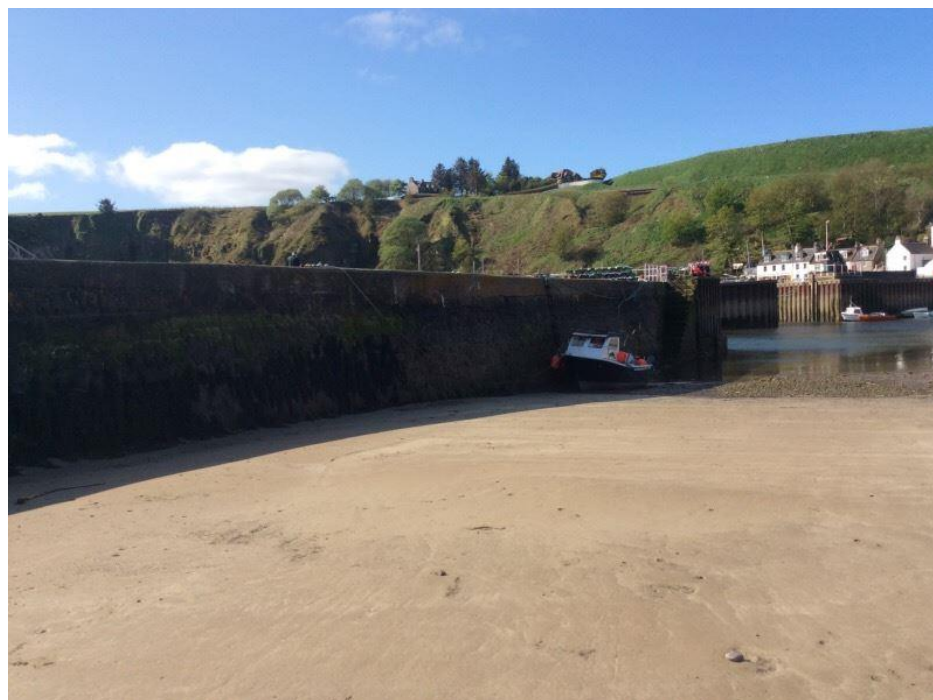
Photo number: 11

Description: View of
Section F

Elements: Quay face,
deck, sheet piling.

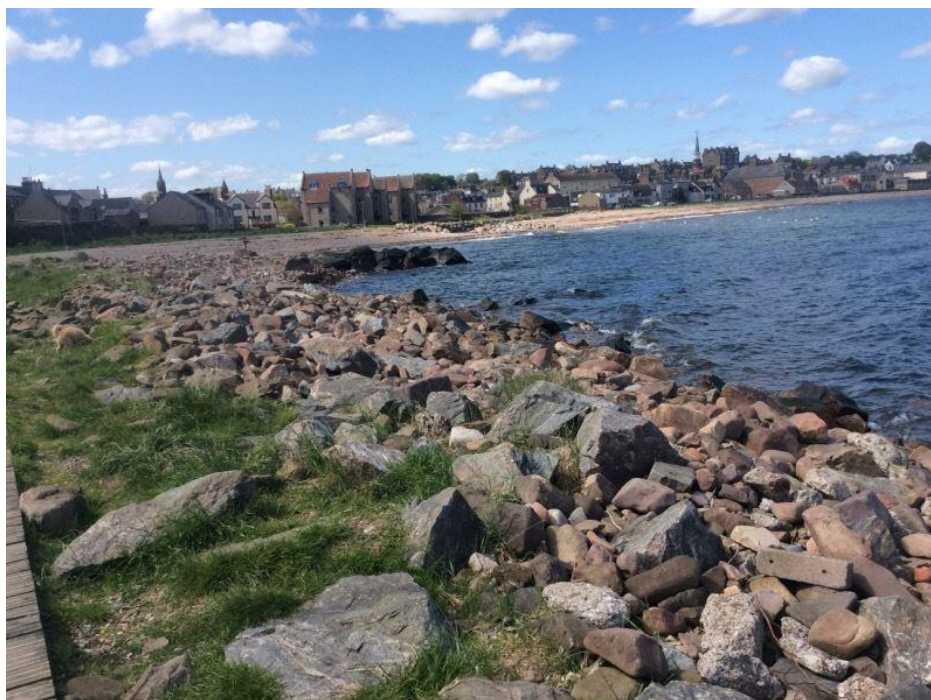
Description: View of Section H (looking northwest)
Asset Type: Defence
Sub Type: Embankment
Elements: Rock armour, splash wall.
Photo number: 8

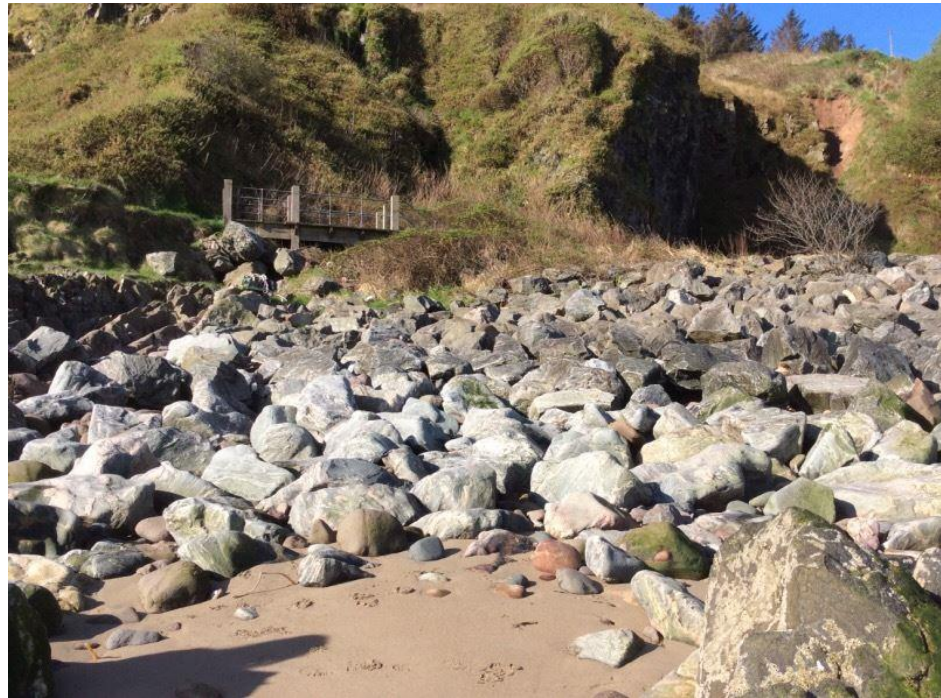
Section A
Rock armour
Defect Ref: D1
Description: D1 - Nonuniform rock armour profile, insufficient protection to timber footbridge.
Photo number: 102

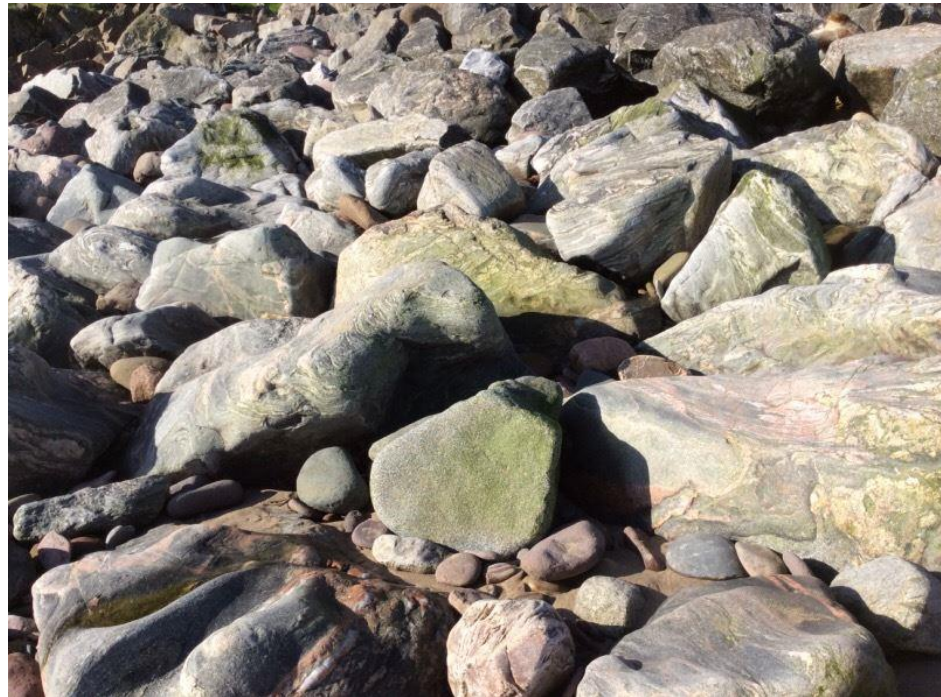
Section A
Rock armour
Defect Ref: D2
Description: D2 - Undersized rock armour.
Photo number: 103

- The rock armour units are expelled and undersized and the access path is in poor condition with missing planks.

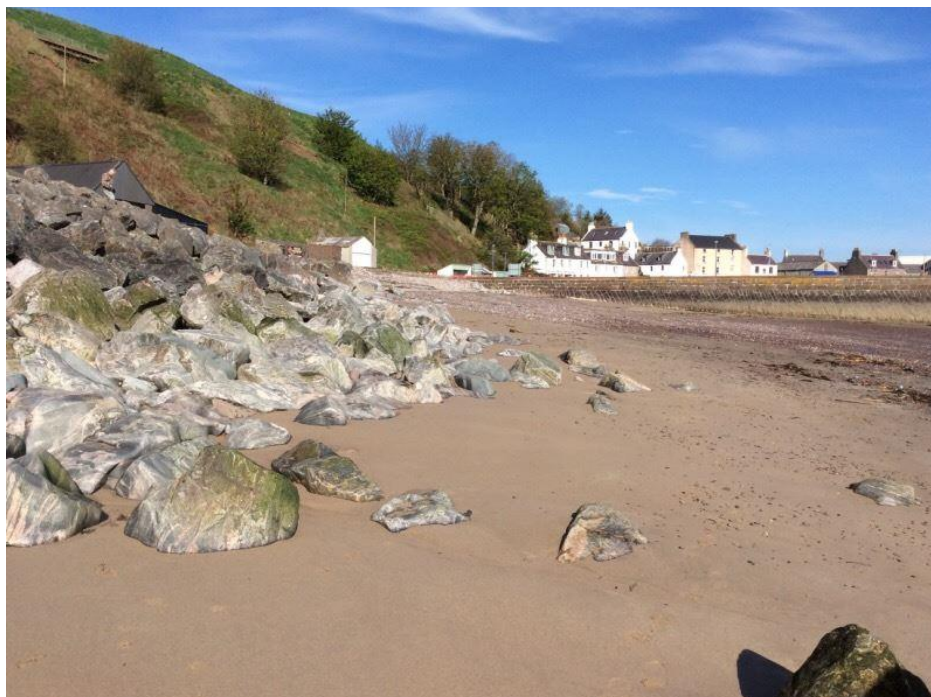
Section A
Rock armour
Defect Ref: D3
Description: D3 -
Expelled rock armour,
also present on slipway
blocking access.
Photo number: 104

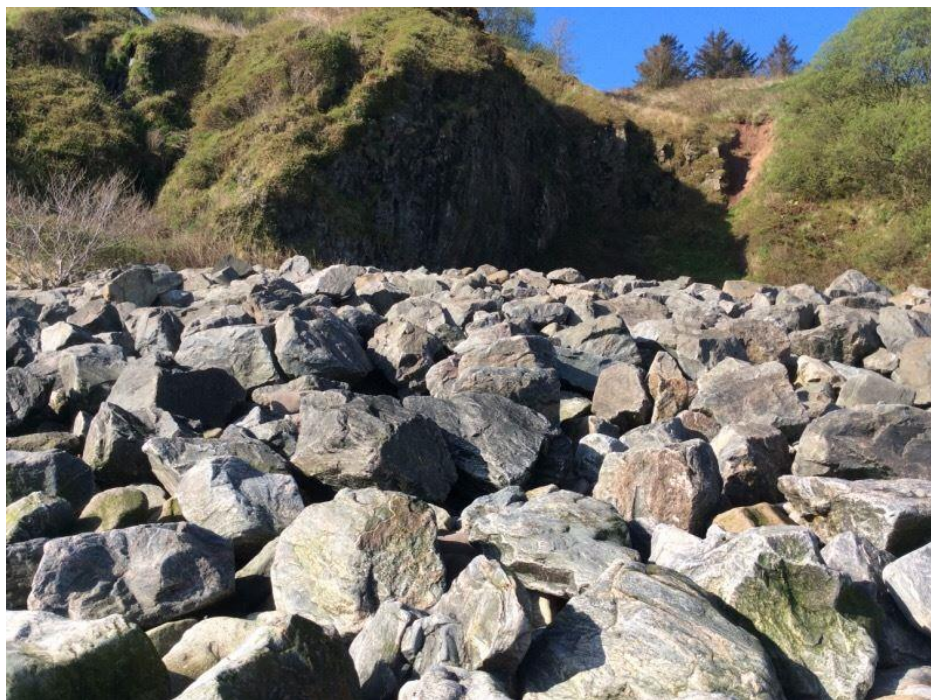
Section A
Rock armour
Defect Ref: D4
Description: D4 - Poorly placed and non-interlocking rock profile.
Photo number: 105

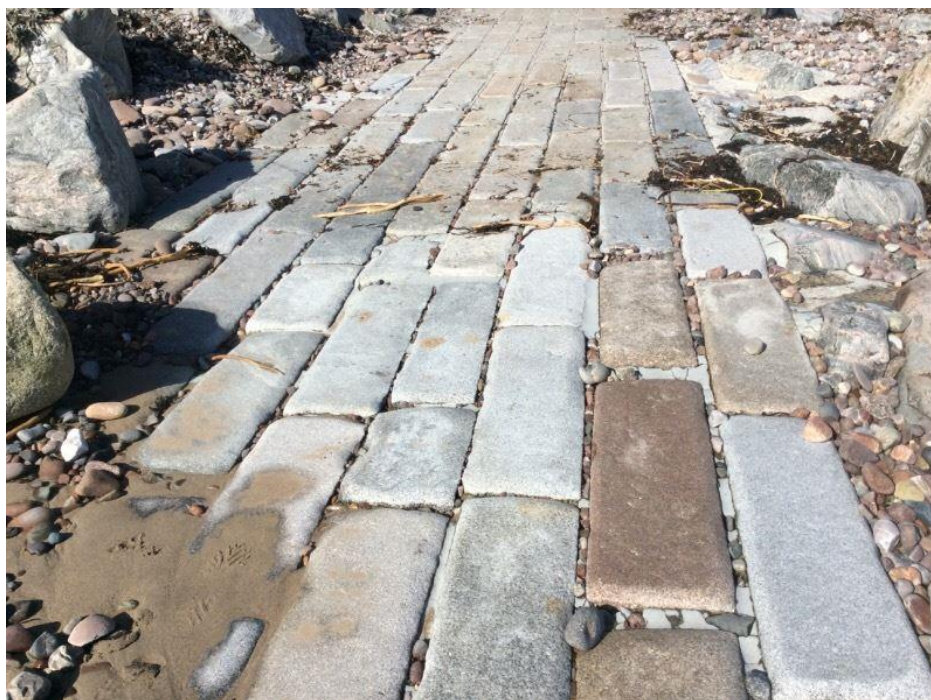
Section A
Access strip
Defect Ref: D5
Description: D5 - Open joints between granite blocks.
Photo number: 106

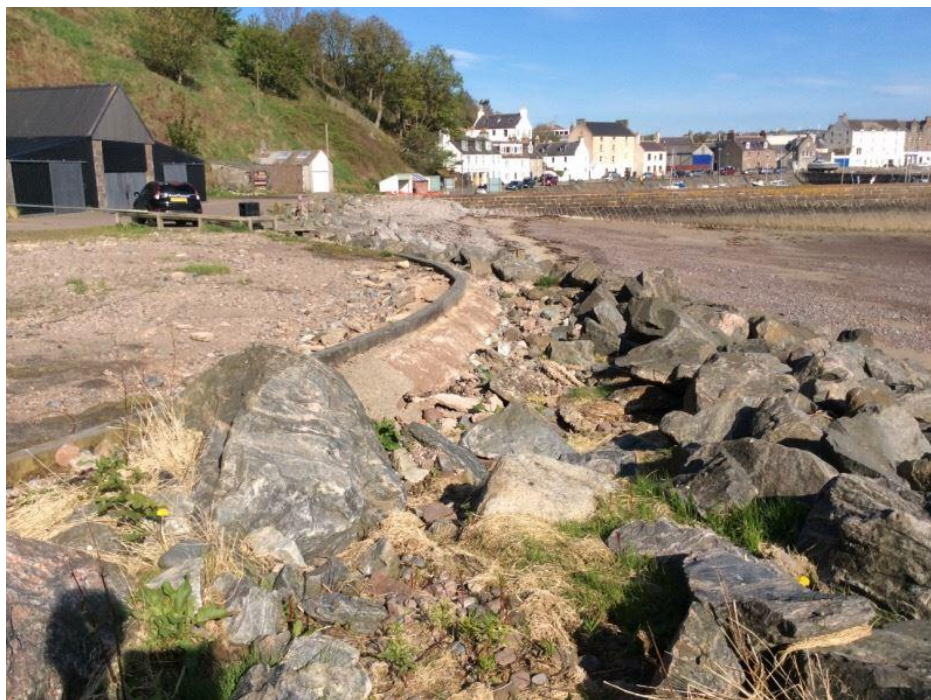
Section A
Rock armour
Defect Ref: D6
Description: D6 - Poor condition of rock armour crest, too narrow under design guidance and provides insufficient protection to the timber walkway.
Photo number: 107

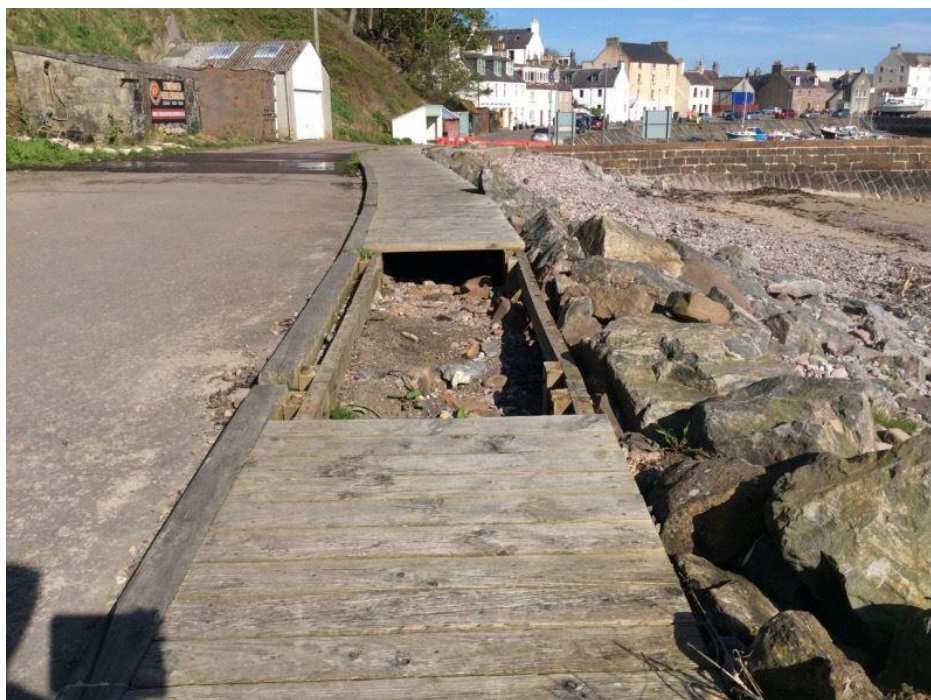
Section A
Access strip
Defect Ref: D7
Description: D7 - H&S uneven and damaged access path, with missing planking.
Photo number: 108

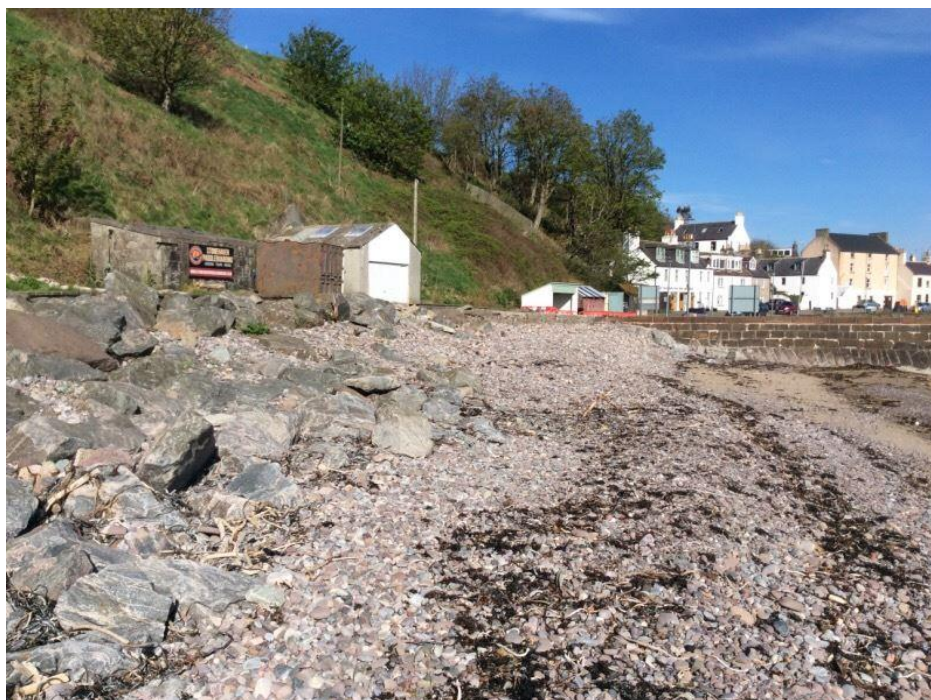
Section A
Rock armour
Defect Ref: D8
Description: D8 - Insufficient rock armour protection at tie-in with harbour arm.
Photo number: 109

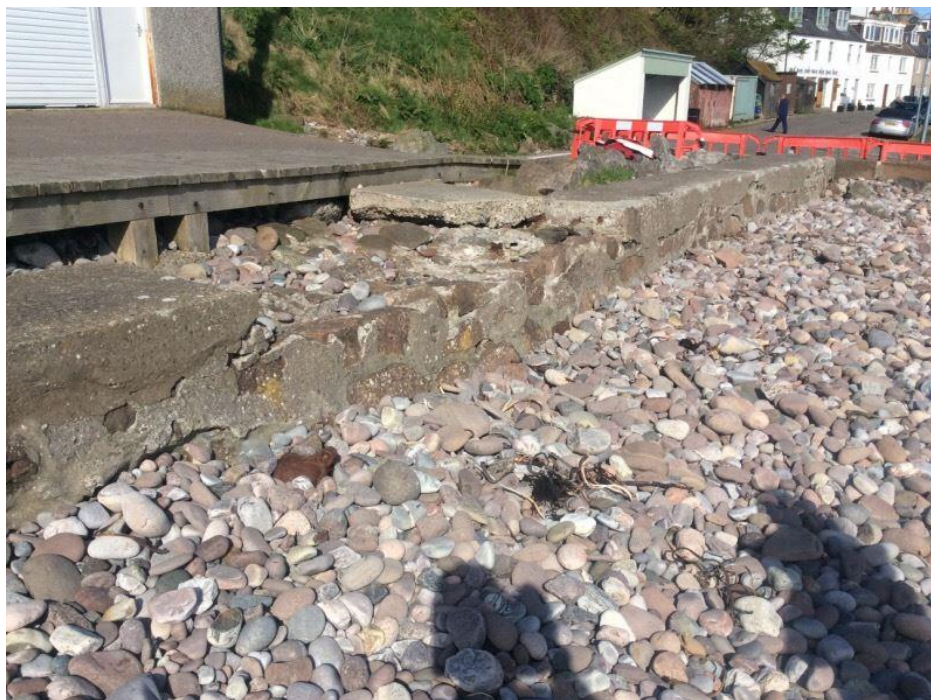
Section A
Splash wall
Defect Ref: D9
Description: D9 -
General dilapidation and
damaged capping repairs
Photo number: 110

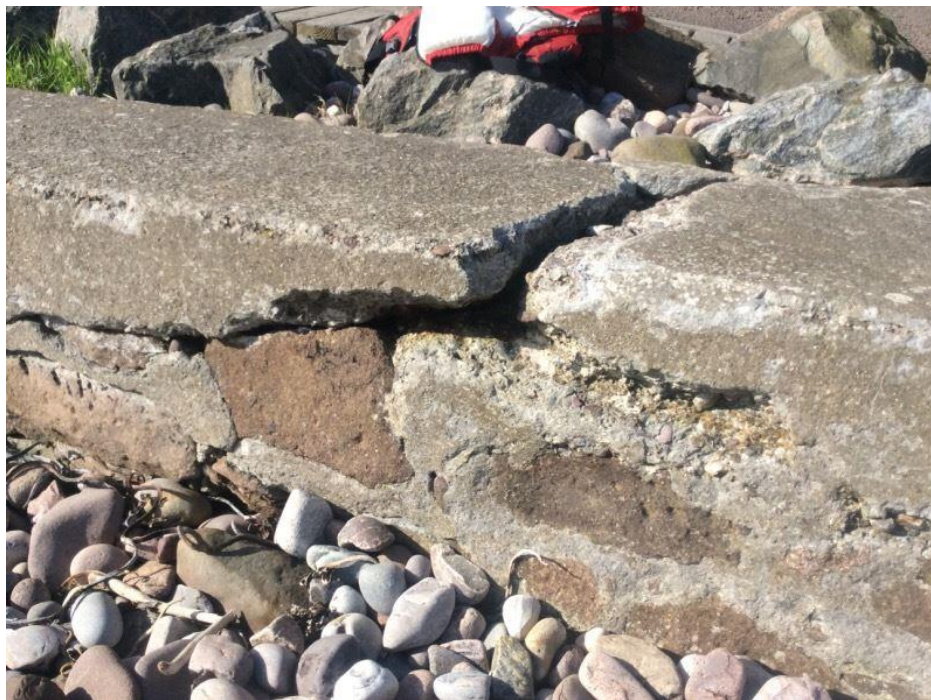
Section A
Splash wall
Defect Ref: D9
Description: D9 -
General dilapidation and
damaged capping repairs
Photo number: 189

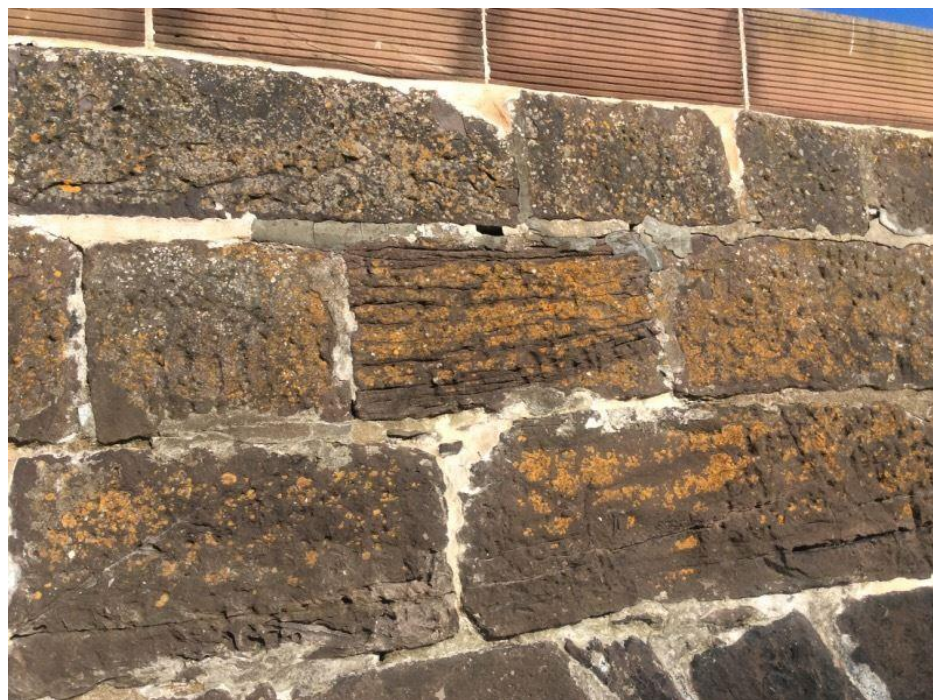
Section B
Seaward face
Defect Ref: D10
Description: D10 - Open
joints.
Photo number: 111

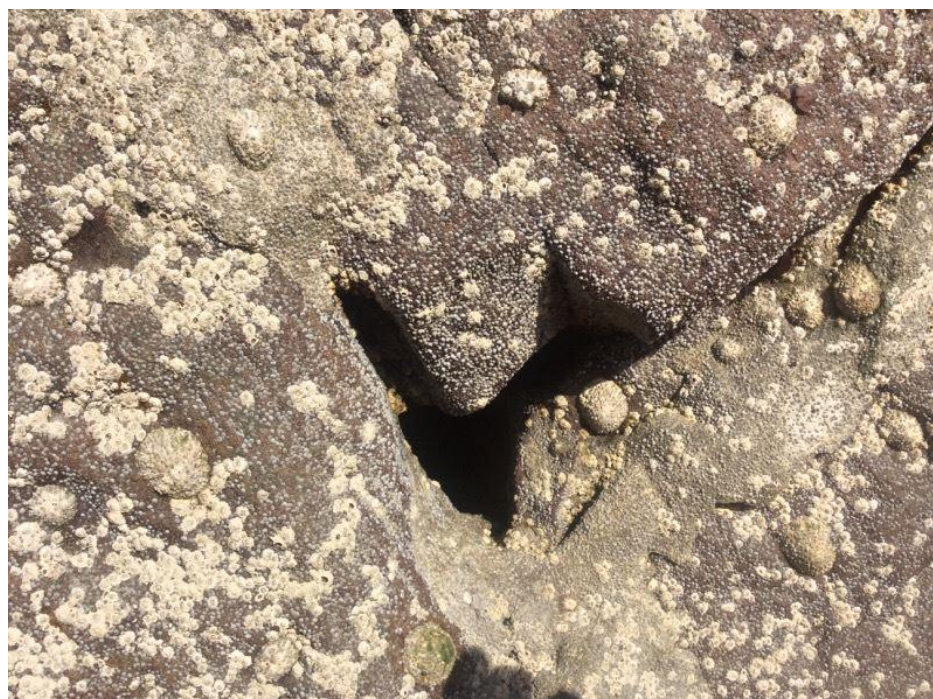
Section B
Seaward face
Defect Ref: D11
Description: D11 -
Voiding behind seaward
face
Photo number: 112

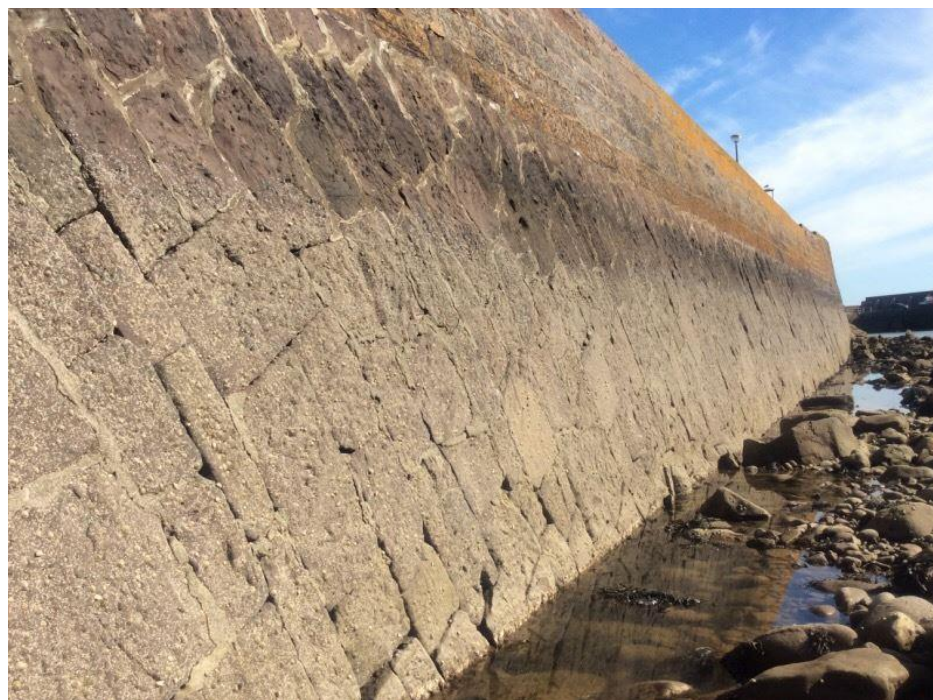
Section B
Seaward face
Defect Ref: D11
Description: D11 -
Voiding behind seaward
face
Photo number: 190

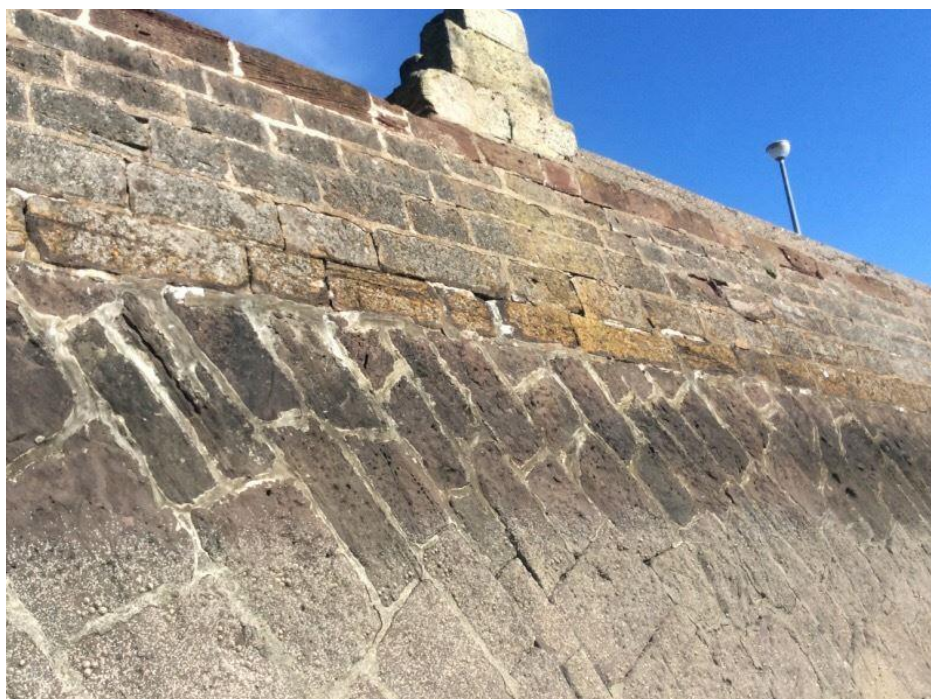
Section B
Capping
Defect Ref: D12
Description: D12 - Open
joints
Photo number: 113

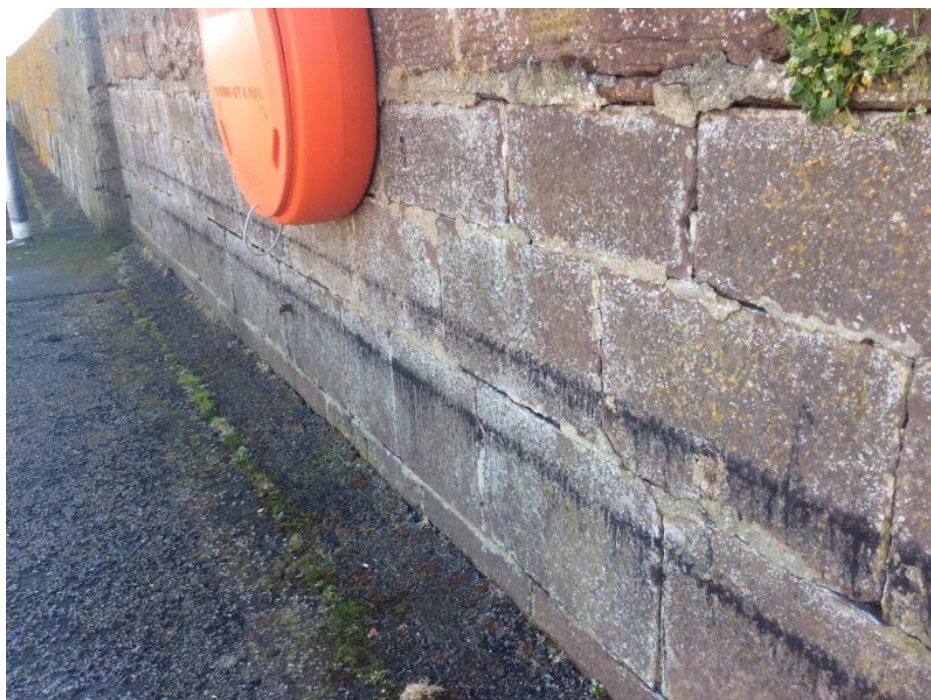
Section B
Capping
Defect Ref: D12
Description: D12 - Open
joints
Photo number: 192

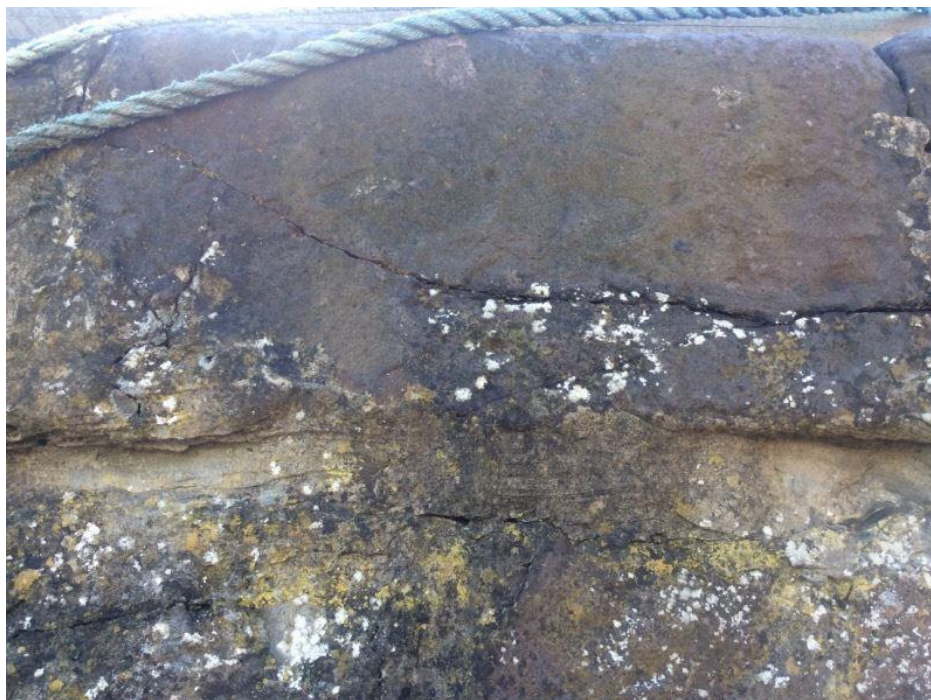
Section B
Quay face
Defect Ref: D13
Description: D13 -
Small cracks of masonry
blocks.
Photo number: 114

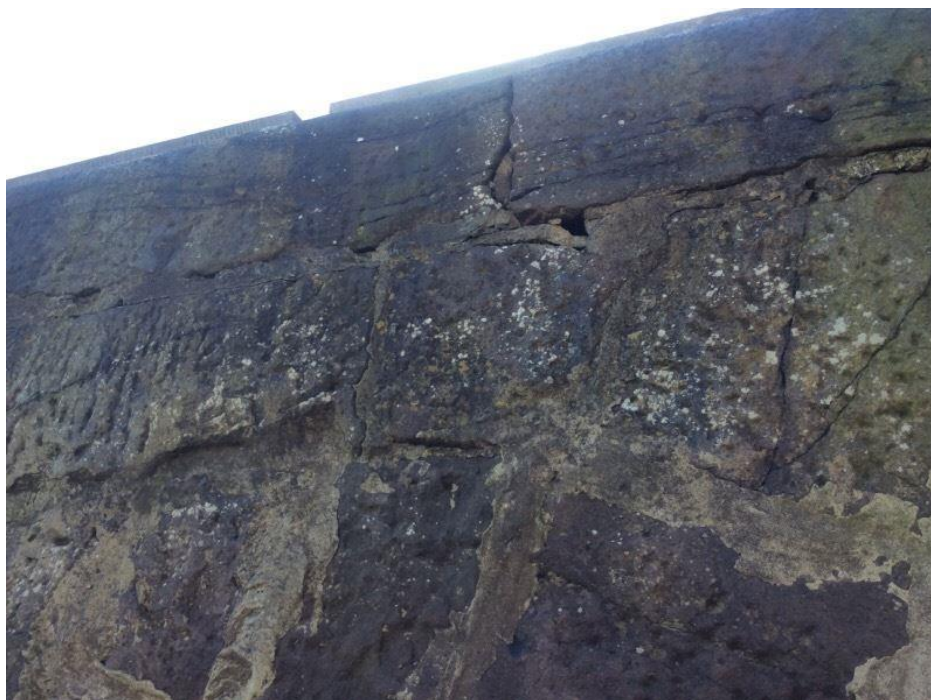
Section B
Quay face
Defect Ref: D13
Description: D13 -
Small cracks of masonry
blocks.
Photo number: 191

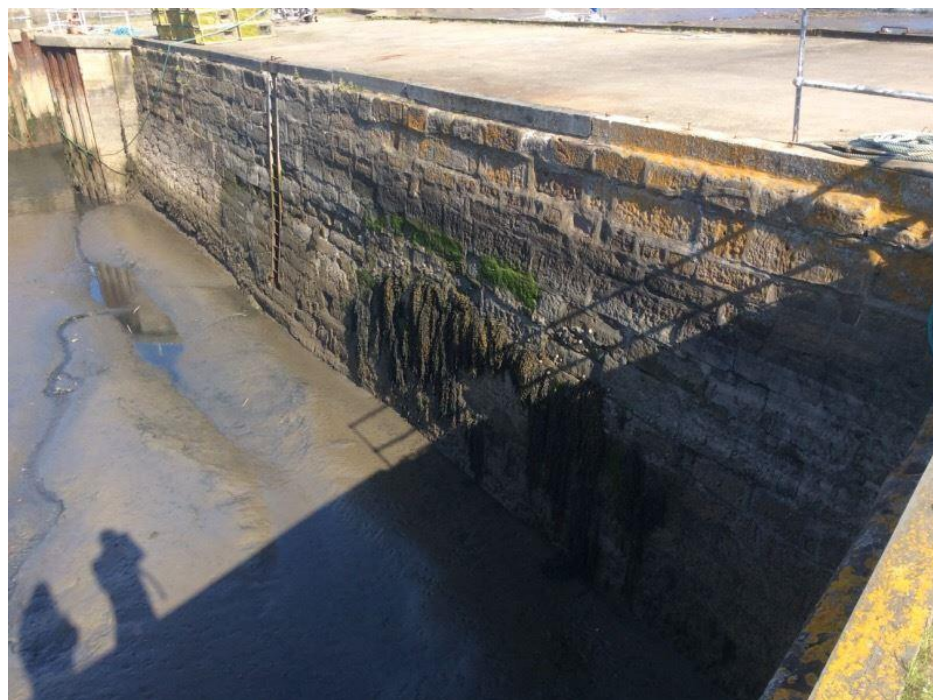
Section B
Quay face
Defect Ref: D14
Description: D14 - Open
joints.
Photo number: 168
