Stonehaven Bay Coastal Flood Protection Study

Final Report

December 2019

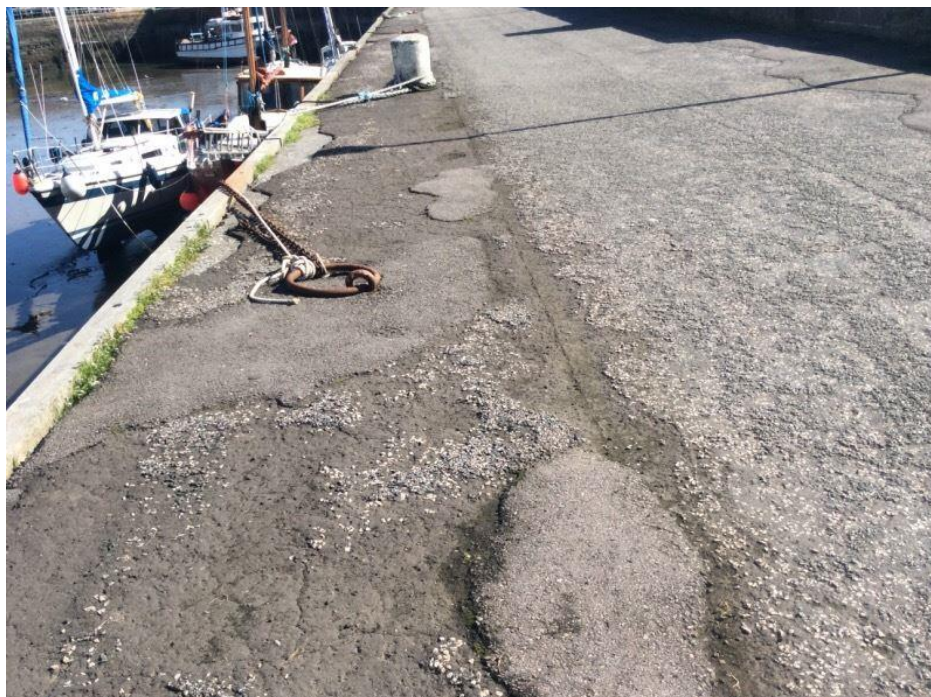
Photo number: 115

Section B

Deck

Defect Ref: D15

Description: D15 -
Dilapidated tarmac
surface.

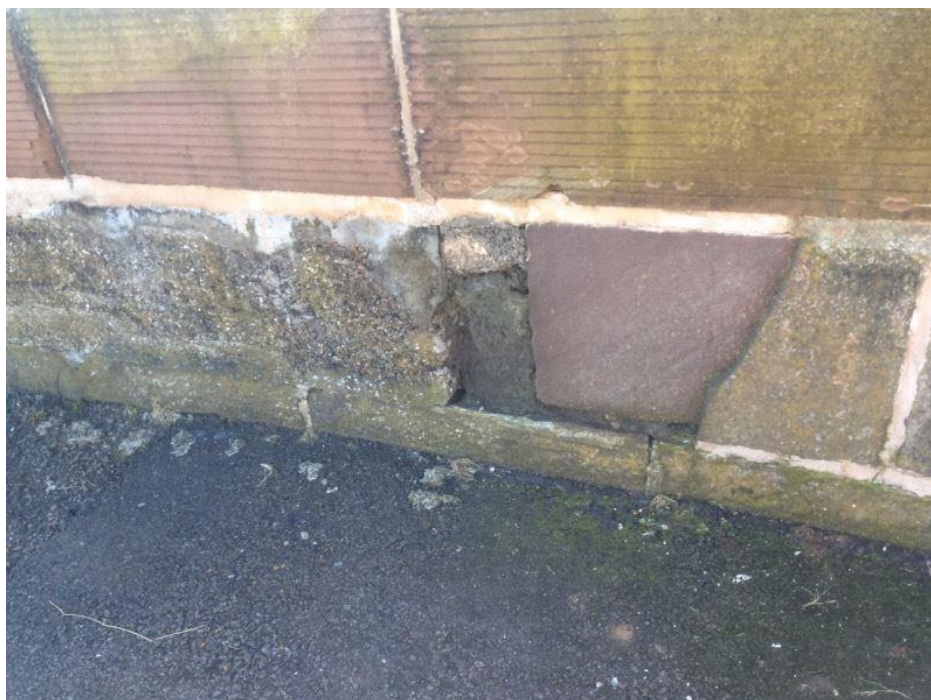
Photo number: 116

Section B

Capping

Defect Ref: D16

Description: D16 -
Weathering of repairs

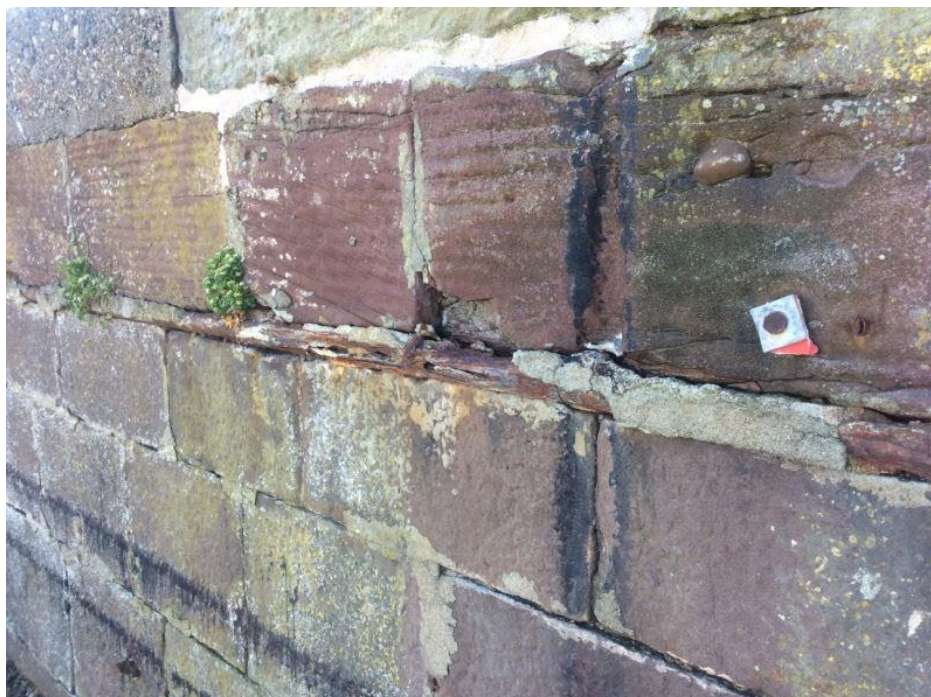
Section B
Capping
Defect Ref: D17
Description: D17 -
Corroding piping joints.
Photo number: 117

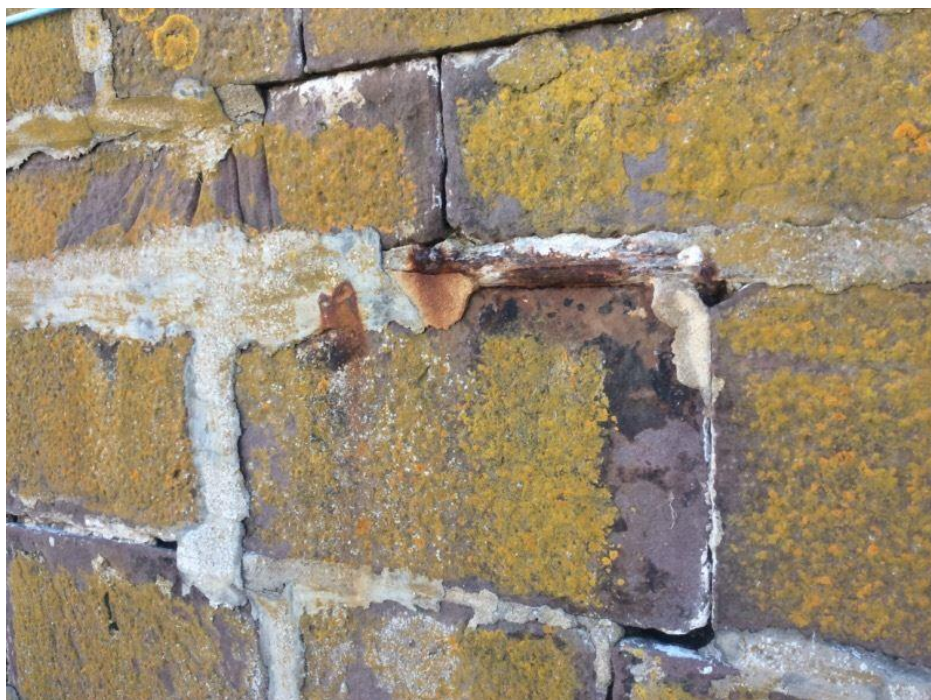
Section B
Capping
Defect Ref: D17
Description: D17 -
Corroding piping joints.
Photo number: 194

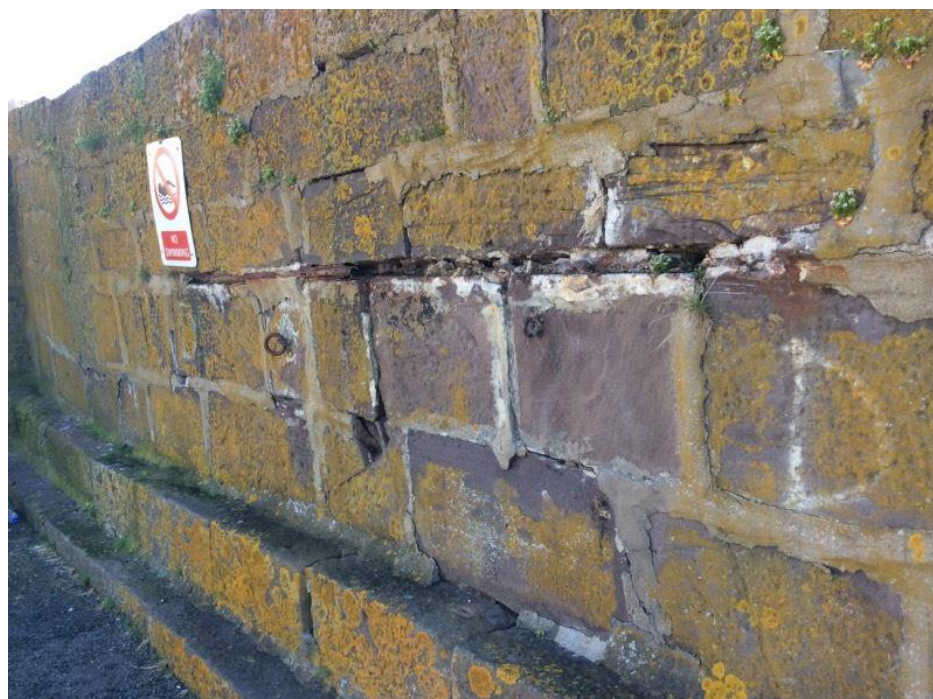
Section B
Capping
Defect Ref: D17
Description: D17 -
Corroding piping joints.
Photo number: 223

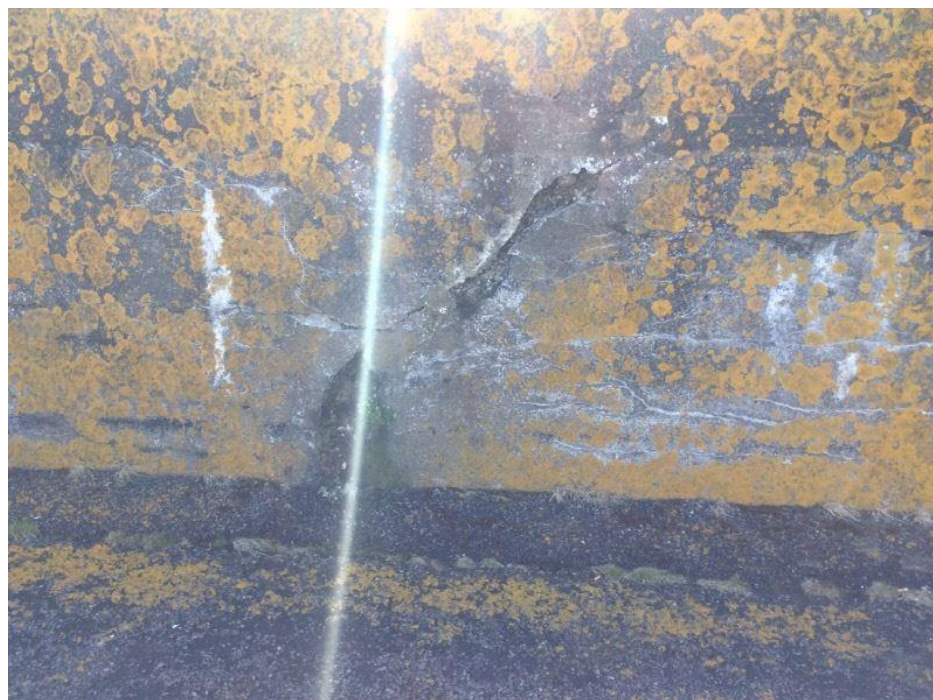
Section B
Capping
Defect Ref: D18
Description: D18 -
Cracking and spalling of
concrete rendering
throughout section.
Photo number: 118

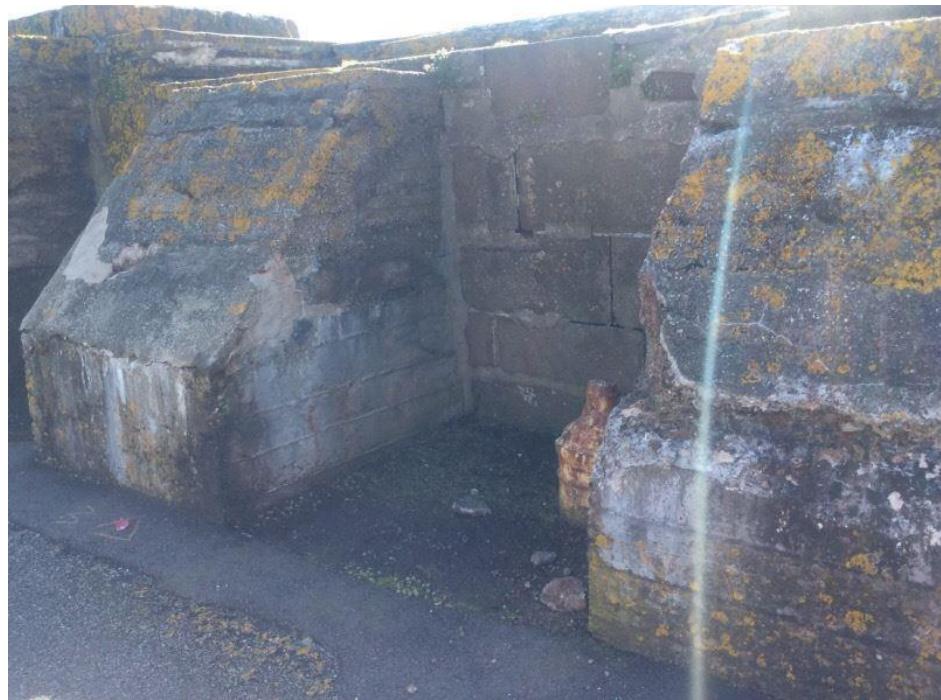
Section B
Capping
Defect Ref: D19
Description: D19 -
Spalling, cracking and
honeycombing of
buttress elements of the
wall.
Photo number: 119

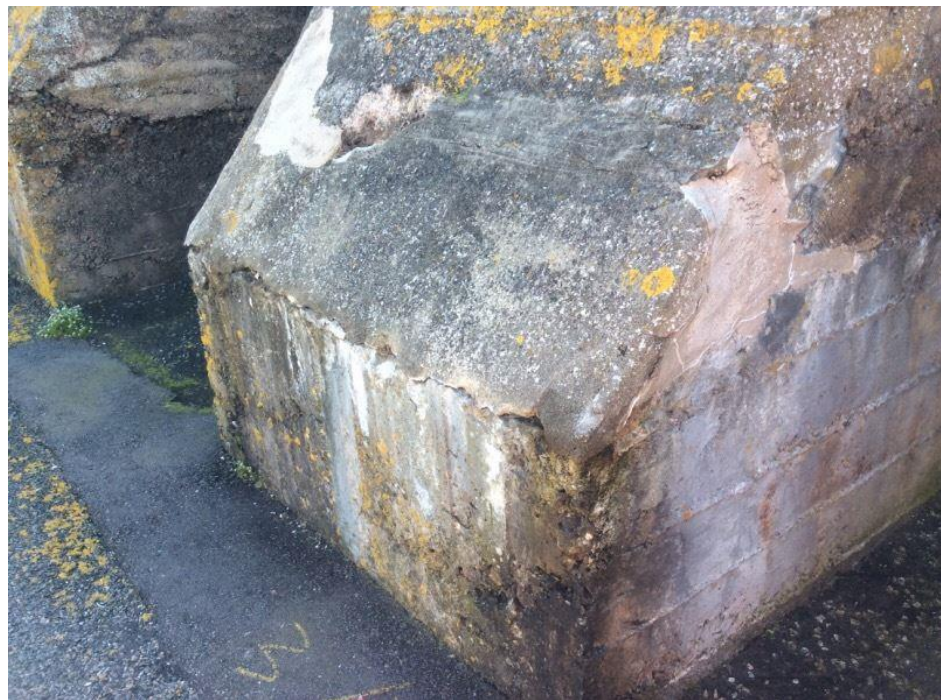
Section B
Capping
Defect Ref: D19
Description: D19 -
Spalling, cracking and
honeycombing of
buttress elements of the
wall.
Photo number: 193

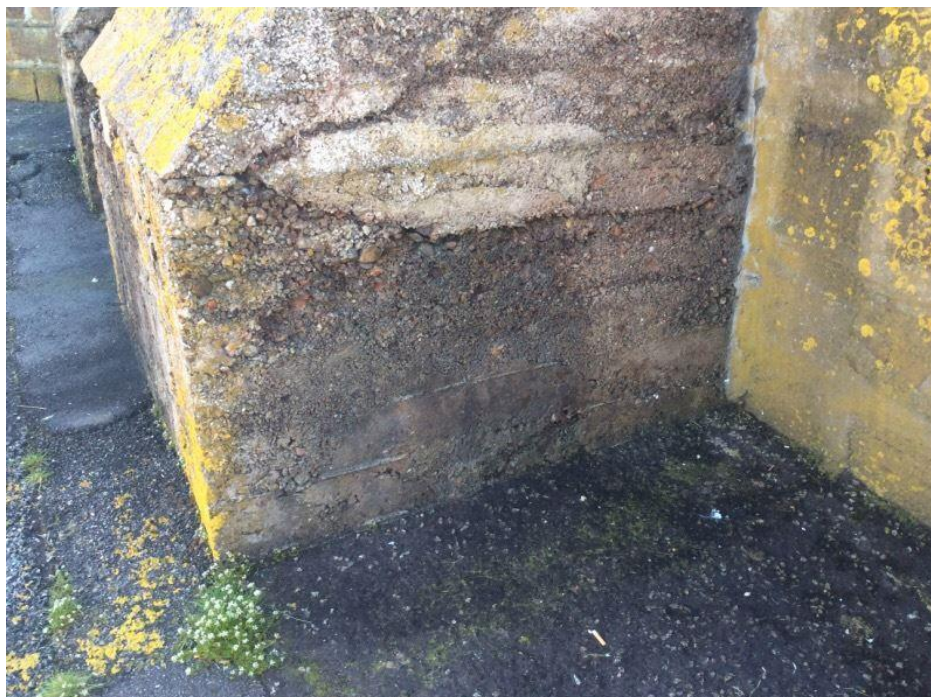
Section B
Capping
Defect Ref: D19
Description: D19 -
Spalling, cracking and
honeycombing of
buttress elements of the
wall.
Photo number: 222

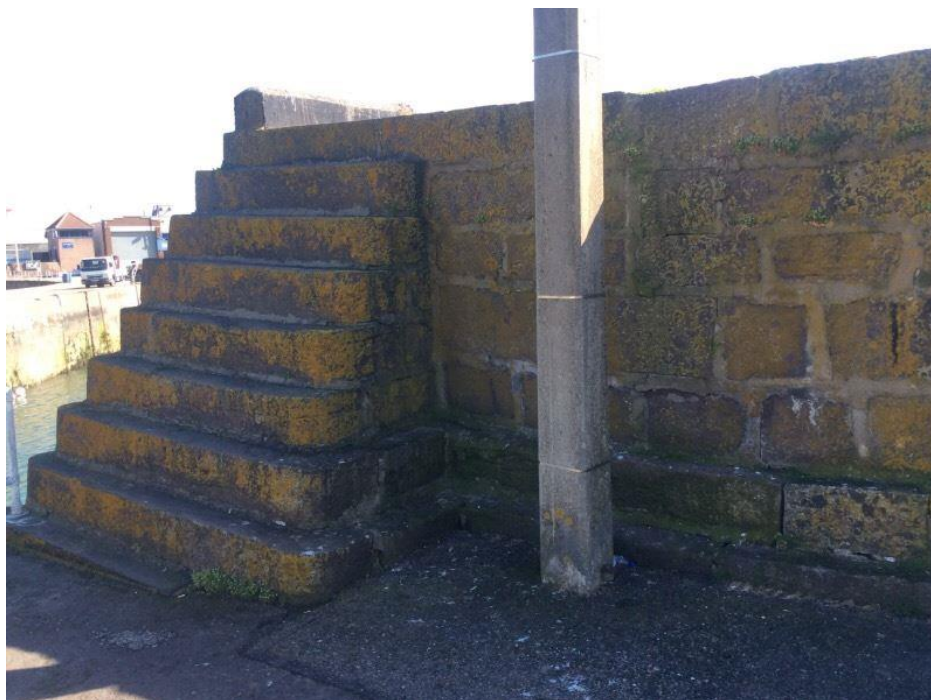
Section B
Capping
Defect Ref: D20
Description: D20 -
Settlement of the wall.
Photo number: 120

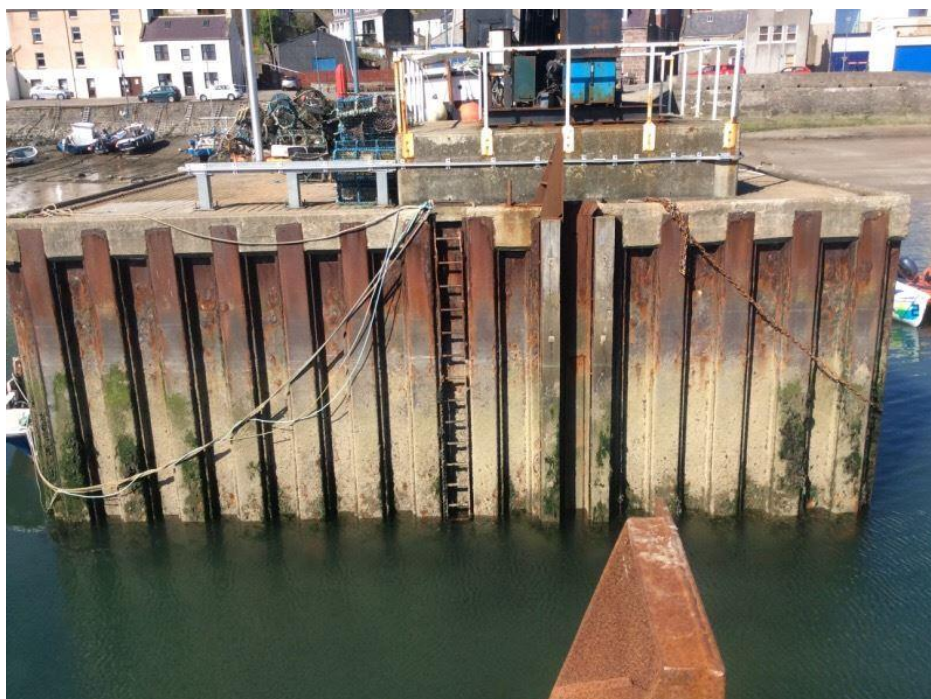
Section D
Sheet piling
Defect Ref: D21
Description: D21 -
Corrosion of sheet piles.
Photo number: 121

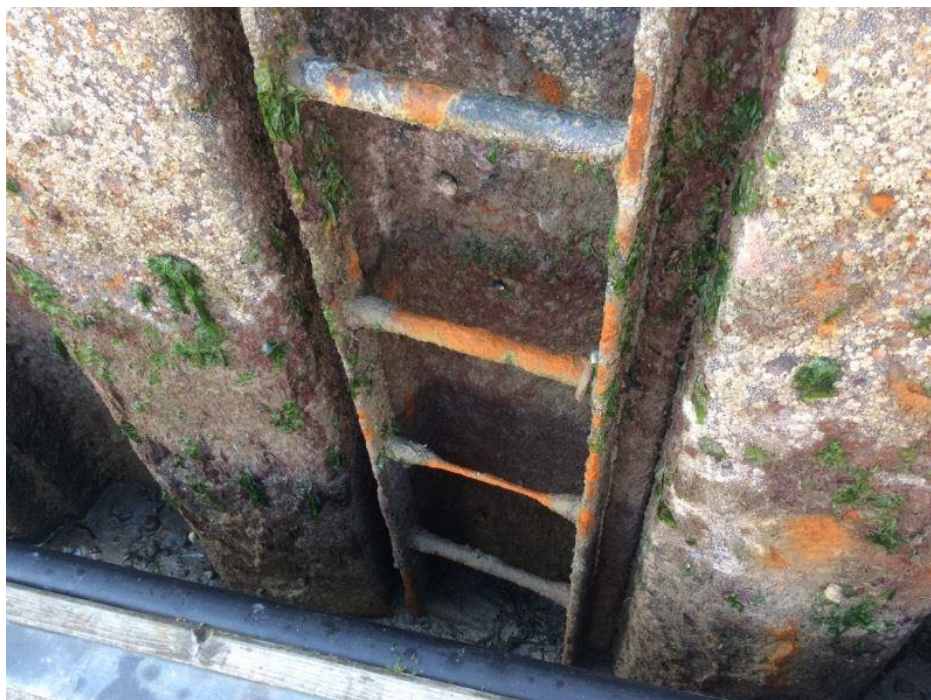
Section D
Sheet piling
Defect Ref: D22
Description: D22 -
Health and Safety -
Heavily corroded ladder.
Photo number: 216

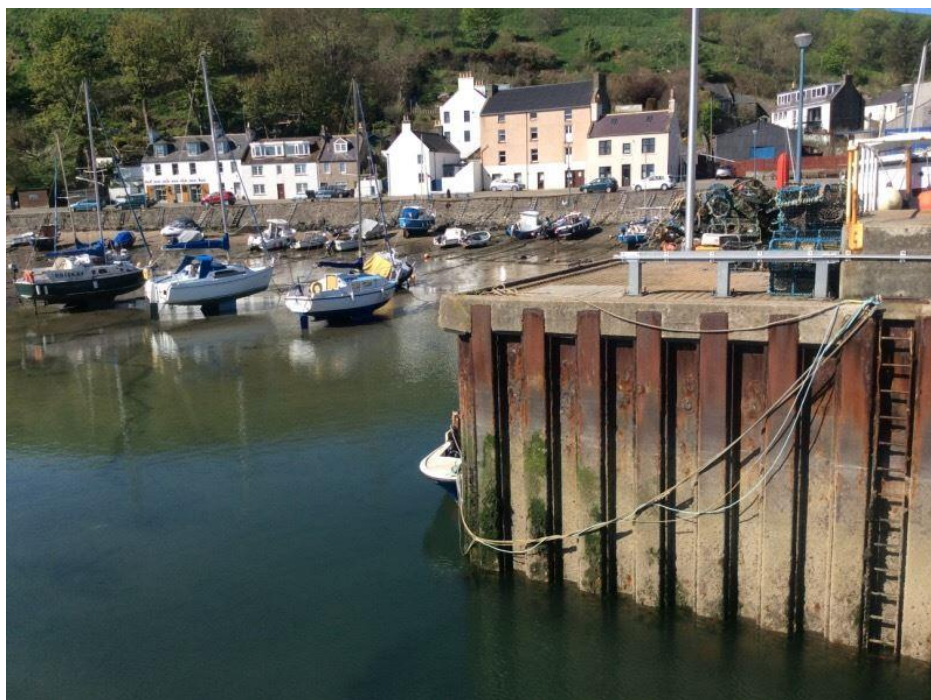
Section D
Sheet piling
Defect Ref: D23
Description: D23 -
Capping beam cracked.
Photo number: 123

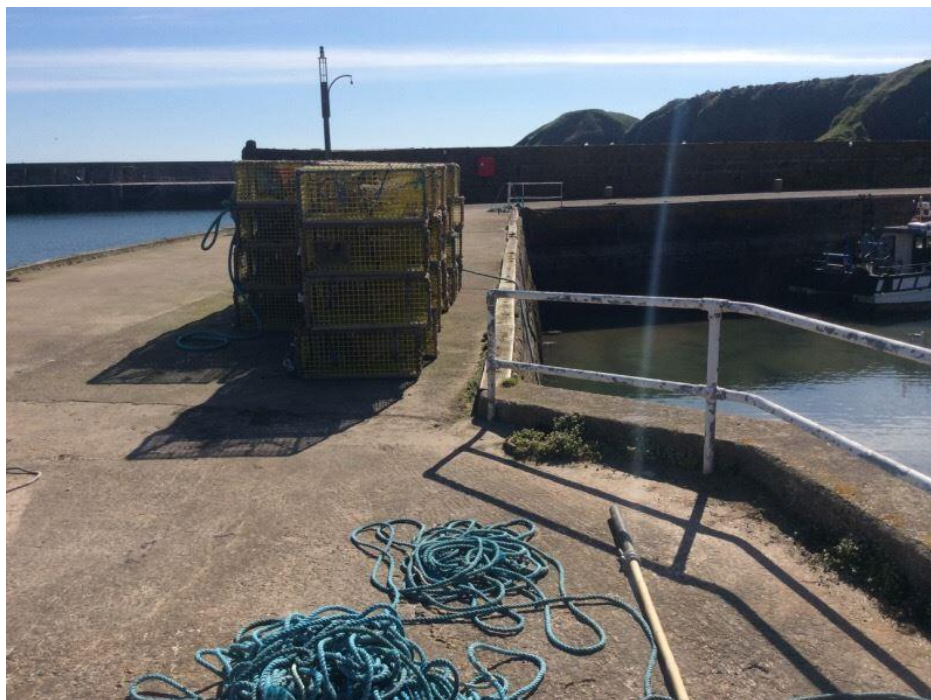
Section B
Deck
Defect Ref: D24
Description: D24 -
Insufficient hand railing
Photo number: 124

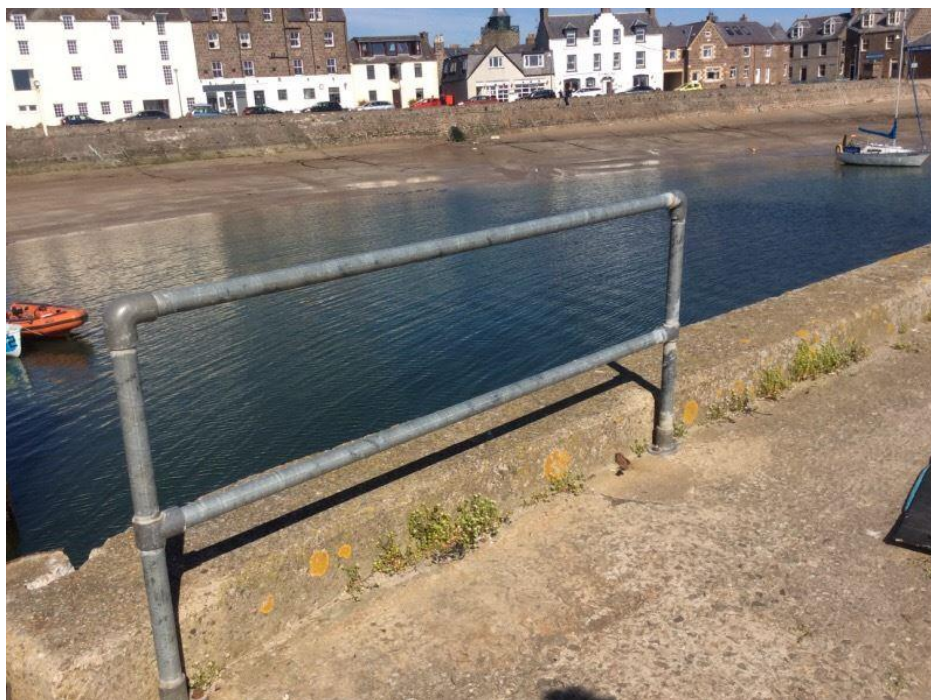
Section B
Deck
Defect Ref: D25
Description: D25 -
Loose handrailing
Photo number: 125

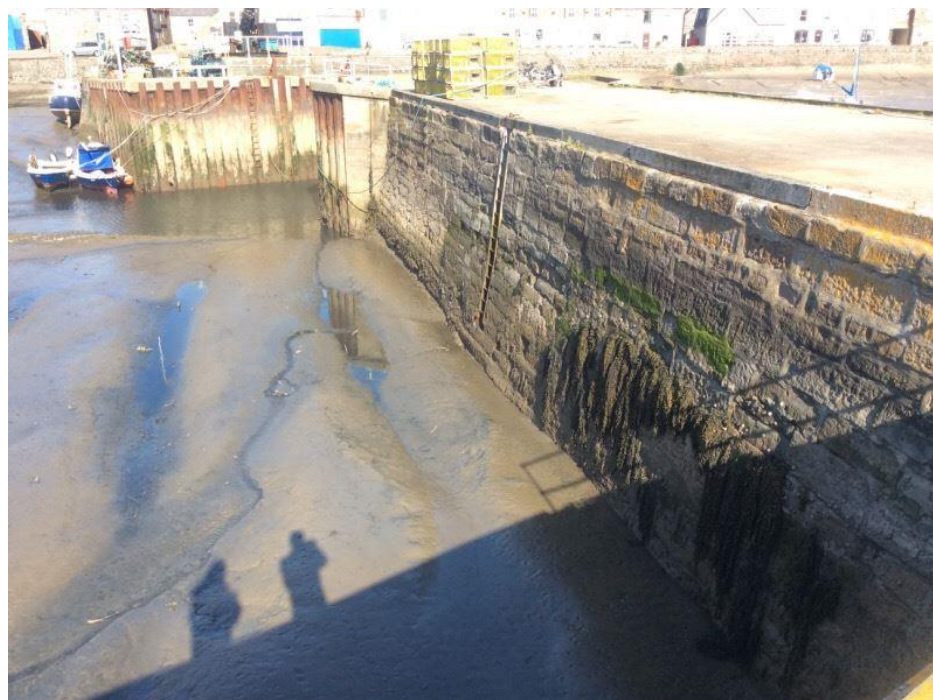
Section B
Quay face
Defect Ref: D26
Description: D26 -
Weathering of blockwork.
Photo number: 213

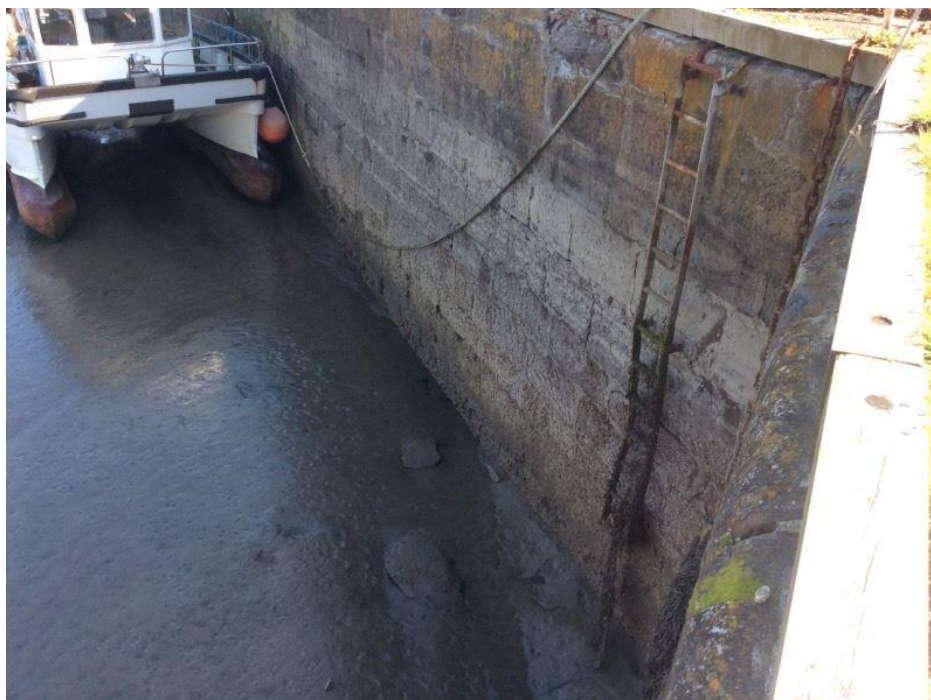
Section B
Quay face
Defect Ref: D27
Description: D27 -
Corroded ladder
Photo number: 212

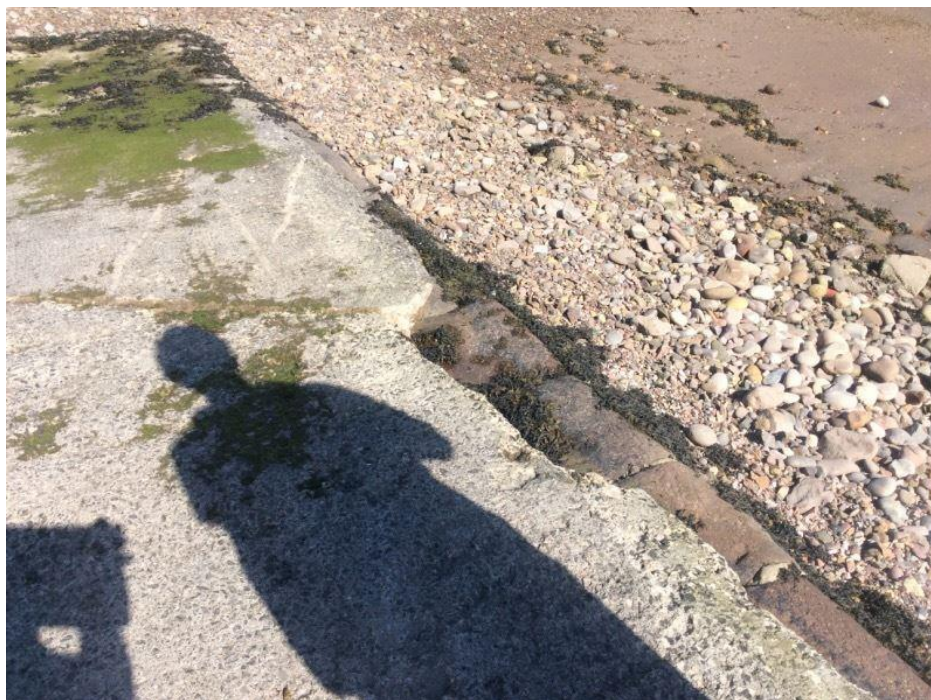
Section C
Access strip
Defect Ref: D28
Description: D28 -
Cracking and loss of
concrete on the slipway
Photo number: 128

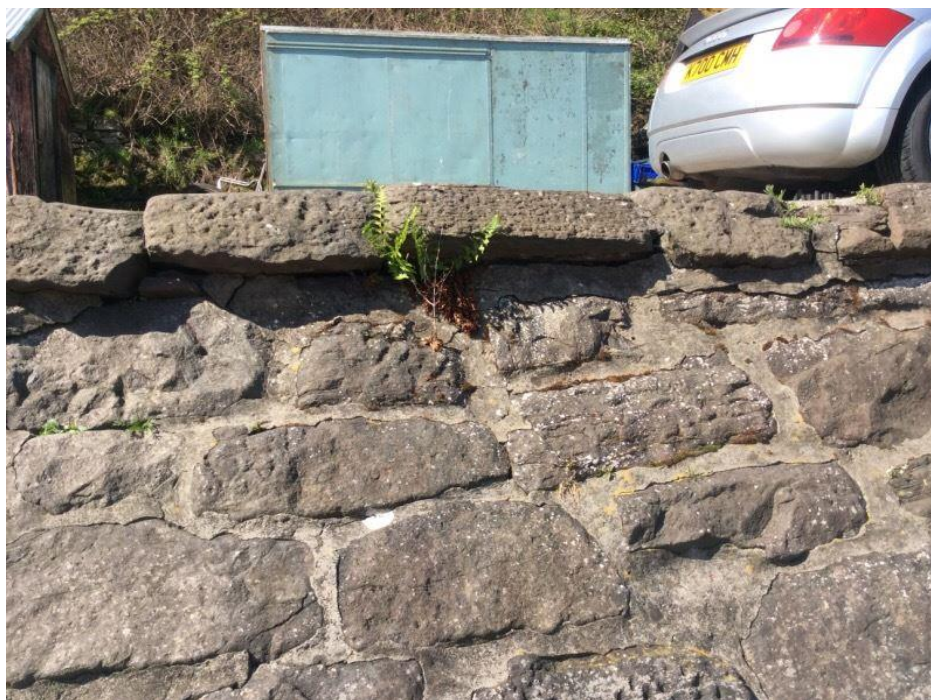
Section C
Exposed face
Defect Ref: D29
Description: D29 -
Cracking of pointing
along the entire length
and loose blockwork.
Photo number: 129

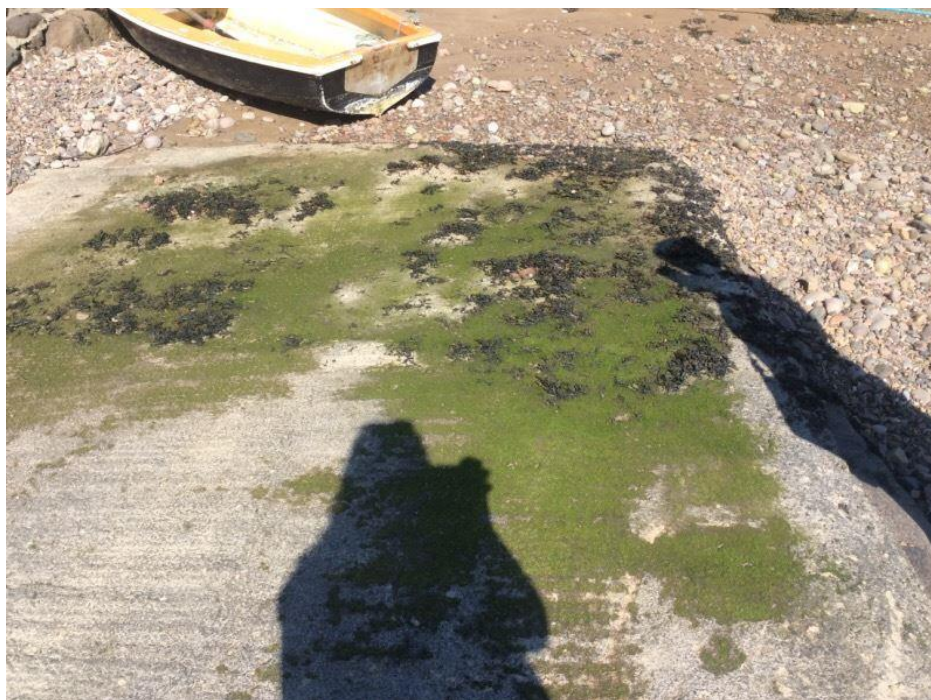
Section C
Access strip
Defect Ref: D30
Description: D30 -
Algae growth on slipway
Photo number: 130

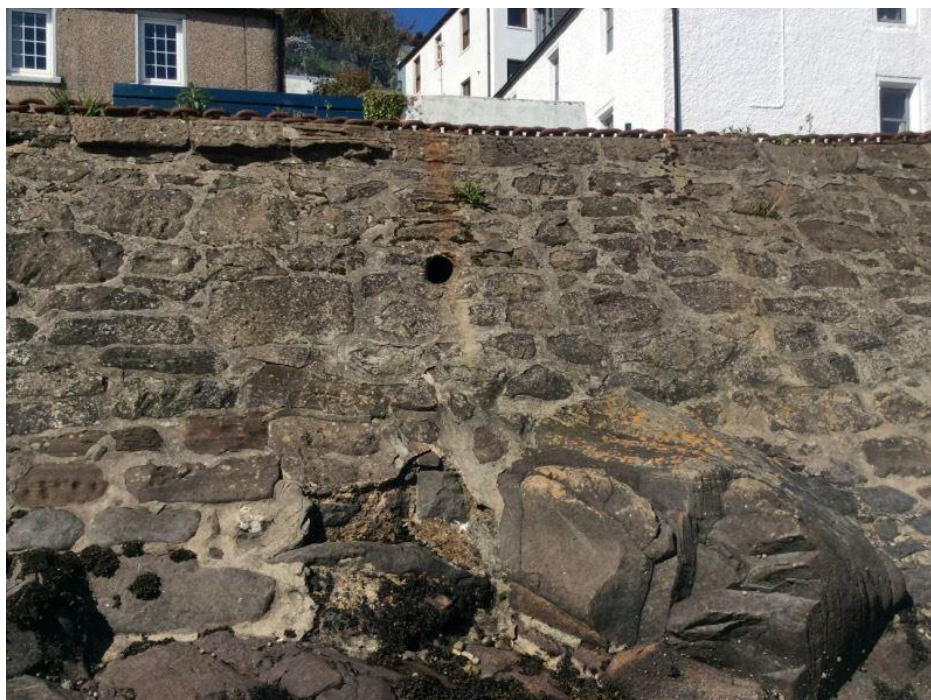
Section C
Exposed face
Defect Ref: D31
Description: D31 -
Missing flap valve
Photo number: 197

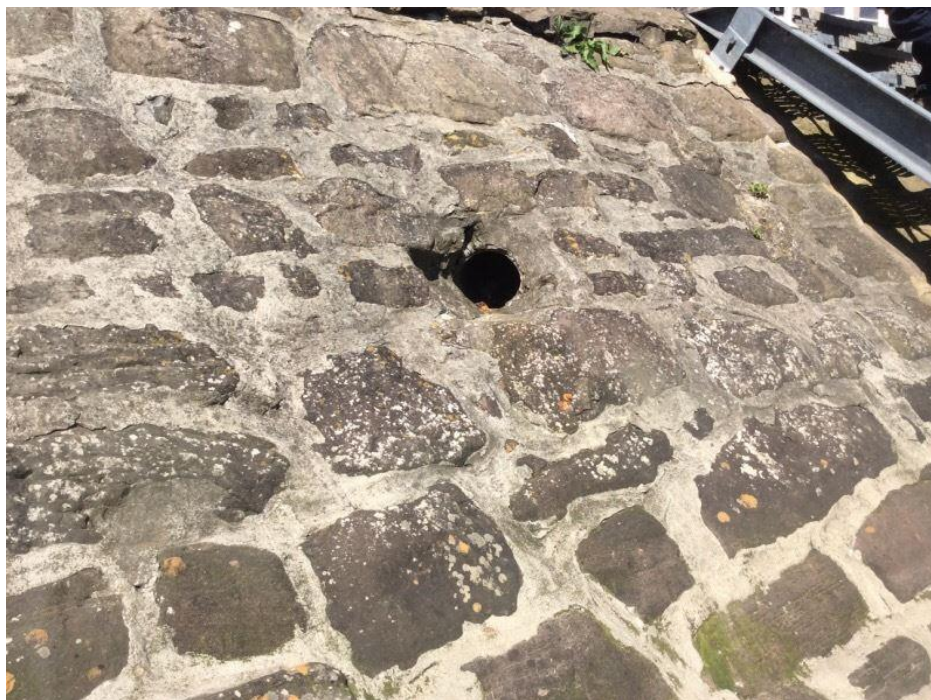
Section C
Exposed face
Defect Ref: D31
Description: D31 -
Missing flap valve
Photo number: 226

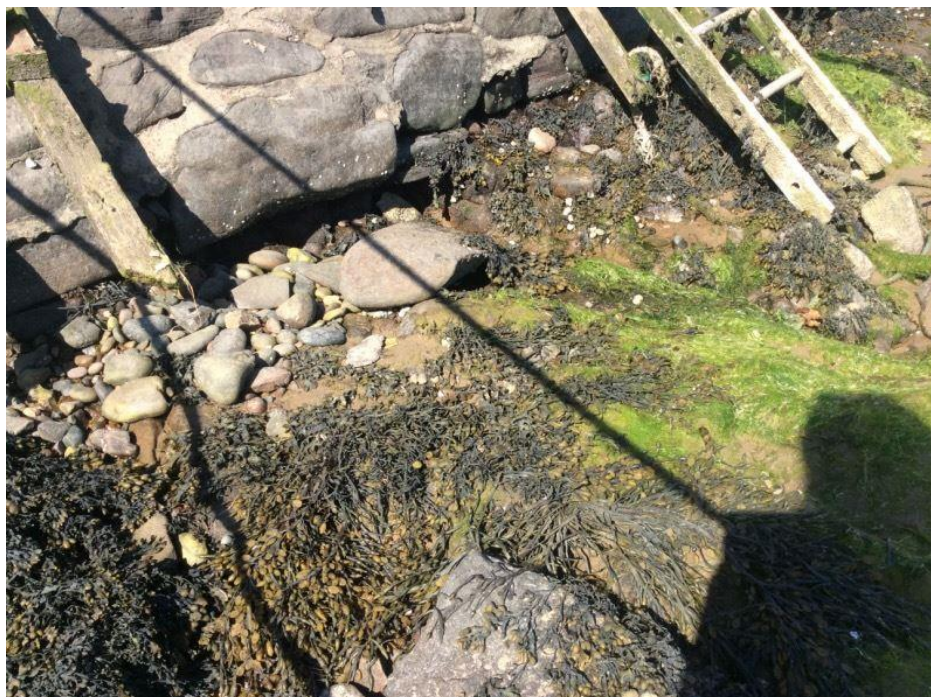
Section C
Exposed face
Defect Ref: D32
Description: D32 -
Undermining scour of
exposed face
approximately 10m
Photo number: 196

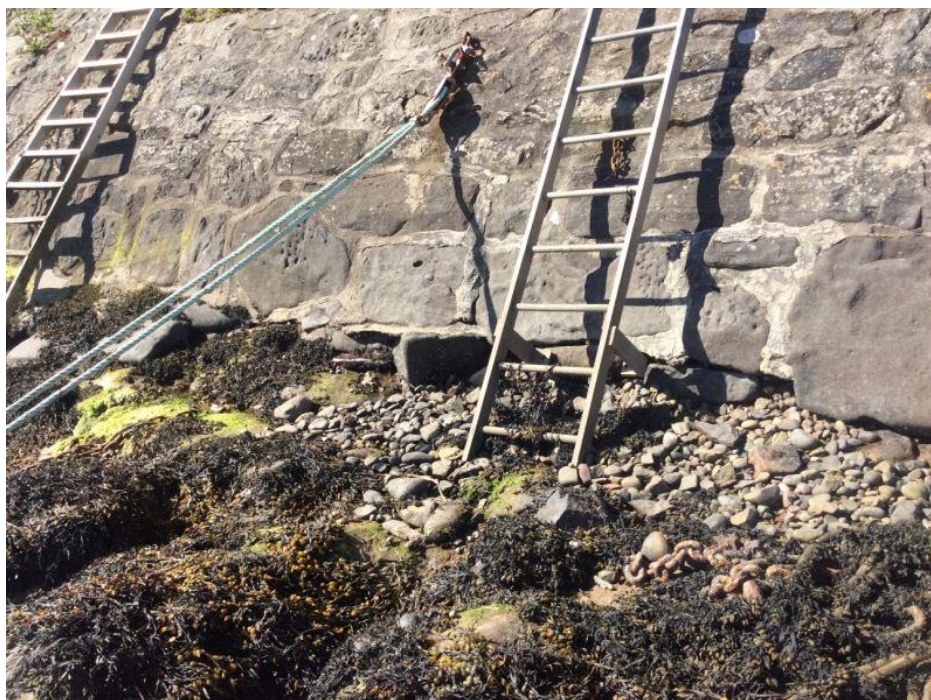
Section C
Exposed face
Defect Ref: D32
Description: D32 -
Undermining scour of
exposed face
approximately 10m
Photo number: 225

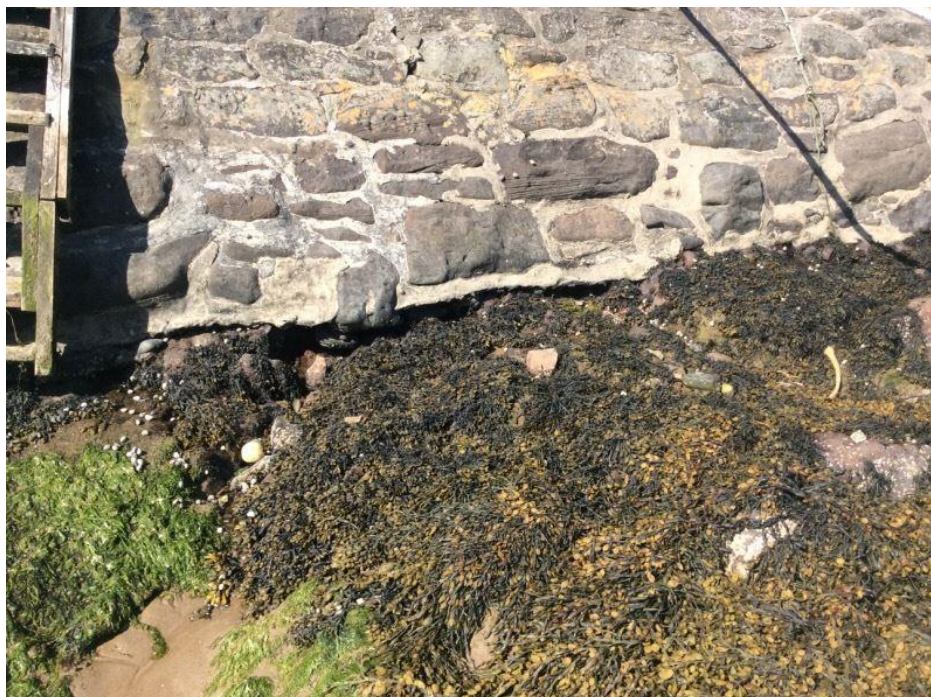
Section C
Exposed face
Defect Ref: D32
Description: D32 -
Undermining scour of
exposed face
approximately 10m
Photo number: 233

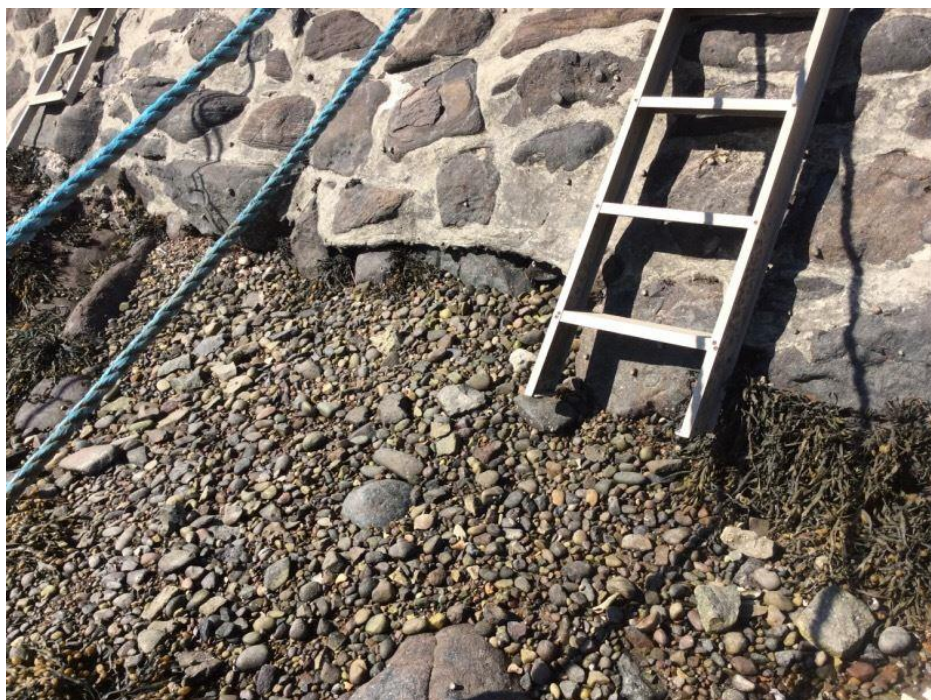
Section C
Exposed face
Defect Ref: D33
Description: D33 -
Undermining scour of
exposed face
approximately 2m long.
Photo number: 133

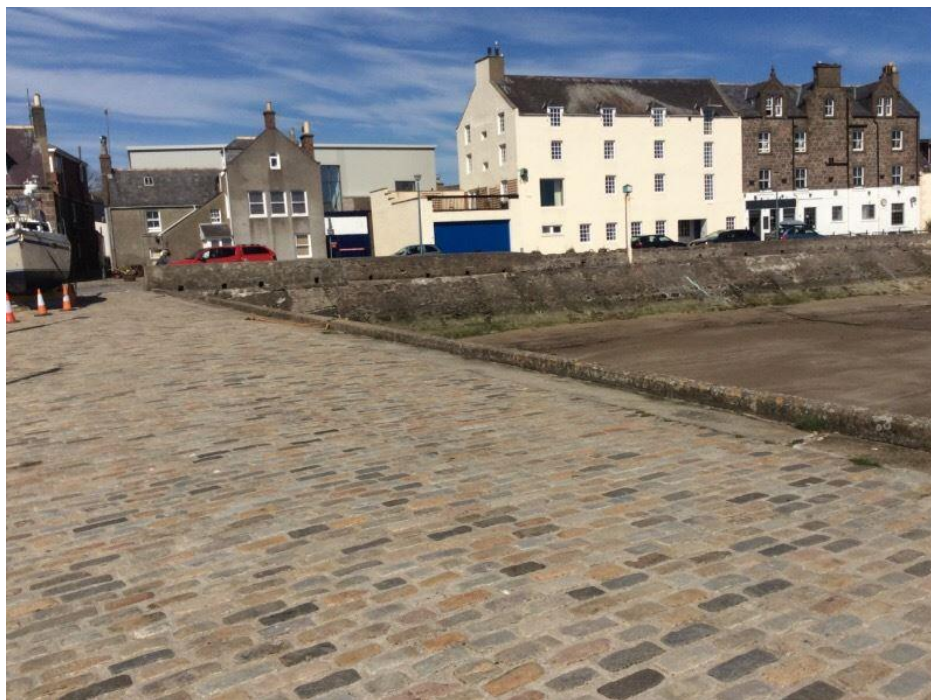
Photo number: 136

Section D

Deck

Defect Ref: D36

Description: D36 - H&S
Insufficient handrailing.

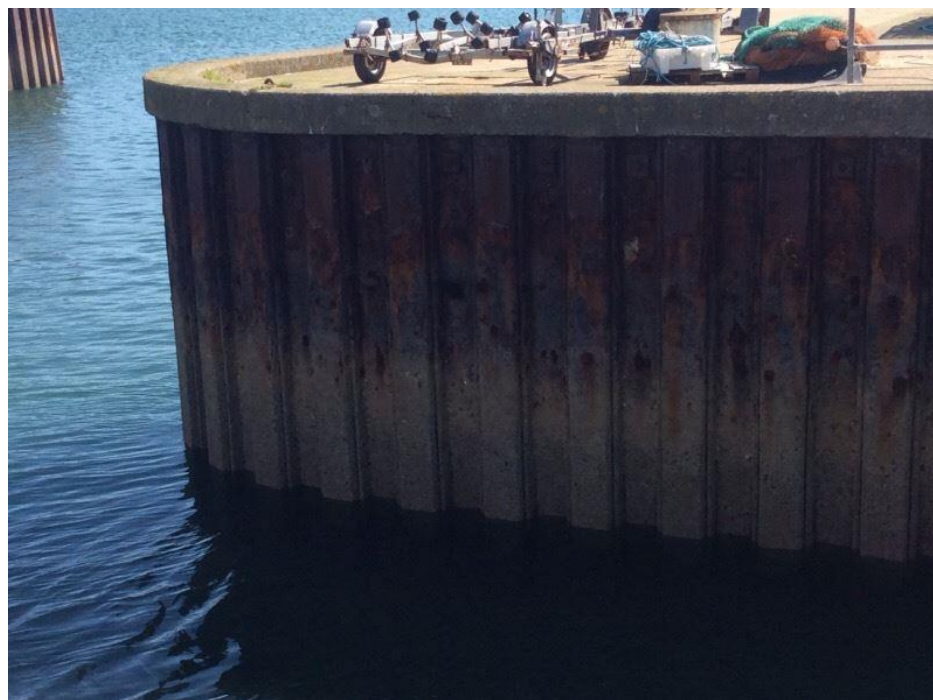
Section B
Piling
Defect Ref: D39
Description: D39 -
Missing anchors
Photo number: 139

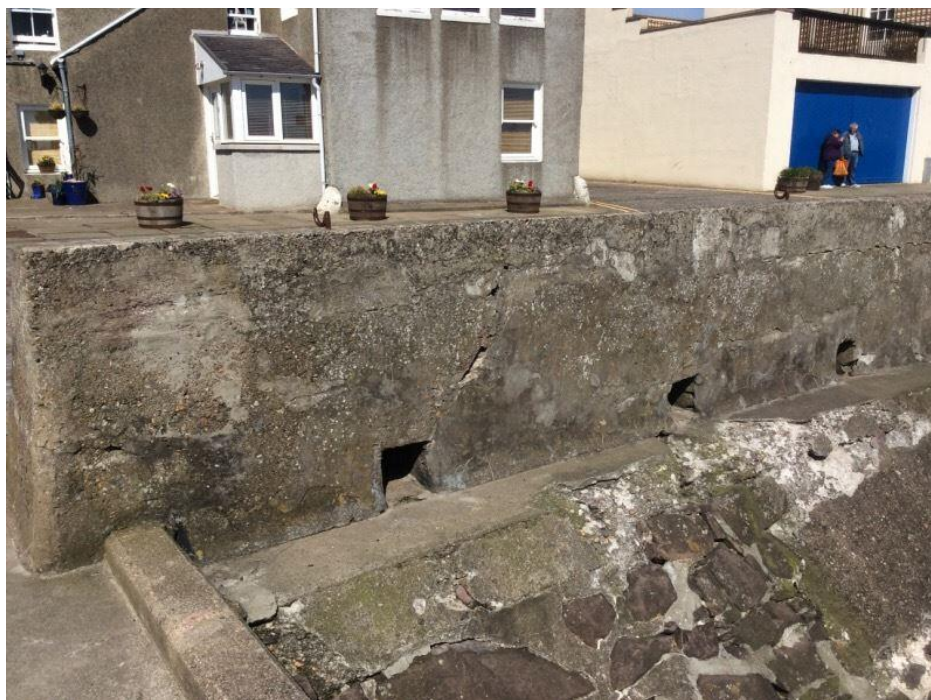
Section C
Capping wall
Defect Ref: D41
Description: D41 - Large horizontal cracks. Cracking also visible on landward side
Photo number: 141

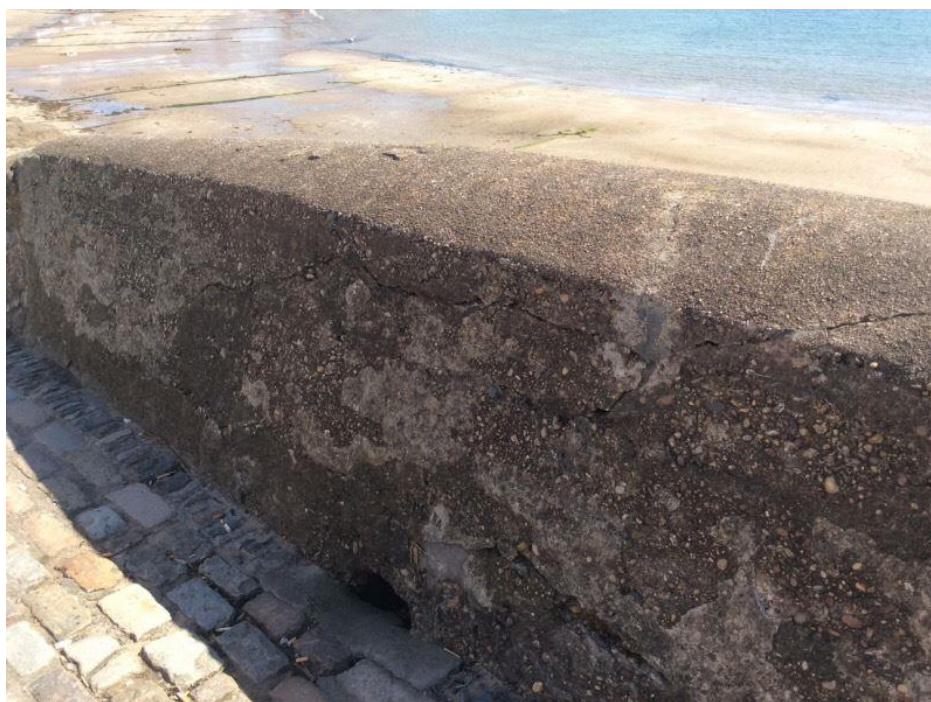
Section C
Capping wall
Defect Ref: D41
Description: D41 -
Large horizontal cracks.
Cracking also visible on
landward side
Photo number: 198

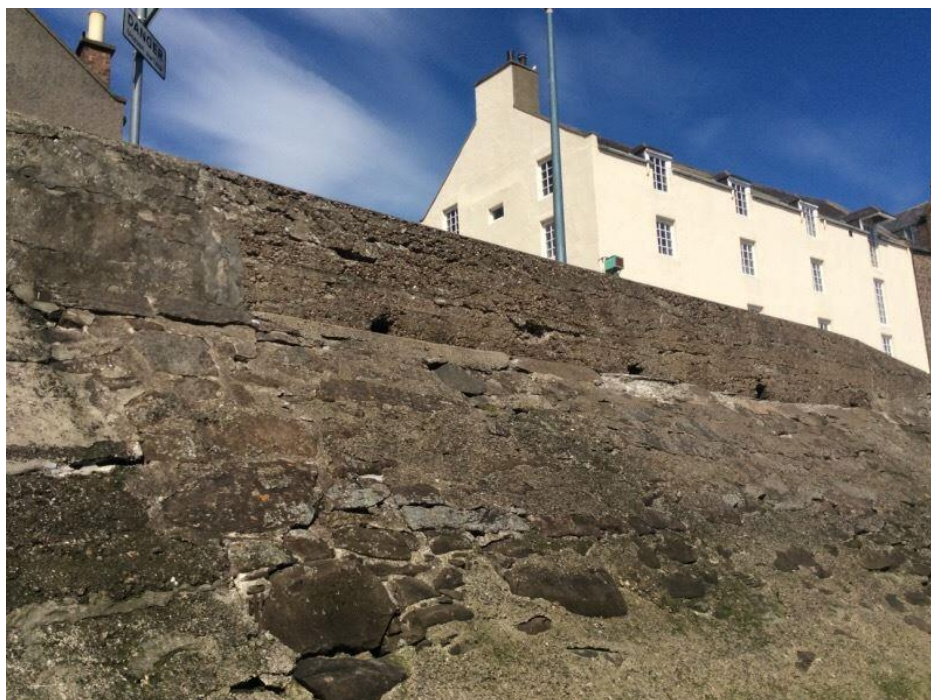
Section C
Capping wall
Defect Ref: D42
Description: D42 -
Spalling and
honeycombing of
concrete approx. 10m
Photo number: 144

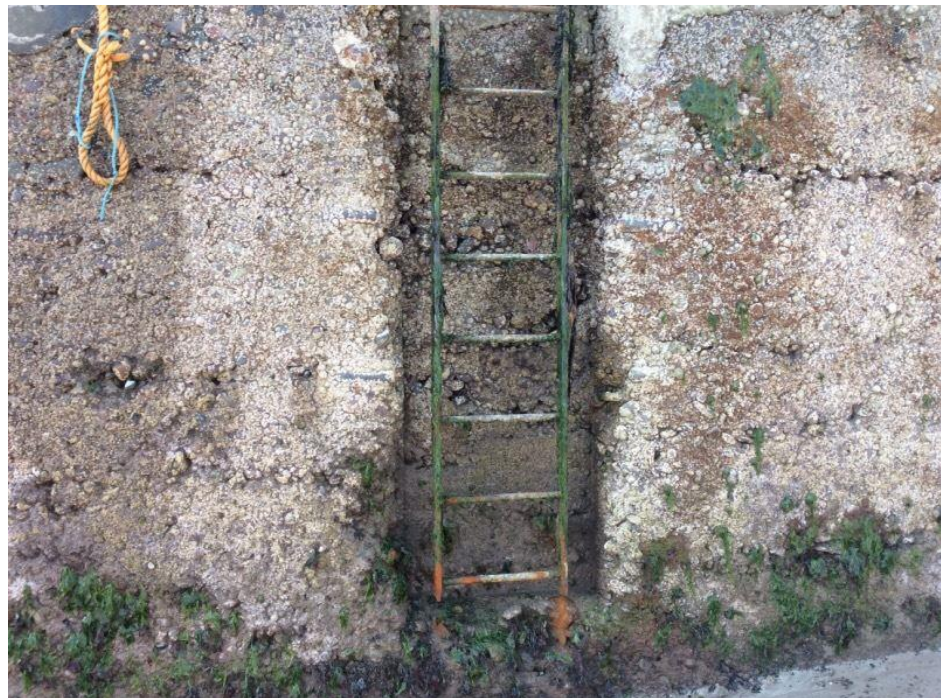
Section D
Quay face
Defect Ref: D43
Description: D43 -
Health and Safety -
Corroded and loose
ladder.
Photo number: 174

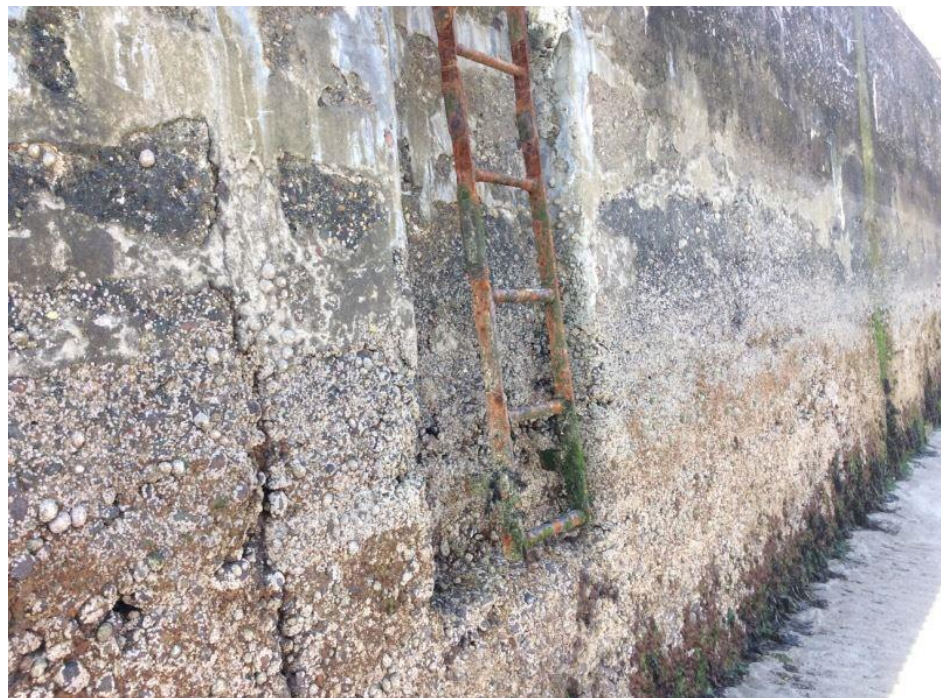
Section D
Quay face
Defect Ref: D43
Description: D43 -
Health and Safety -
Corroded and loose
ladder.
Photo number: 215

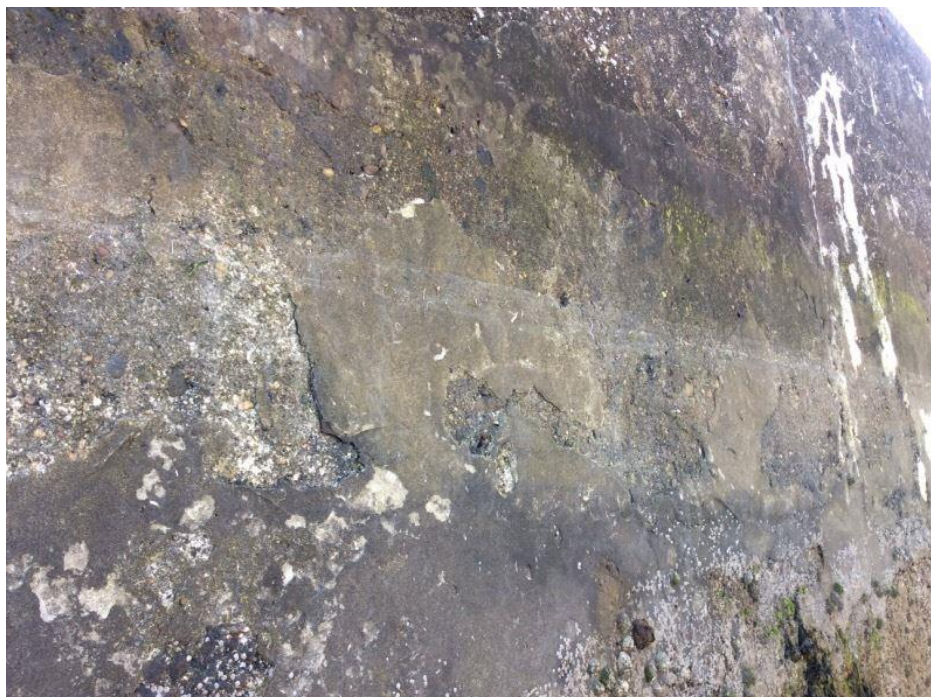
Section D
Quay face
Defect Ref: D44
Description: D44 -
Delaminated surfacing
Photo number: 142
