Stonehaven Bay Coastal Flood Protection Study

Final Report

December 2019

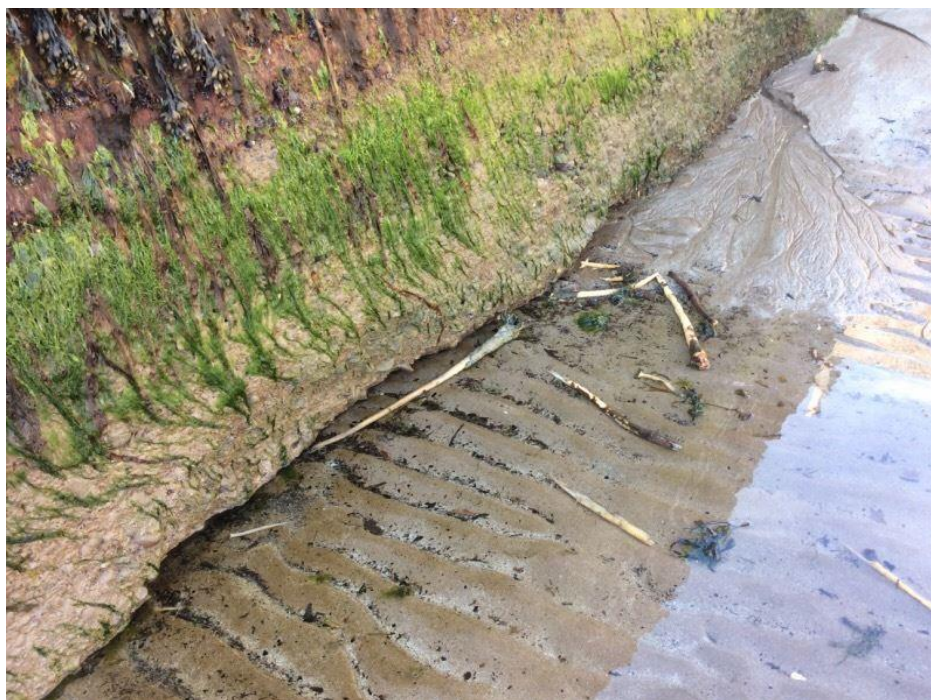
Section D
Quay face
Defect Ref: D45
Description: D45 -
Approximately 1m x 0.3
m scour.
Photo number: 143

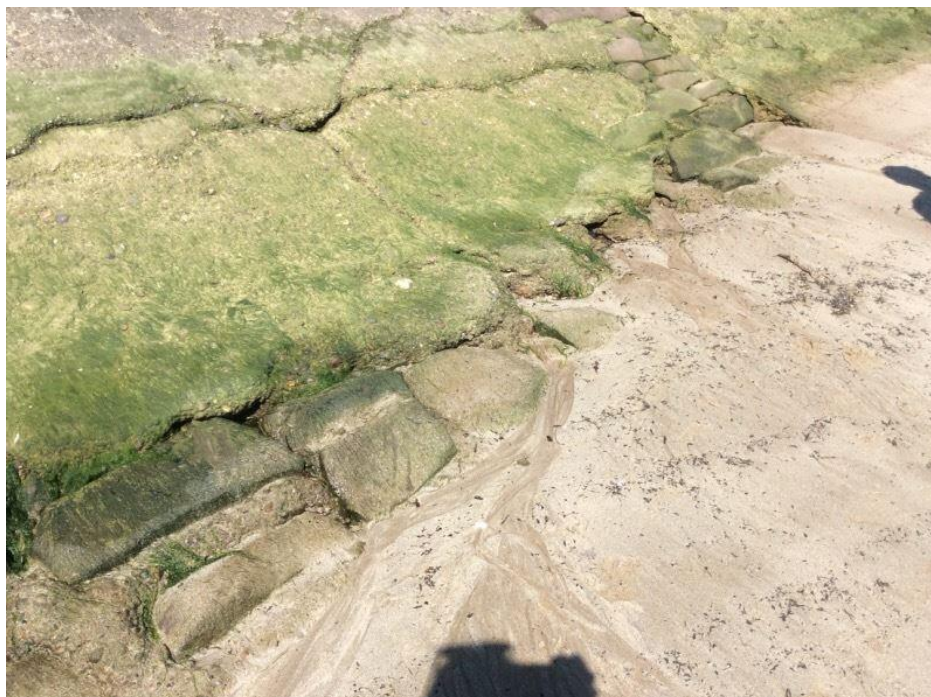
Section C
Exposed face
Defect Ref: D46
Description: D46 -
Delaminating repairs on
toe and potential for
undermining scour,
approximately 30m.
Photo number: 145

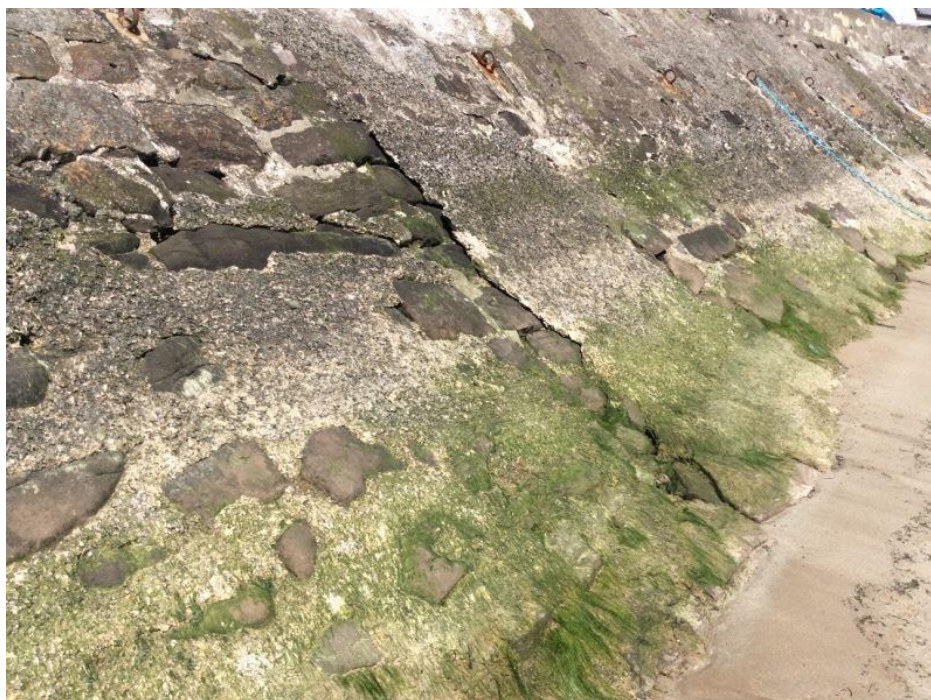
Section C
Exposed face
Defect Ref: D46
Description: D46 -
Delaminating repairs on
toe and potential for
undermining scour,
approximately 30m.
Photo number: 199

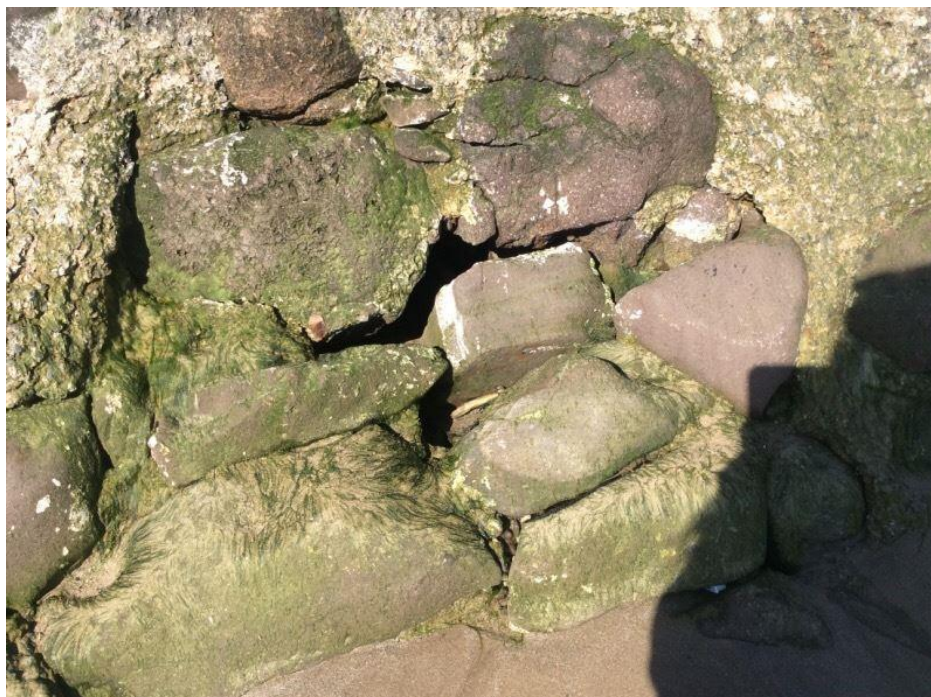
Section C
Exposed face
Defect Ref: D47
Description: D47 -
Voiding behind the
structure. Approximately
1m behind the structure
in 5 locations.
Photo number: 146

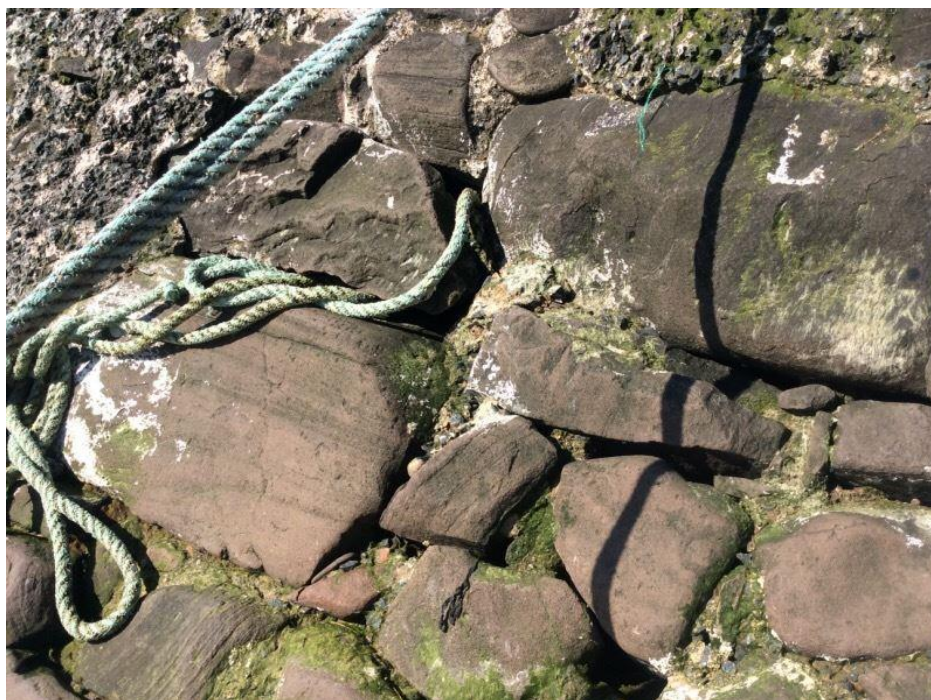
Section C
Exposed face
Defect Ref: D47
Description: D47 -
Voiding behind the
structure. Approximately
1m behind the structure
in 5 locations.
Photo number: 200

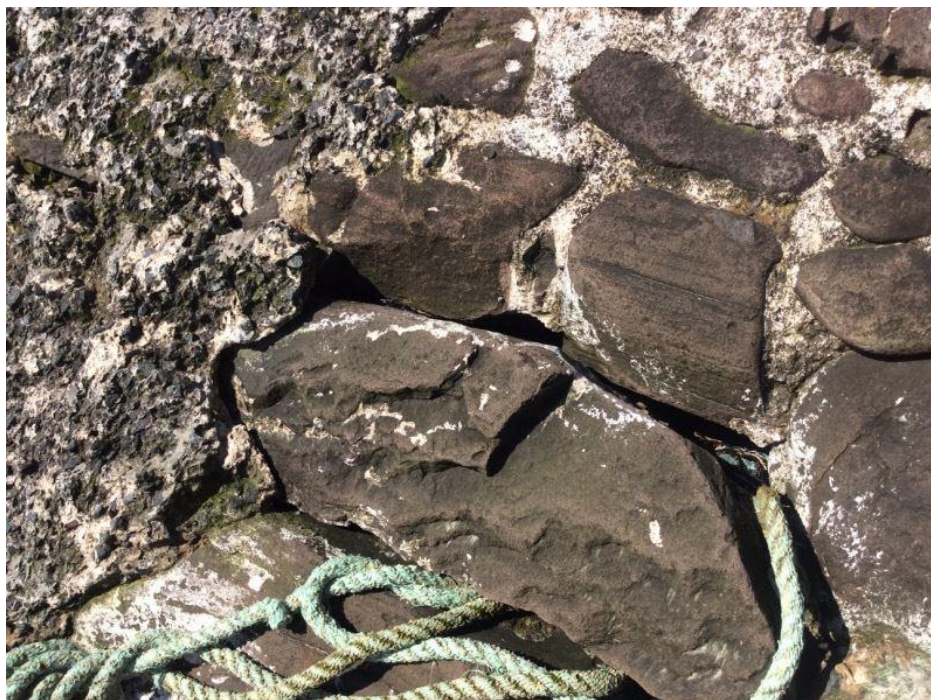
Section C
Exposed face
Defect Ref: D47
Description: D47 -
Voiding behind the
structure. Approximately
1m behind the structure
in 5 locations.
Photo number: 227

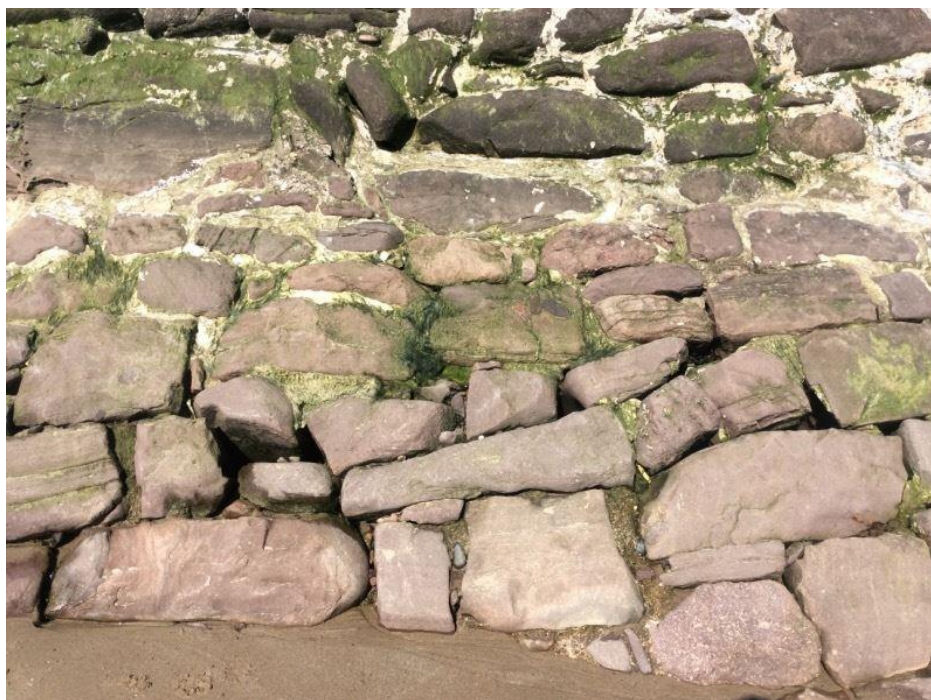
Section C
Exposed face
Defect Ref: D47
Description: D47 -
Voiding behind the
structure. Approximately
1m behind the structure
in 5 locations.
Photo number: 234

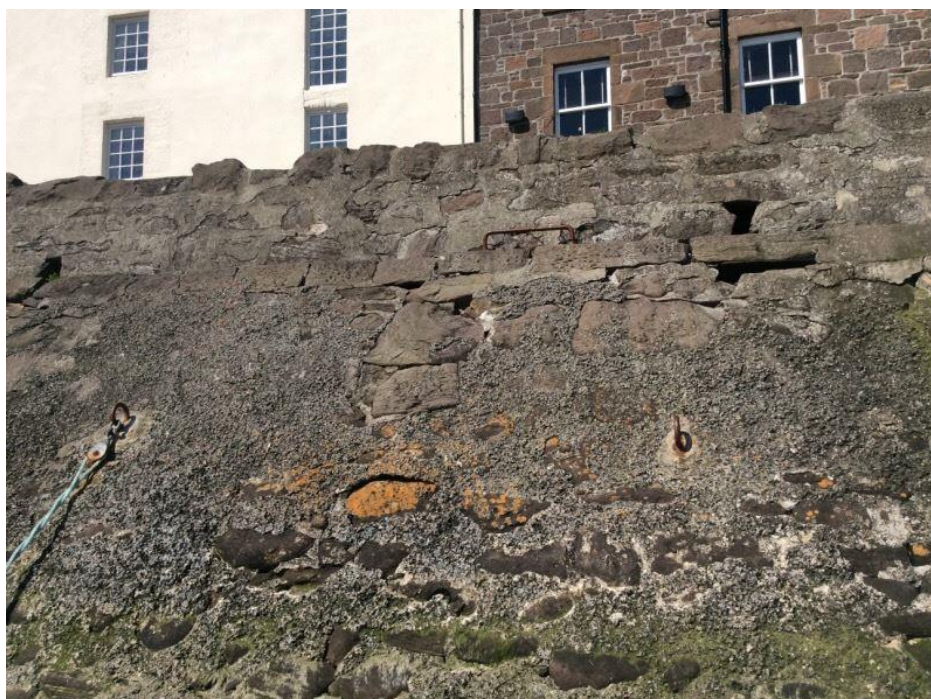
Section C
Capping wall
Defect Ref: D48
Description: D48 -
Drainage points on
capping wall may need
flap valves
Photo number: 147

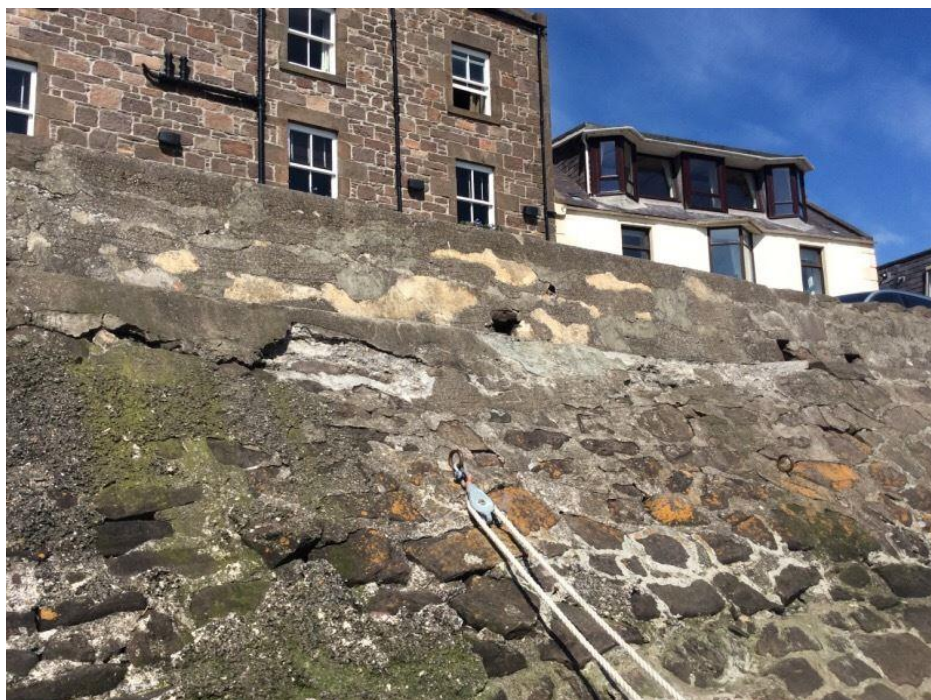
Section C
Capping wall
Defect Ref: D48
Description: D48 -
Drainage points on
capping wall may need
flap valves
Photo number: 201

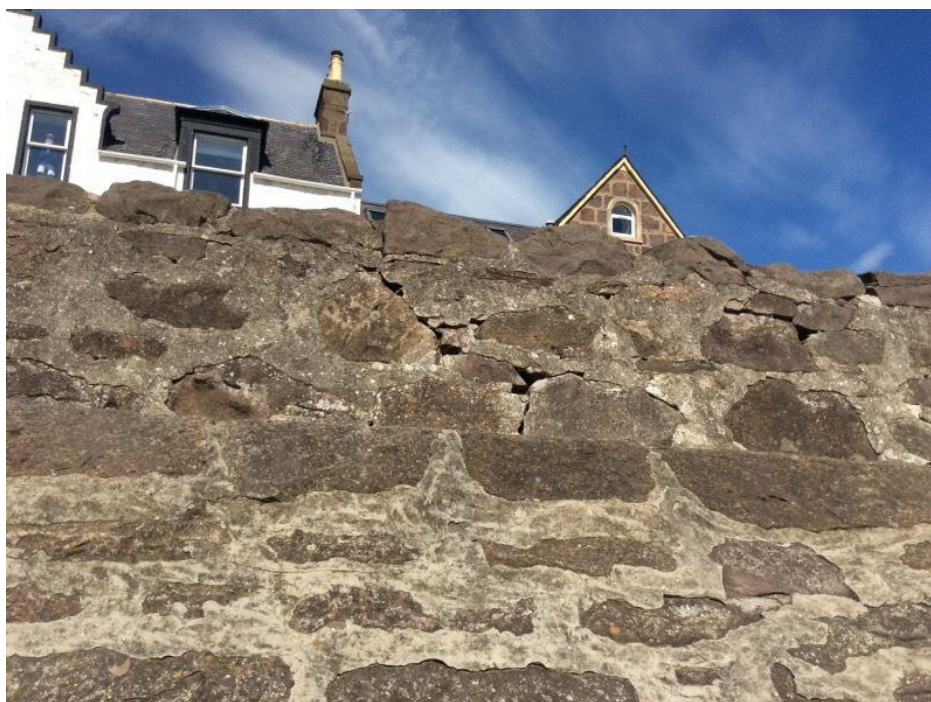
Section C
Capping wall
Defect Ref: D49
Description: D49 - Open joints
Photo number: 148

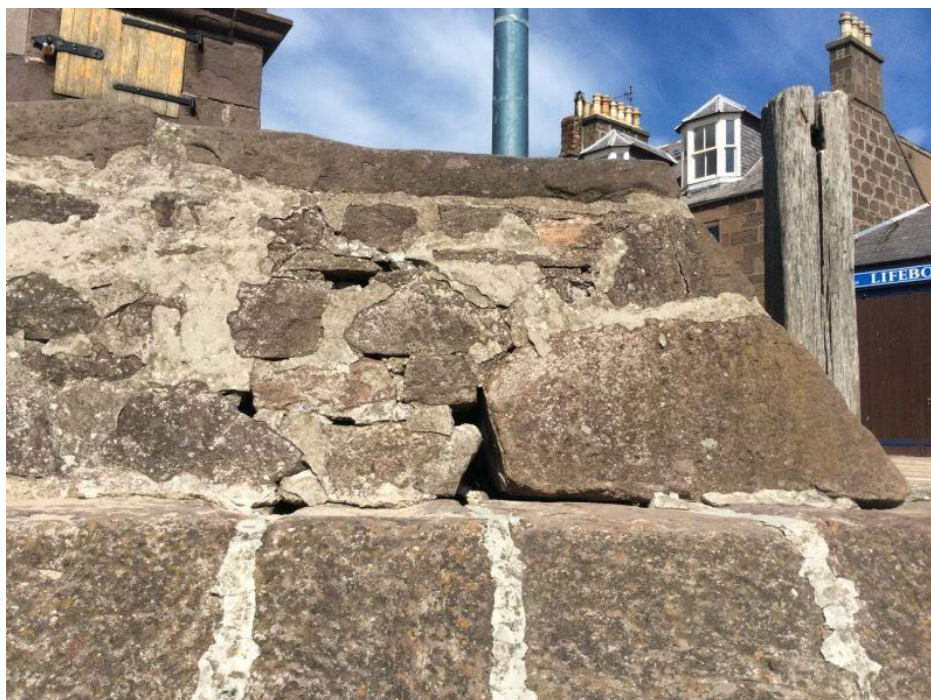
Section C
Capping wall
Defect Ref: D49
Description: D49 - Open joints
Photo number: 202

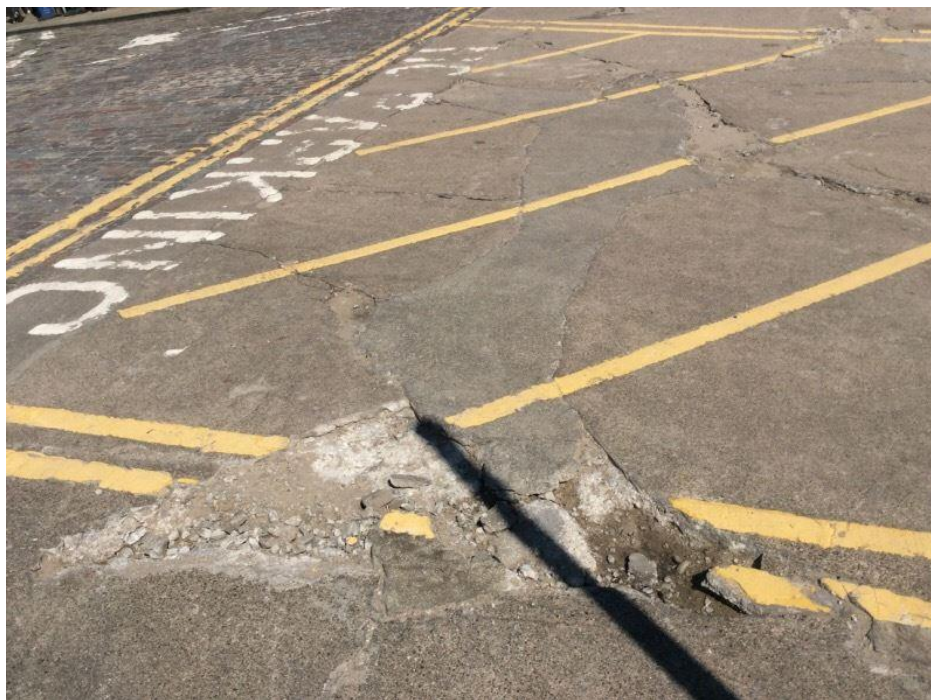
Section E
Access strip
Defect Ref: D50
Description: D50 -
Extensive cracking on
slipway
Photo number: 149

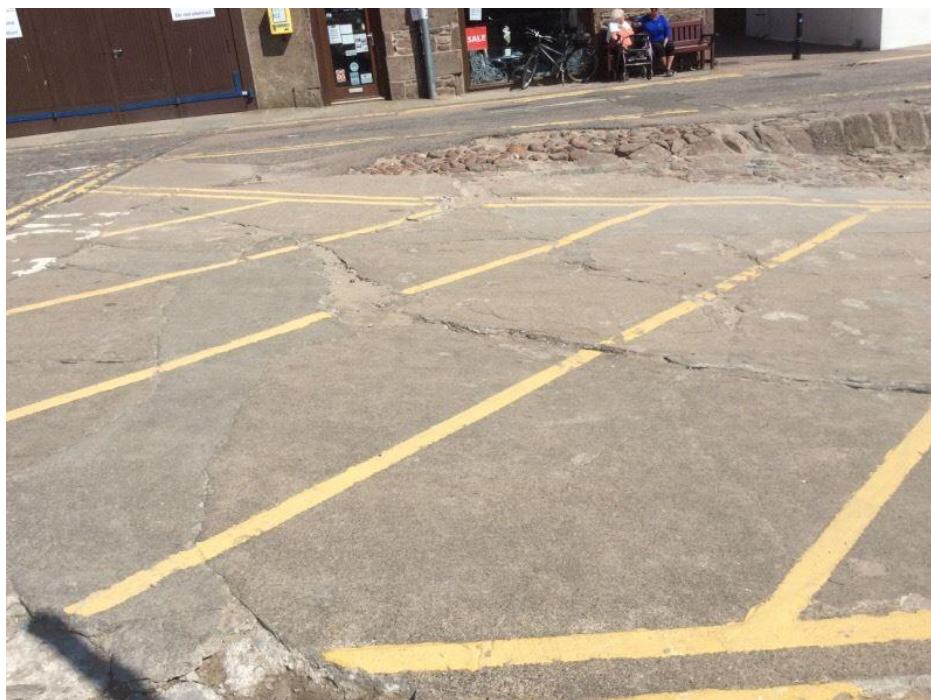
Section E
Access strip
Defect Ref: D50
Description: D50 -
Extensive cracking on
slipway
Photo number: 203

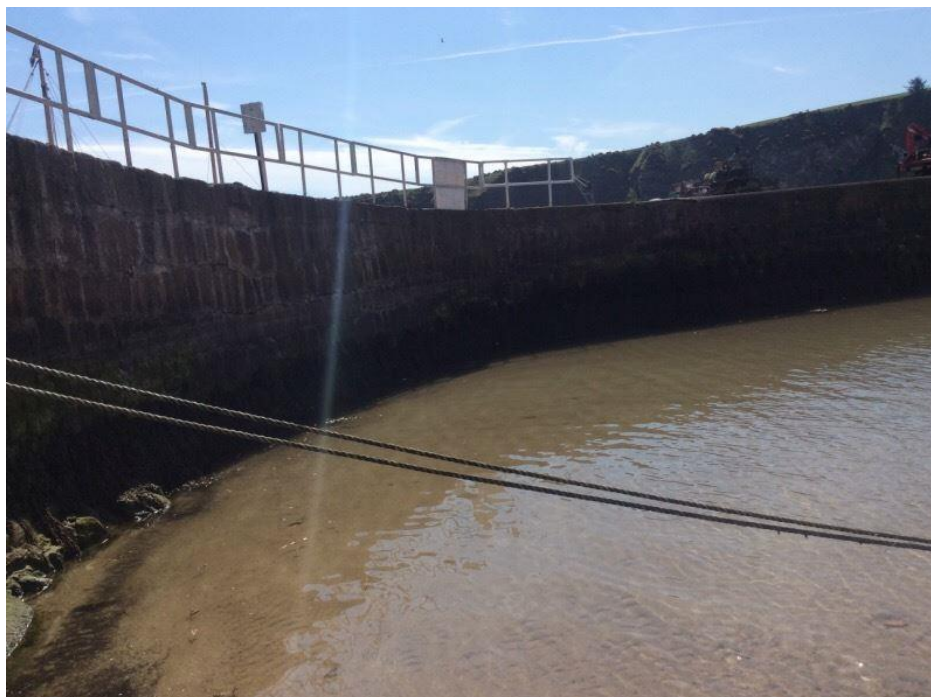
Section F
Quay face
Defect Ref: D52
Description: D52 -
Longitudinal cracks
approximately 8m.
Photo number: 151

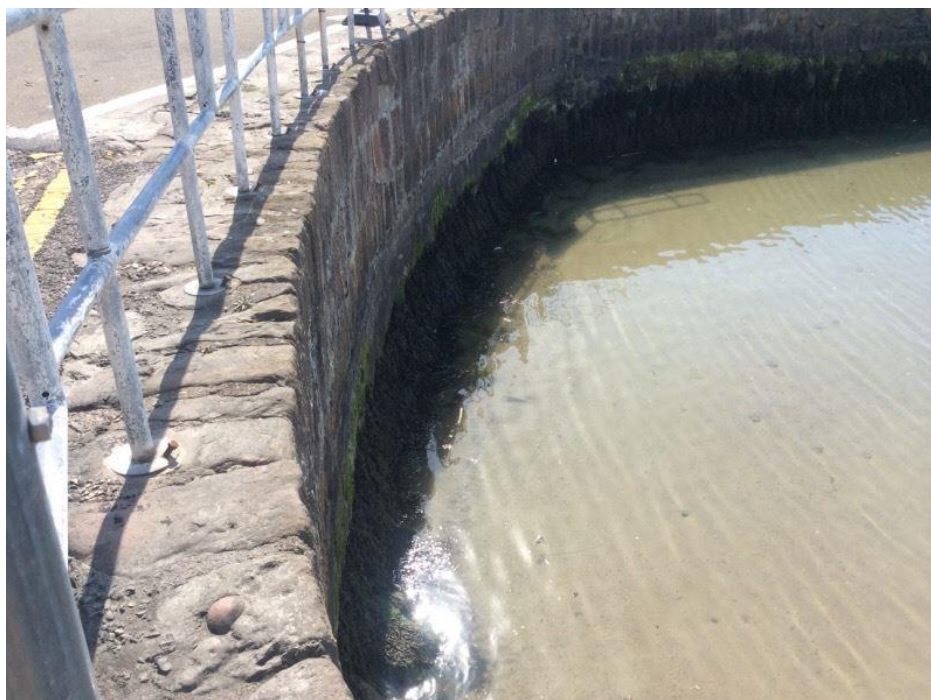
Section F
Quay face
Defect Ref: D52
Description: D52 -
Longitudinal cracks
approximately 8m.
Photo number: 205

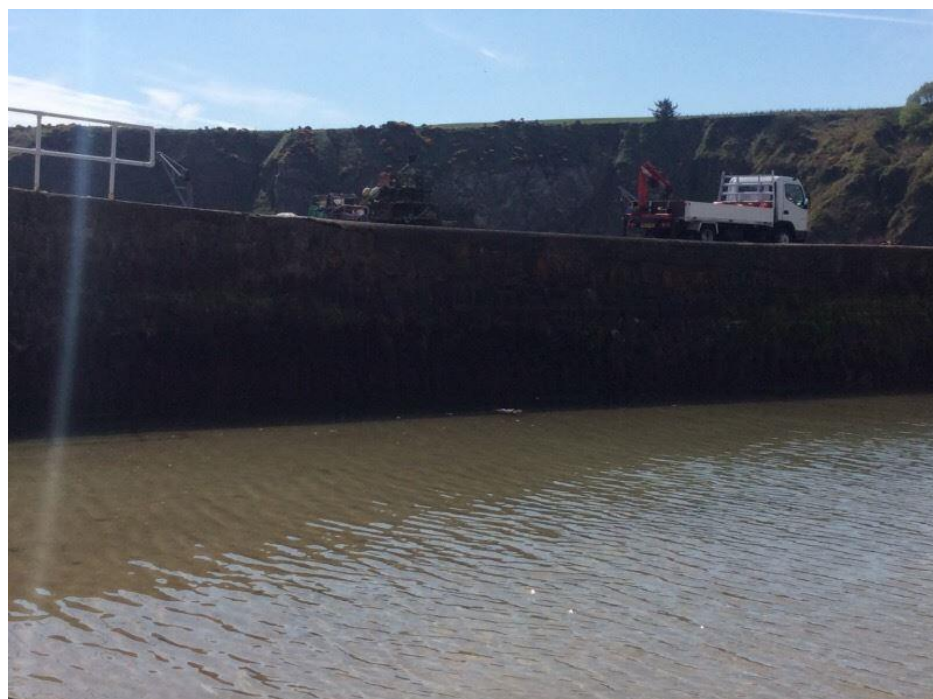
Section F
Quay face
Defect Ref: D53
Description: D53 - Long cracks approximately 3m
Photo number: 152

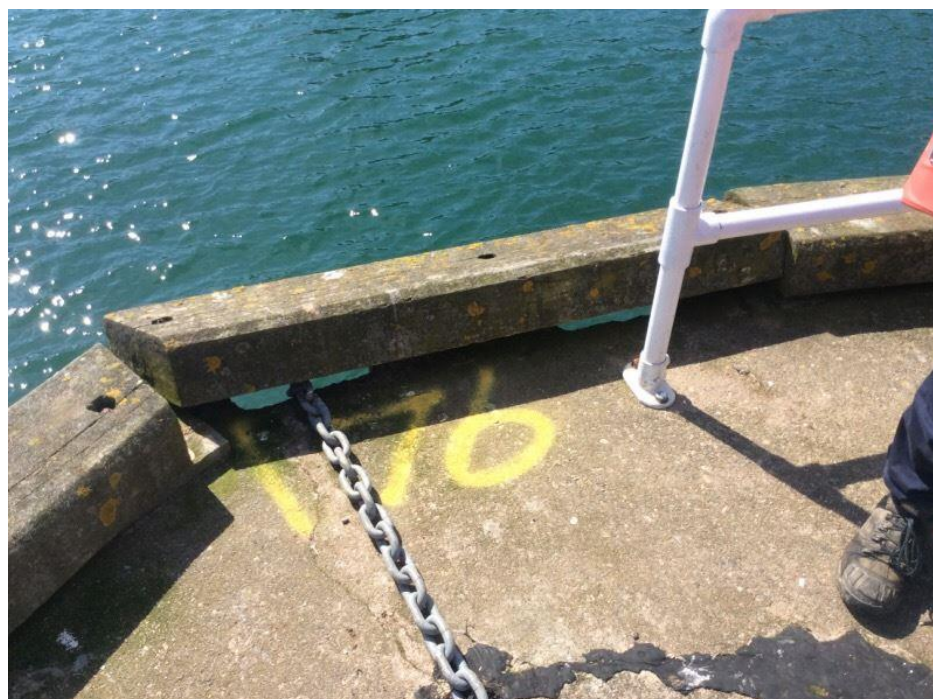
Section F
Deck
Defect Ref: D55
Description: D55 -
Displaced timber beam.
Photo number: 154

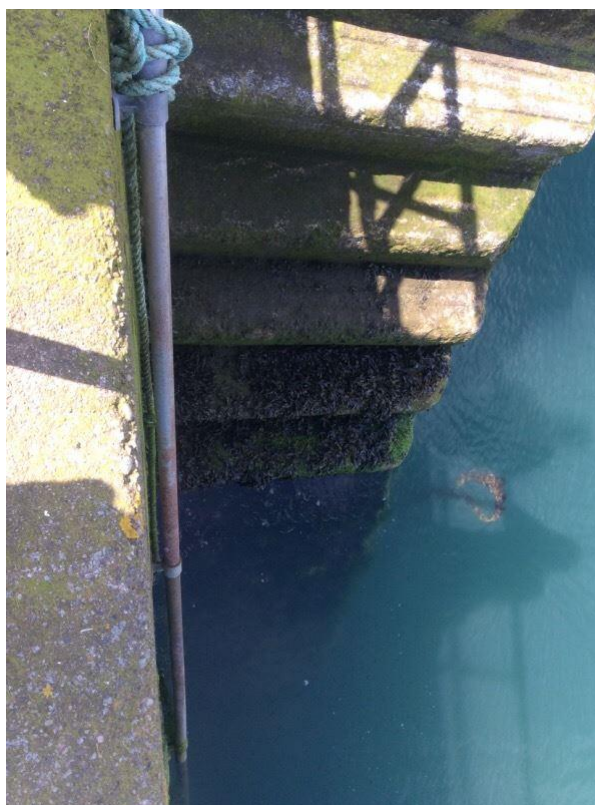
Section F
Quay face
Defect Ref: D57
Description: D57- Algae and seaweed growth on steps. Slipping hazard.
Photo number: 155

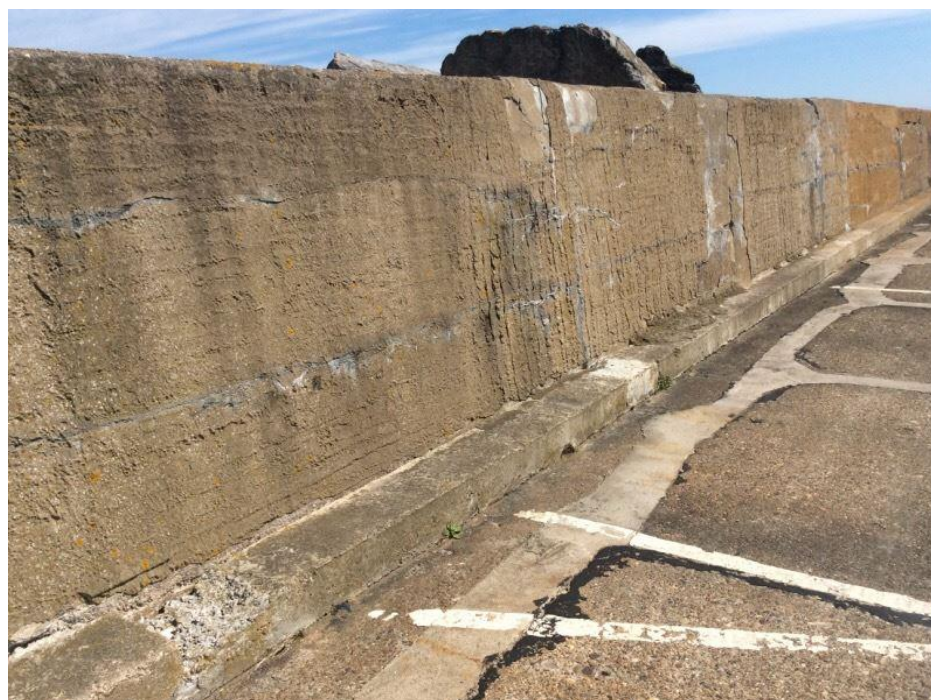
Section G
Capping
Defect Ref: D58
Description: D58 - Delaminating concrete repairs
Photo number: 156

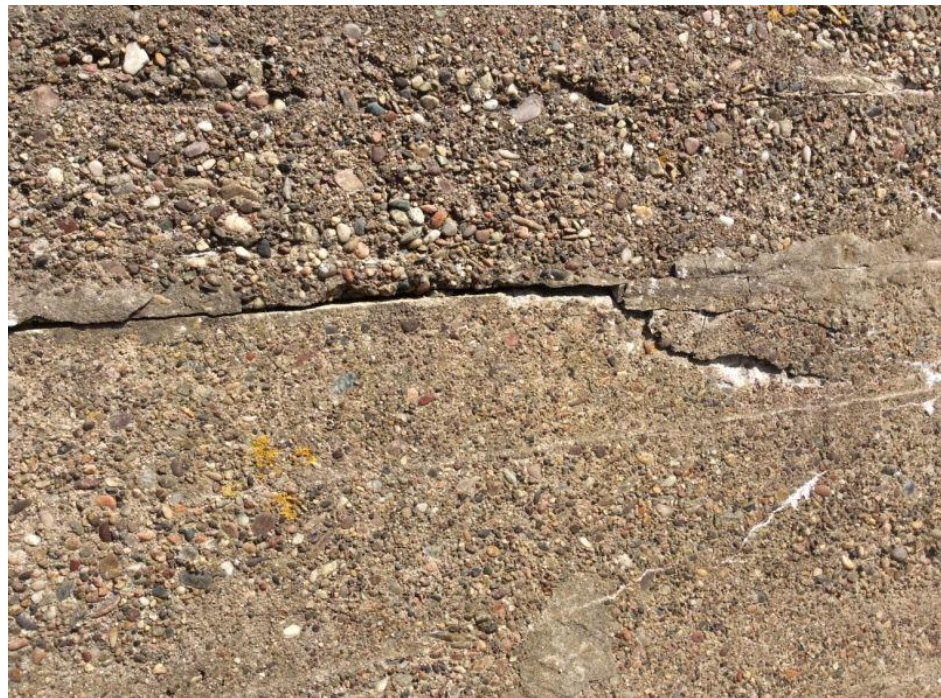
Section G
Capping
Defect Ref: D59
Description: D59 - Open joints
Photo number: 157

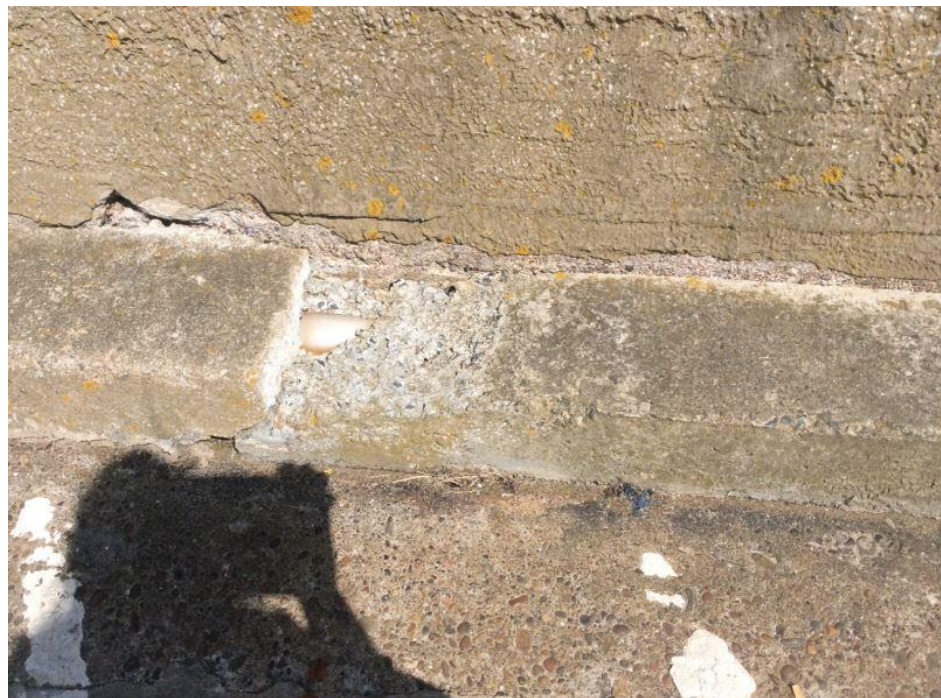
Section G
Capping
Defect Ref: D60
Description: D60 - Missing element, exposed pipe.
Photo number: 158

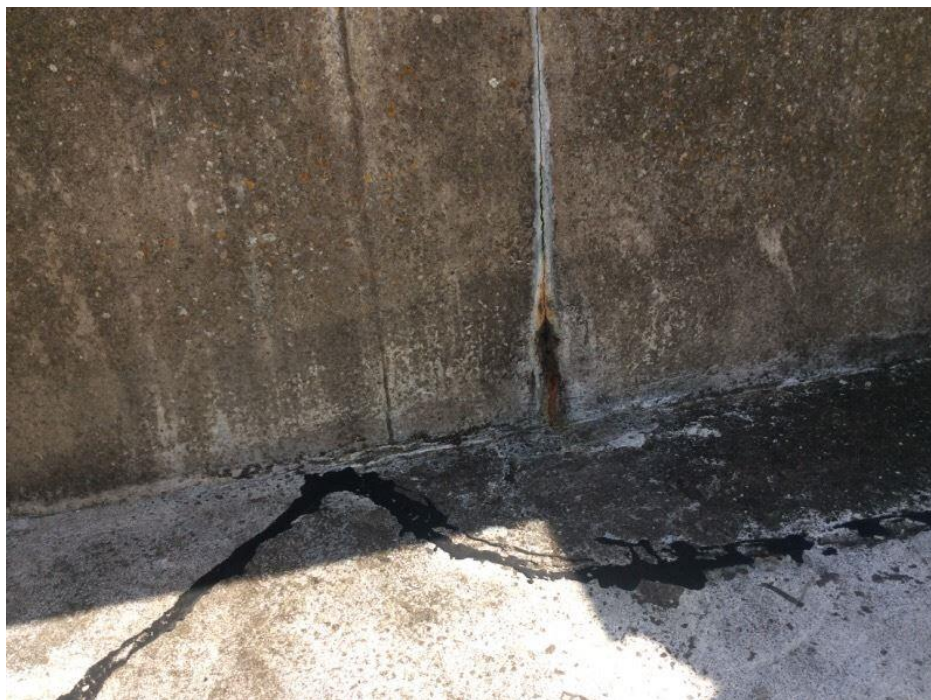
Section G
Seaward face
Defect Ref: D61
Description: D61 -
Stains of corroding
reinforcement.
Photo number: 159

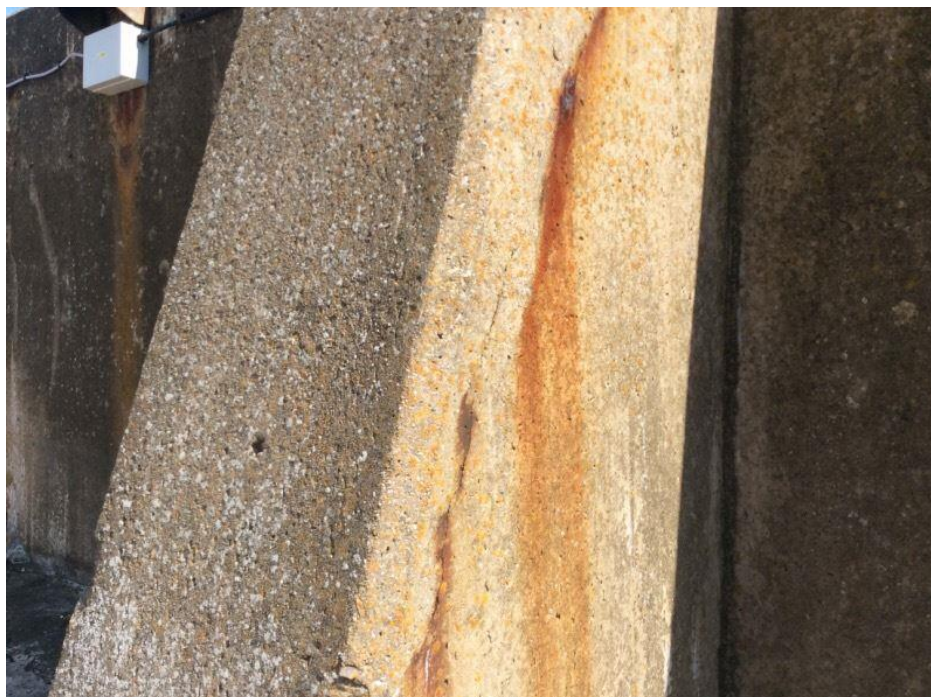
Section G
Seaward face
Defect Ref: D62
Description: D62 -
Cracking of concrete
Photo number: 160

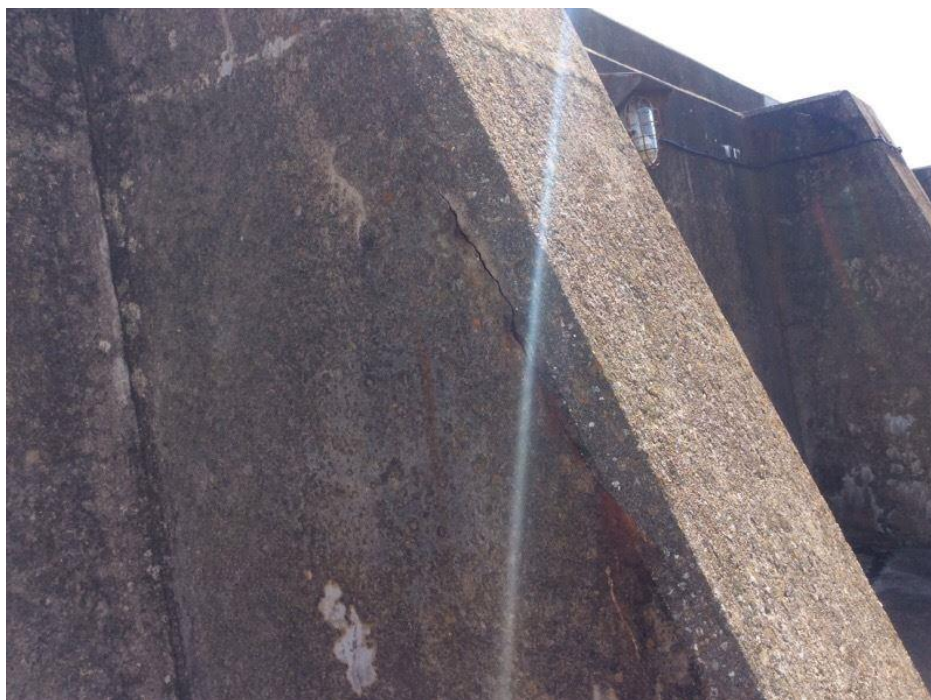
Section G
Seaward face
Defect Ref: D62
Description: D62 -
Cracking of concrete
Photo number: 207

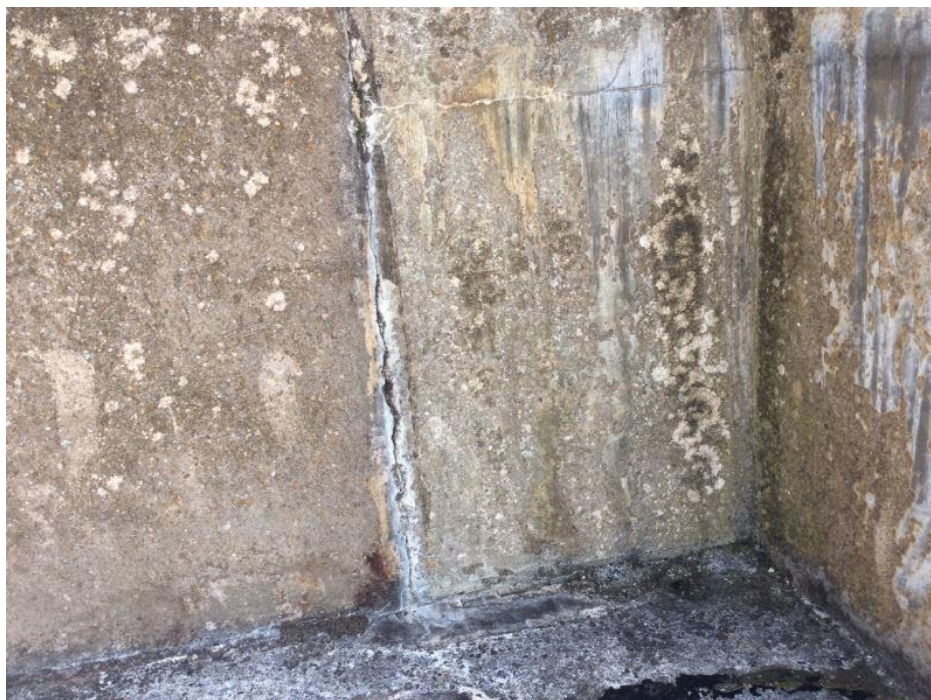
Section G
Seaward face
Defect Ref: D63
Description: D63 -
Cracking of walls.
Repairs coming off.
Photo number: 161

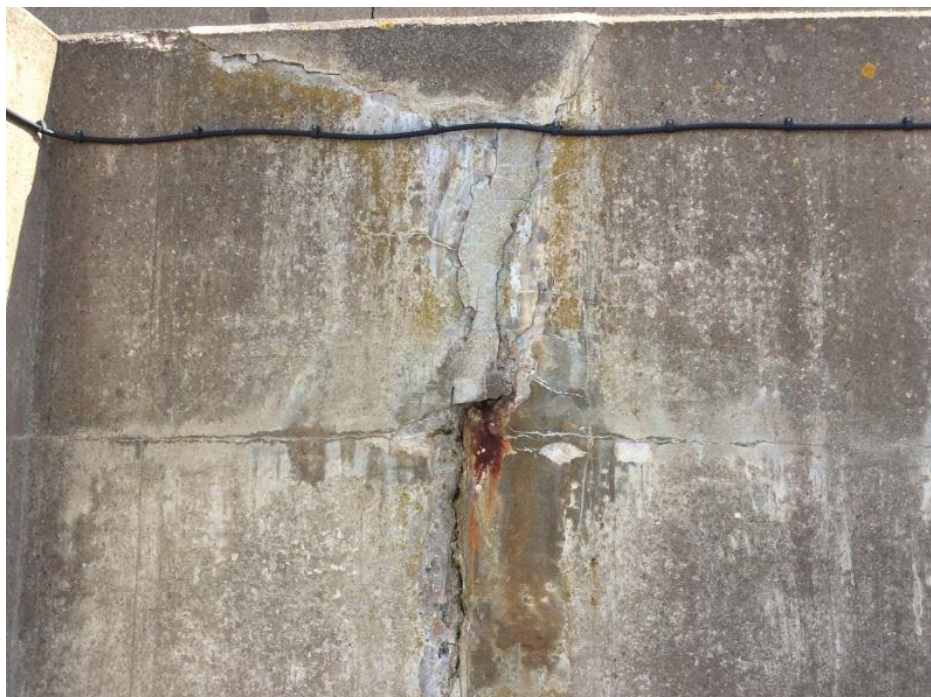
Section G
Seaward face
Defect Ref: D64
Description: D64 -
Damage of concrete
around pipe.
Photo number: 162

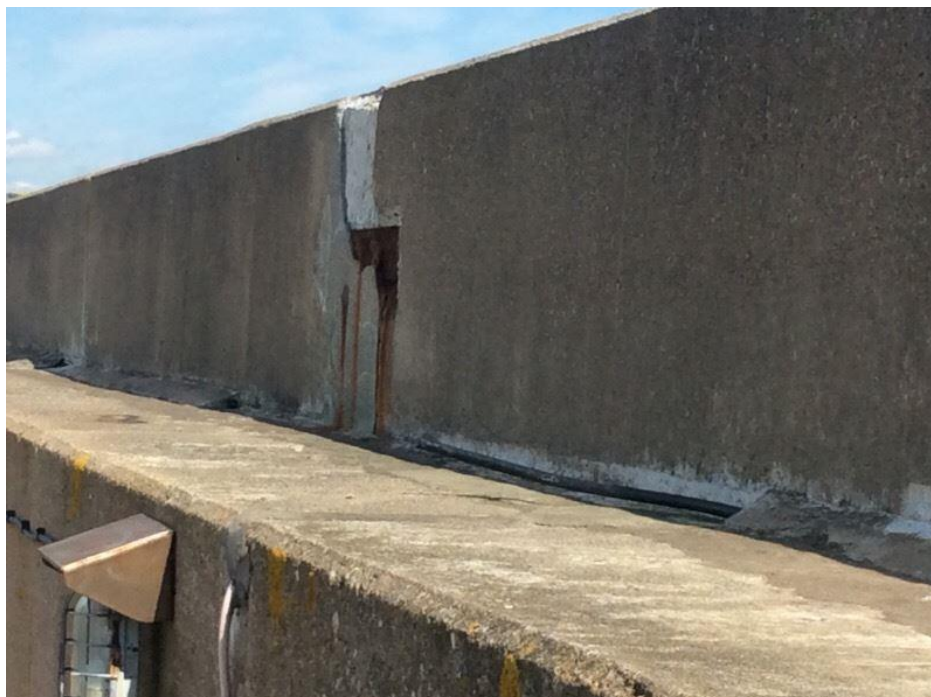
Section G
Seaward face
Defect Ref: D65
Description: D65 -
Exposed steel corroding.
Photo number: 209

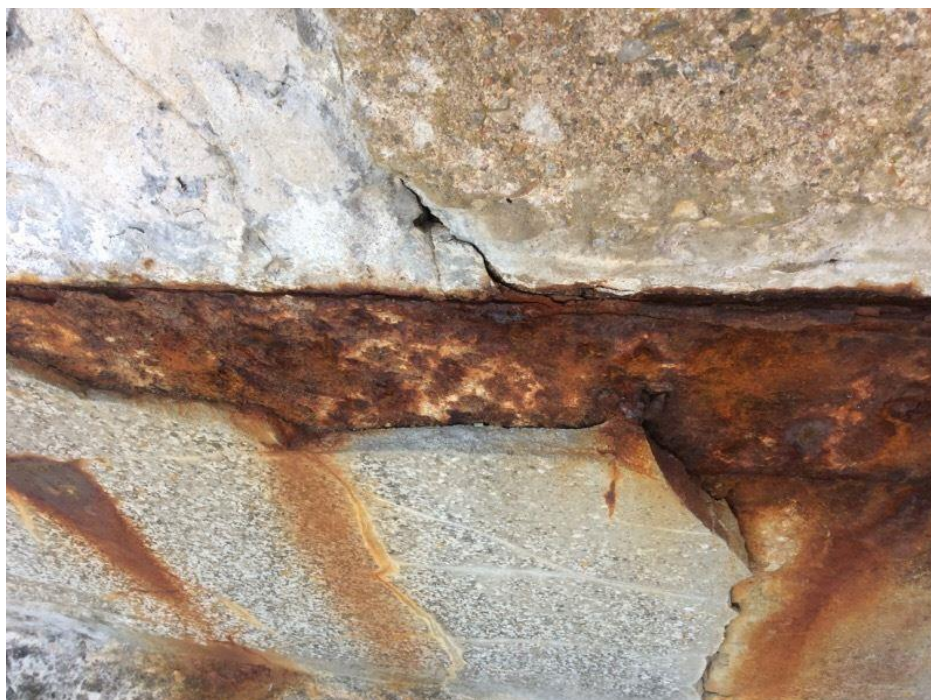
Section G
Seaward face
Defect Ref: D65
Description: D65 -
Exposed steel corroding.
Photo number: 229

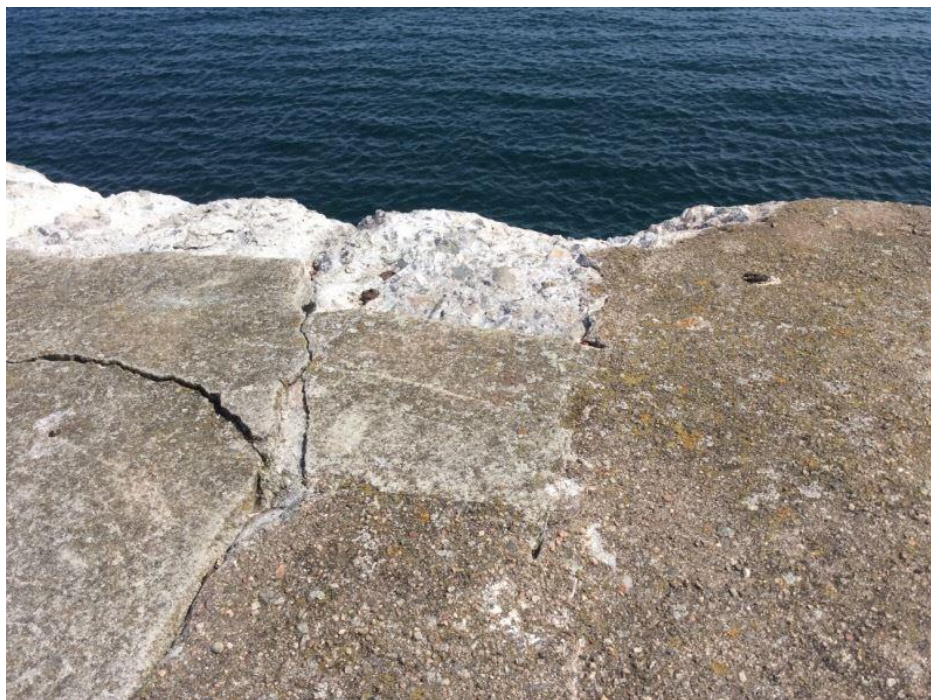
Section G
Seaward face
Defect Ref: D66
Description: D66 -
Corroded handrails
Photo number: 164

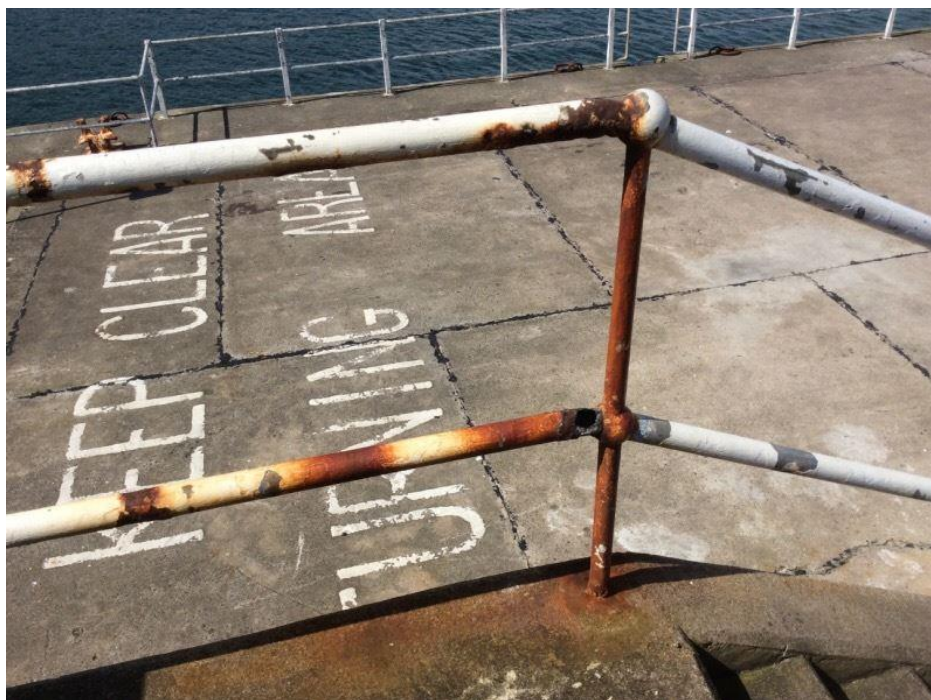
Section G
Seaward face
Defect Ref: D67
Description: D67 -
Health and Safety -
Damaged handrailing
around stepped access.
Photo number: 165

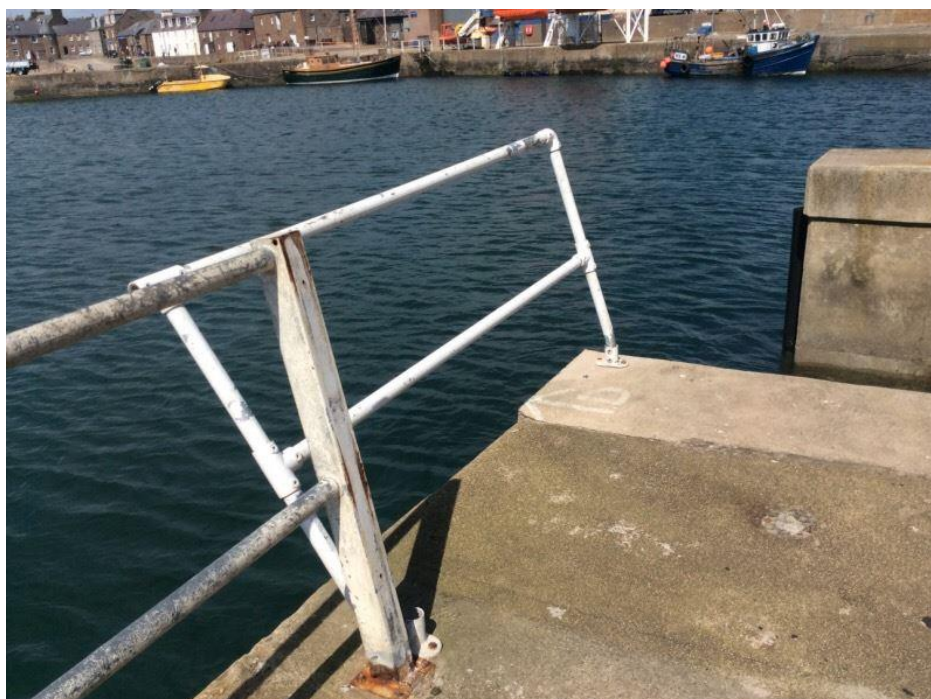
Section G
Seaward face
Defect Ref: D67
Description: D67 -
Health and Safety -
Damaged handrailing
around stepped access.
Photo number: 210

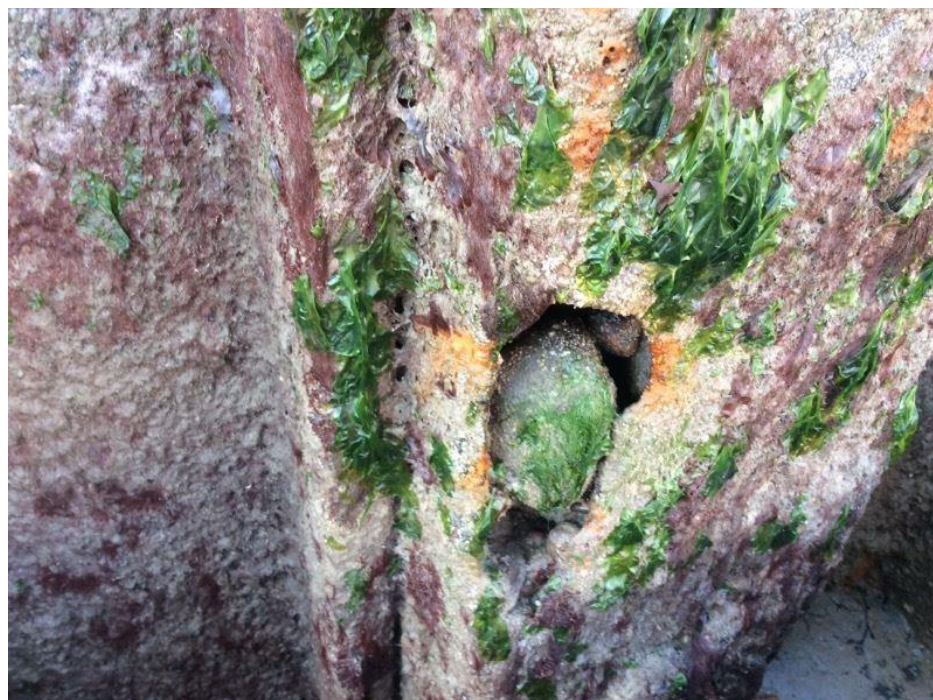
Section D
Sheet piling
Defect Ref: D72
Description: D72 - Two holes in piles, approximately 0.3x0.1m and 0.3x0.3
Photo number: 235

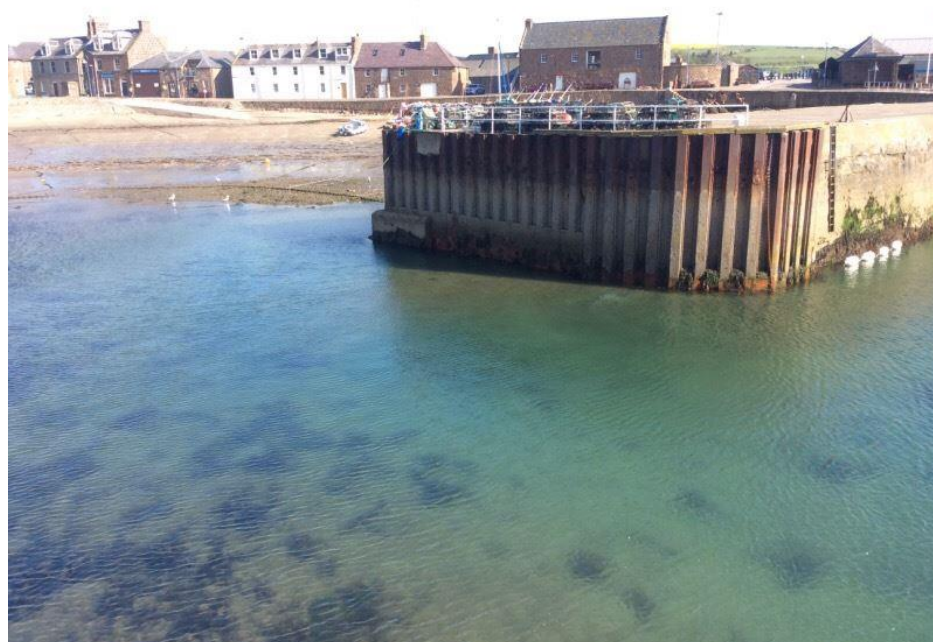
Section F
Sheet piling
Defect Ref: D75
Description: D75 -
Missing anchor plates.
Photo number: 171

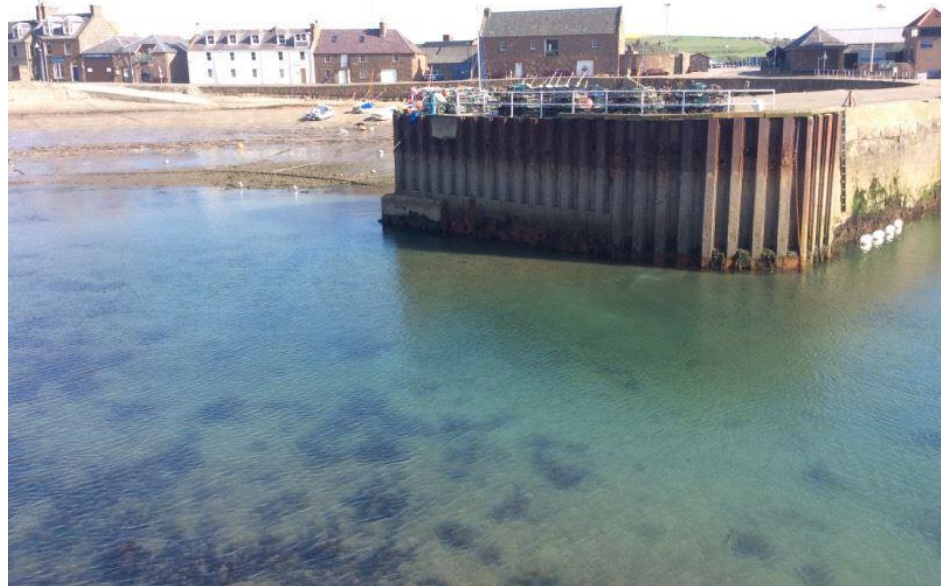
Section F
Quay face
Defect Ref: D76
Description: D76 -
Delaminating concrete
repairs
Photo number: 172
