Stonehaven Bay Coastal Flood Protection Study

Final Report

December 2019

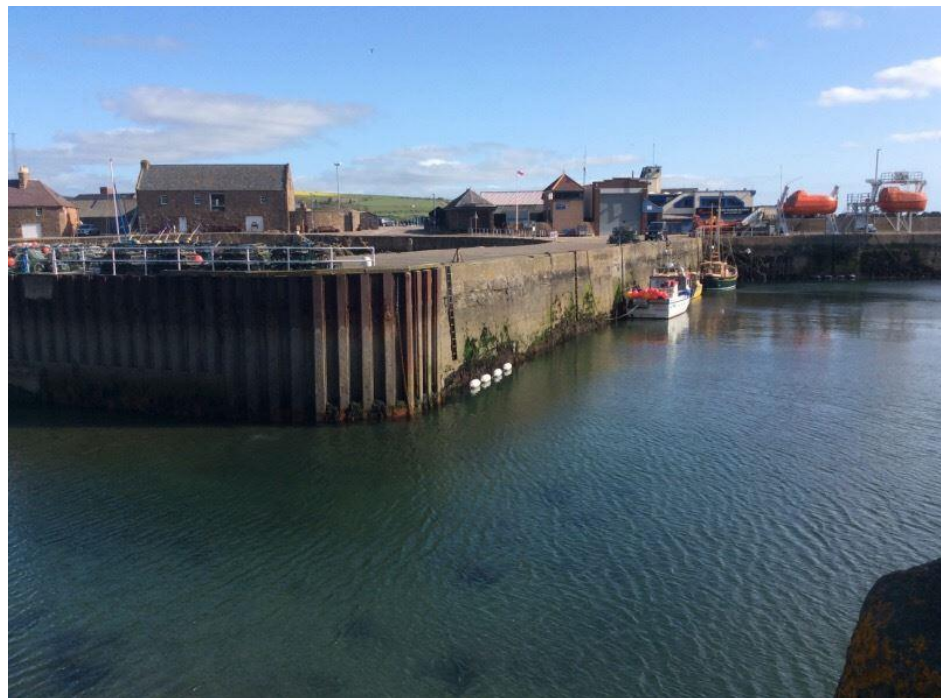
Section F
Quay face
Defect Ref: D77
Description: D77 -
Undermining scour on
toe of old concrete toe
repairs.
Photo number: 175

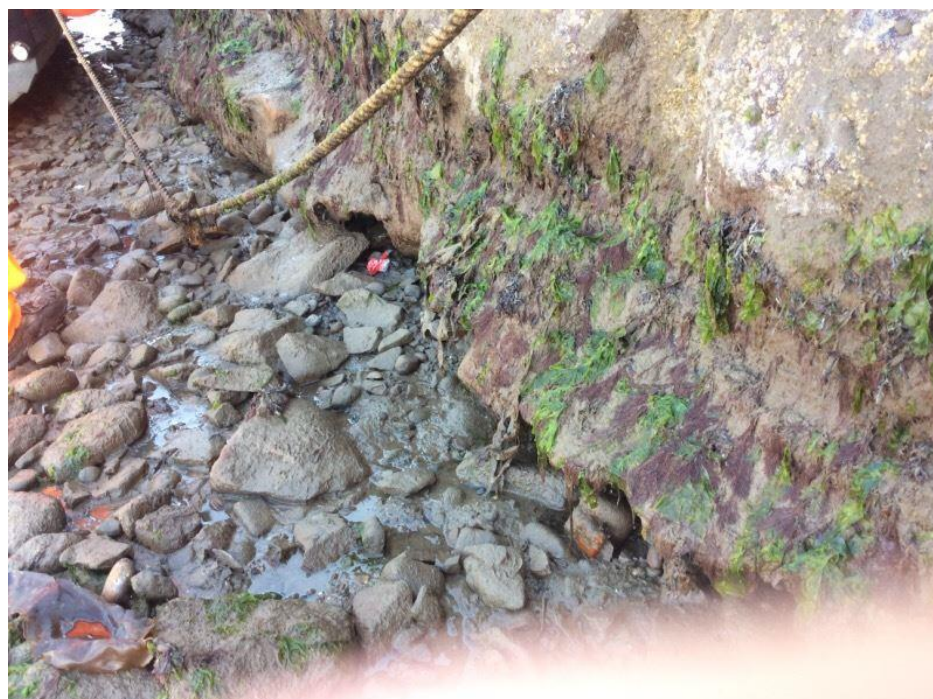
Section F
Quay face
Defect Ref: D77
Description: D77 -
Undermining scour on
toe of old concrete toe
repairs.
Photo number: 217

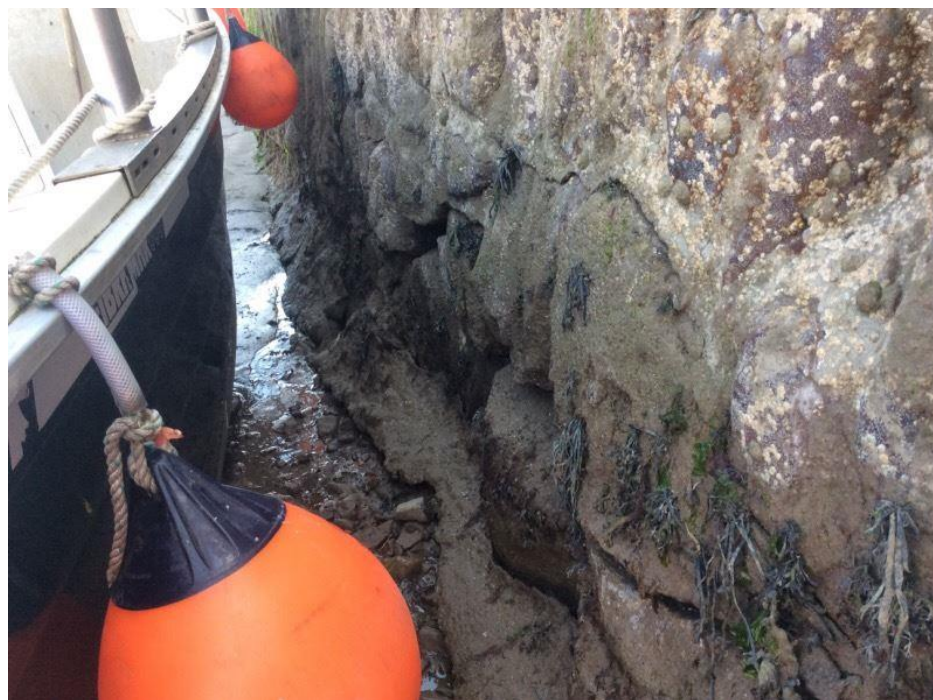
Section F
Quay face
Defect Ref: D78
Description: D78 - Open joints
Photo number: 176

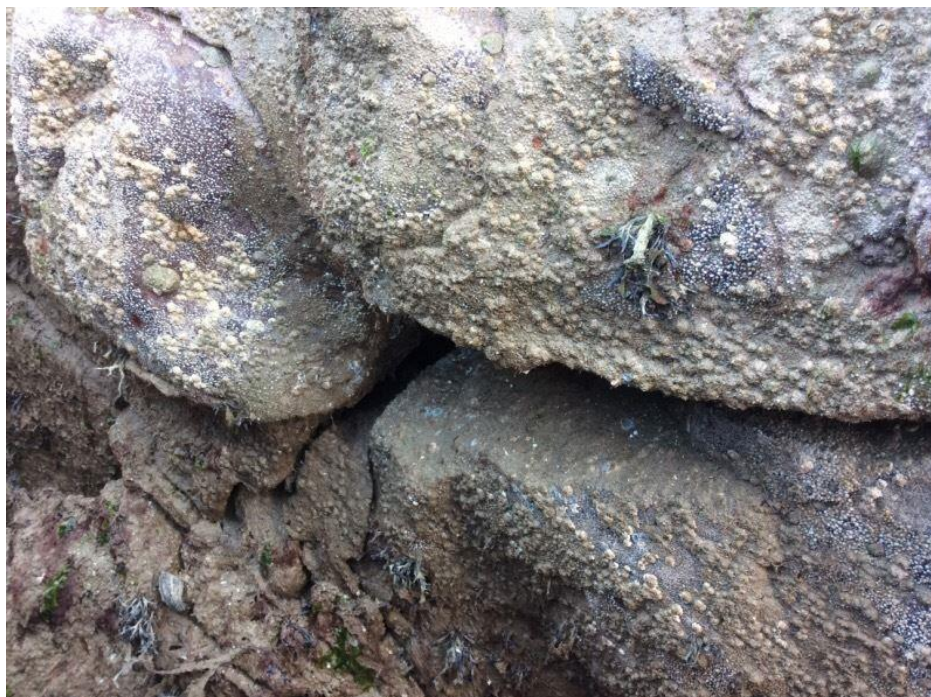
Section F
Quay face
Defect Ref: D78
Description: D78 - Open joints
Photo number: 218

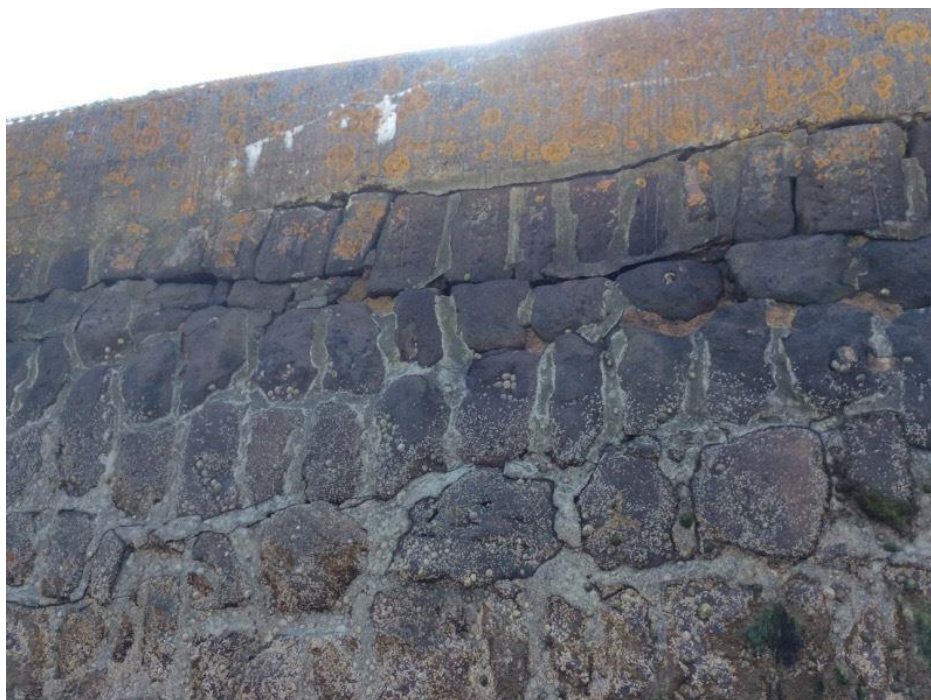
Section B
Seaward face
Defect Ref: D79
Description: D79 -
Protective apron possibly
undermined - not long
enough to provide
protection to that face
Photo number: 177

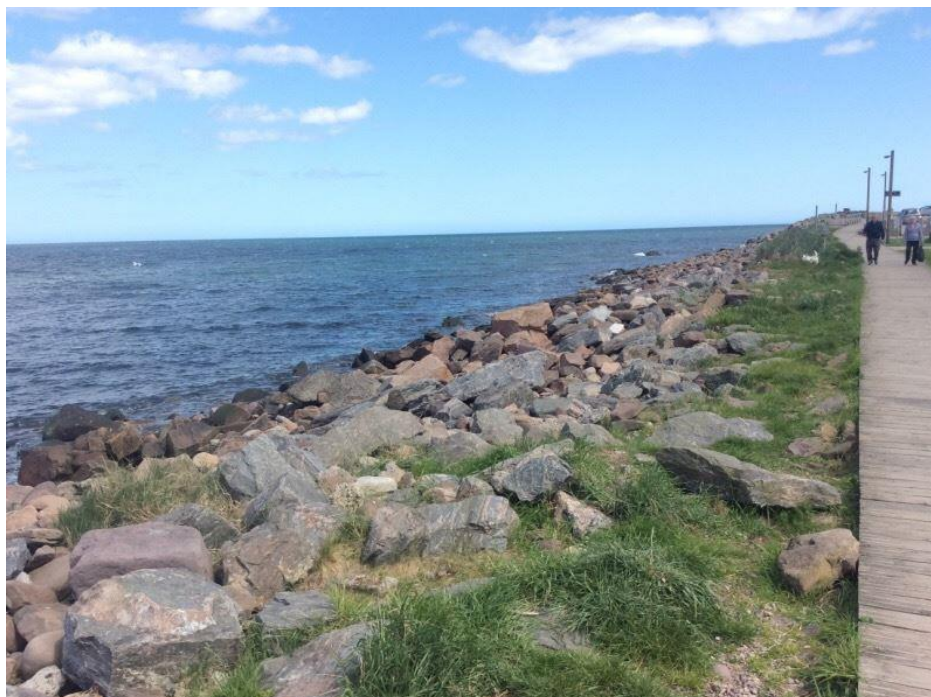
Section H
Rock armour
Defect Ref: D85
Description: D85 -
Undersized rock armour
units
Photo number: 220

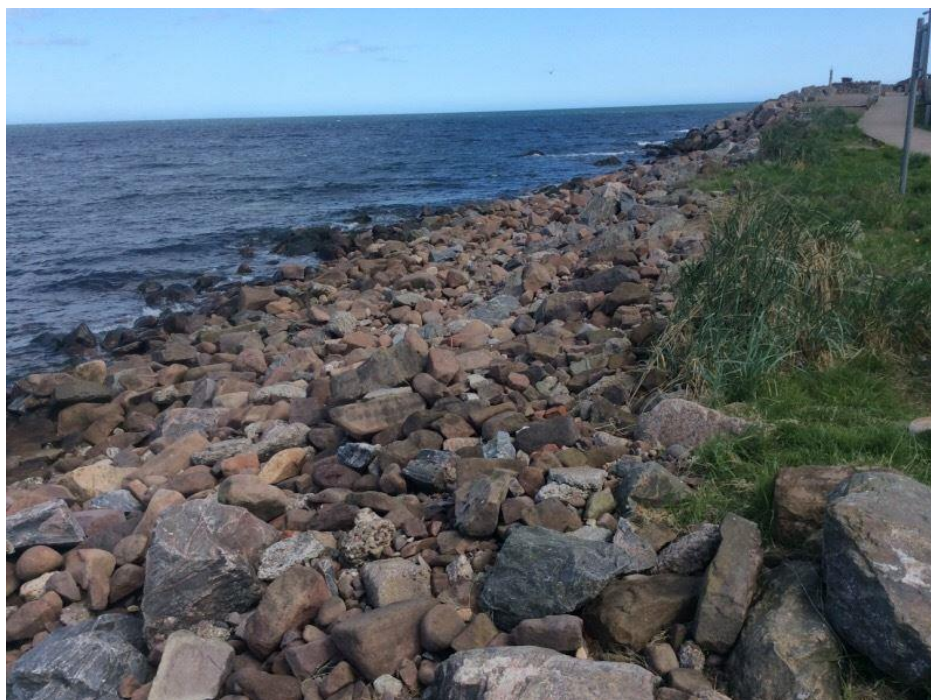
Section H
Rock armour
Defect Ref: D85
Description: D85 -
Undersized rock armour
units
Photo number: 232

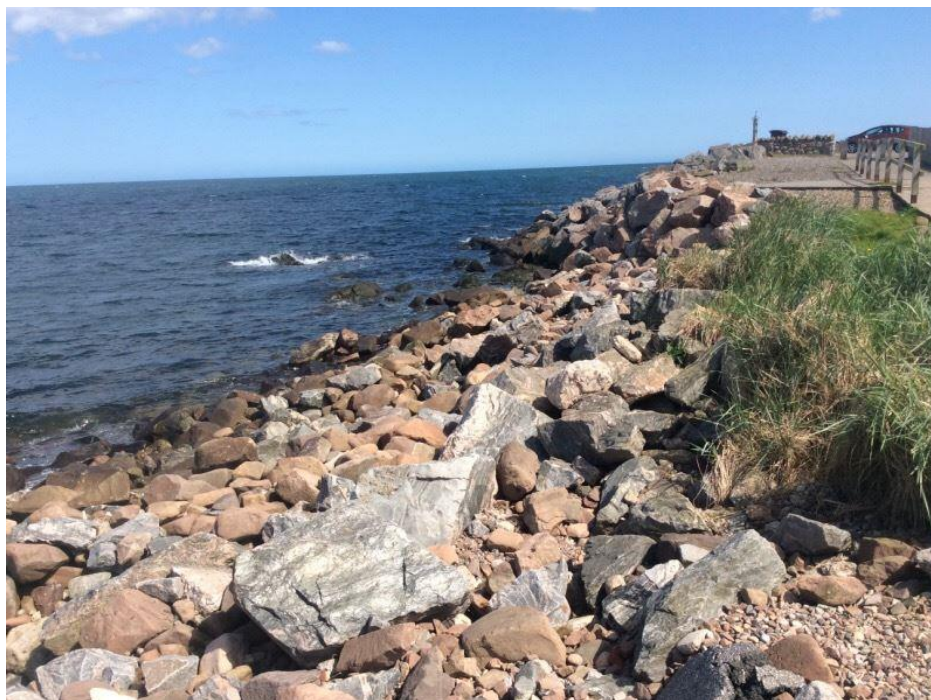
Section H
Rock armour
Defect Ref: D86
Description: D86 -
Overly steep rock armour
profile
Photo number: 186

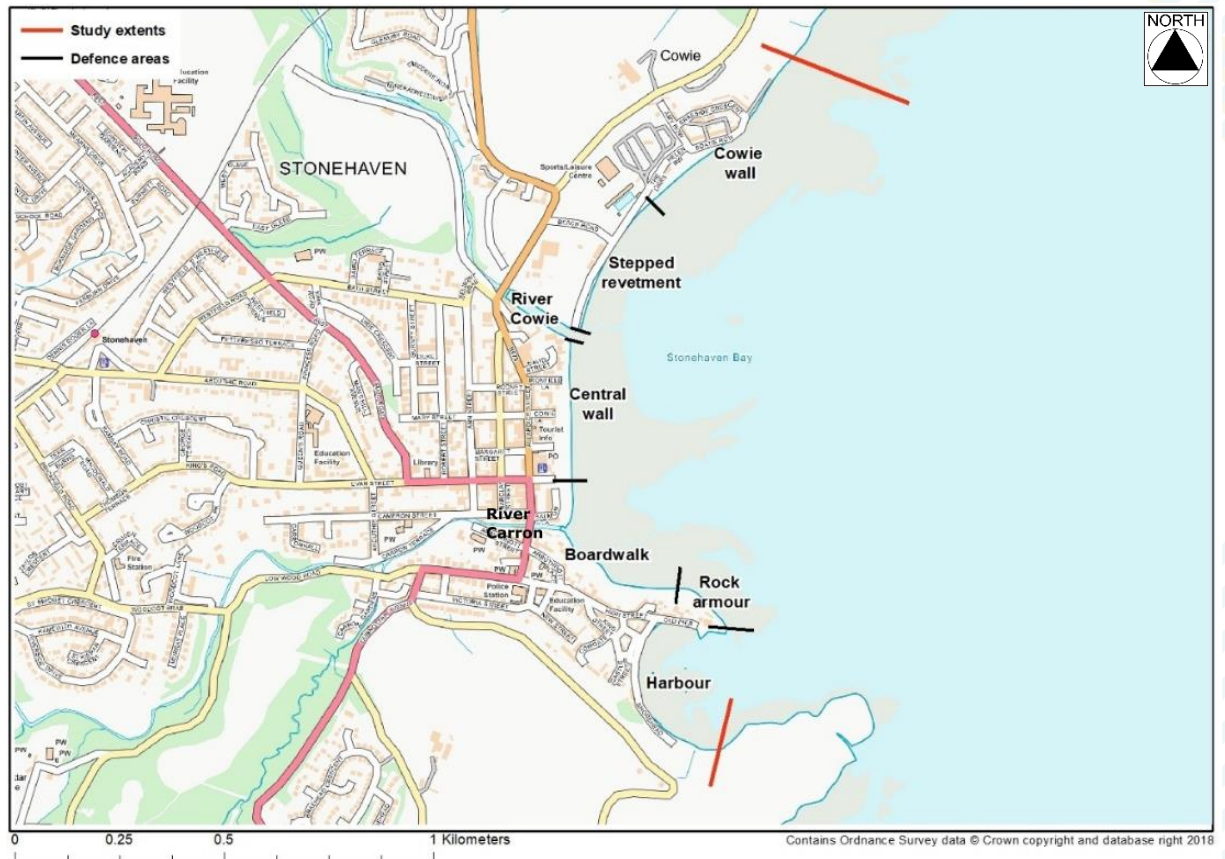
Figure 2-2: Subdivision of existing sea defences in Stonehaven Bay

The area is protected by existing sea defences along the Stonehaven and Cowie frontage. The general arrangement of the different defences within Stonehaven Bay is shown on Figure 2-2 below.

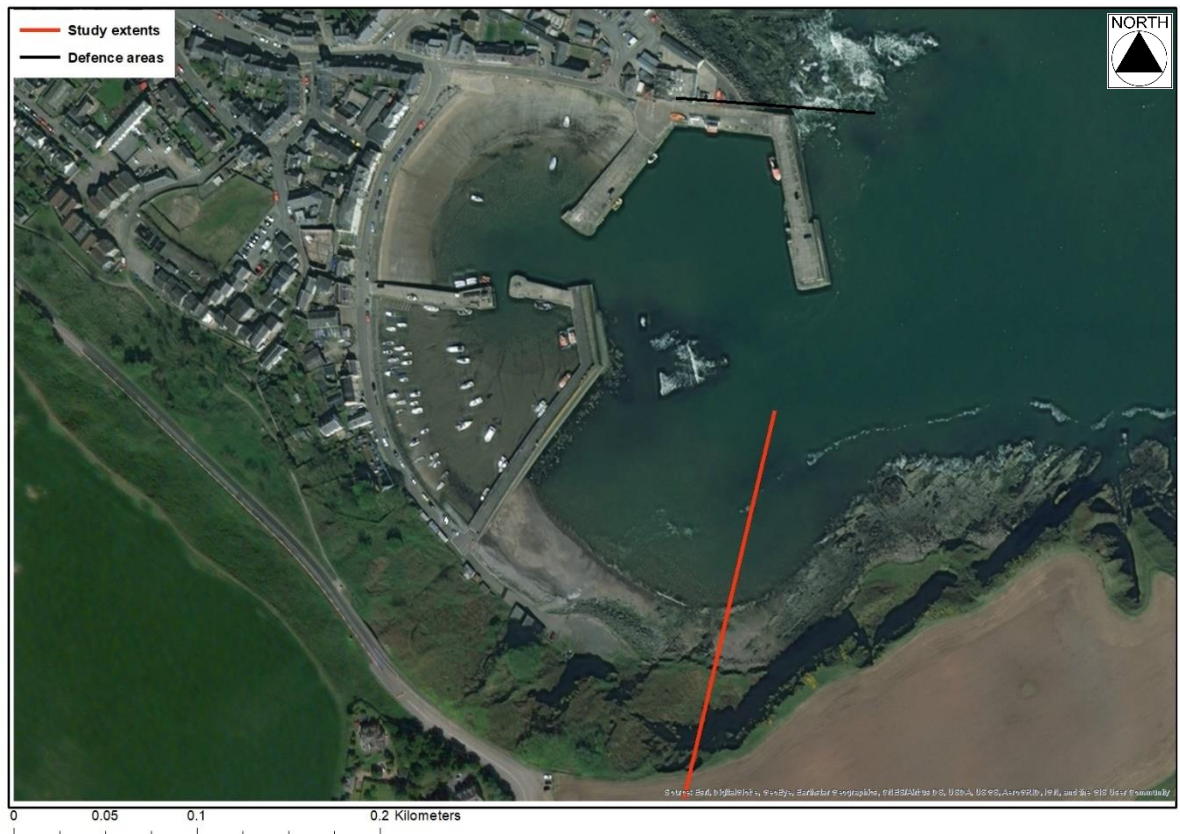
Figure 2-3: Aerial image of harbour area

The harbour area of the sea front is prone to flooding from a combination of high sea levels and the action of waves that can enter the harbour mouth and run along the walls of the inner basin. This area is extended from the red line to the black line, on the outer side of breakwater. A review of the historic flood records shows that the properties along Shorehead have flooded in the past as well as several near misses when sandbags have been deployed as a precaution.

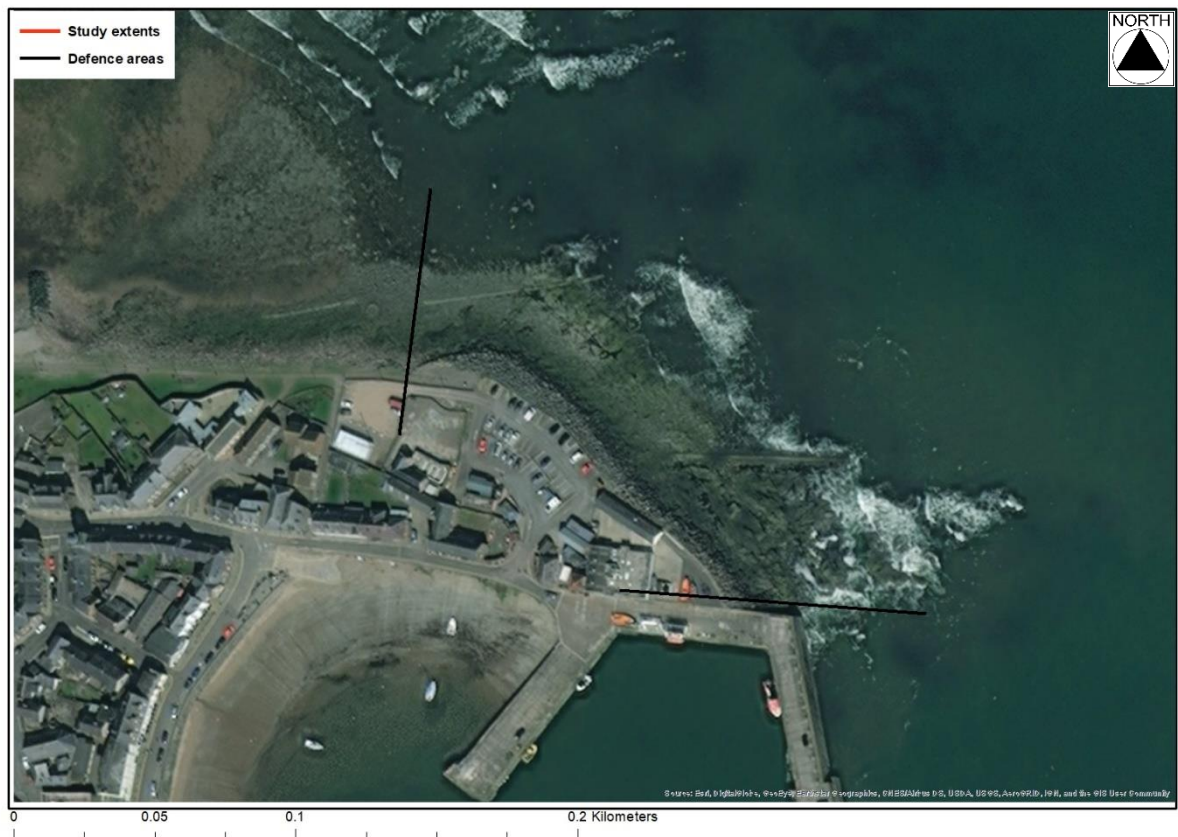
Figure 2-4: Aerial image of the rock armour section

To the north of the harbour is a public car park that is fronted by a substantial rock armour revetment. This is placed along the headland extending from the outer breakwater into the bay.

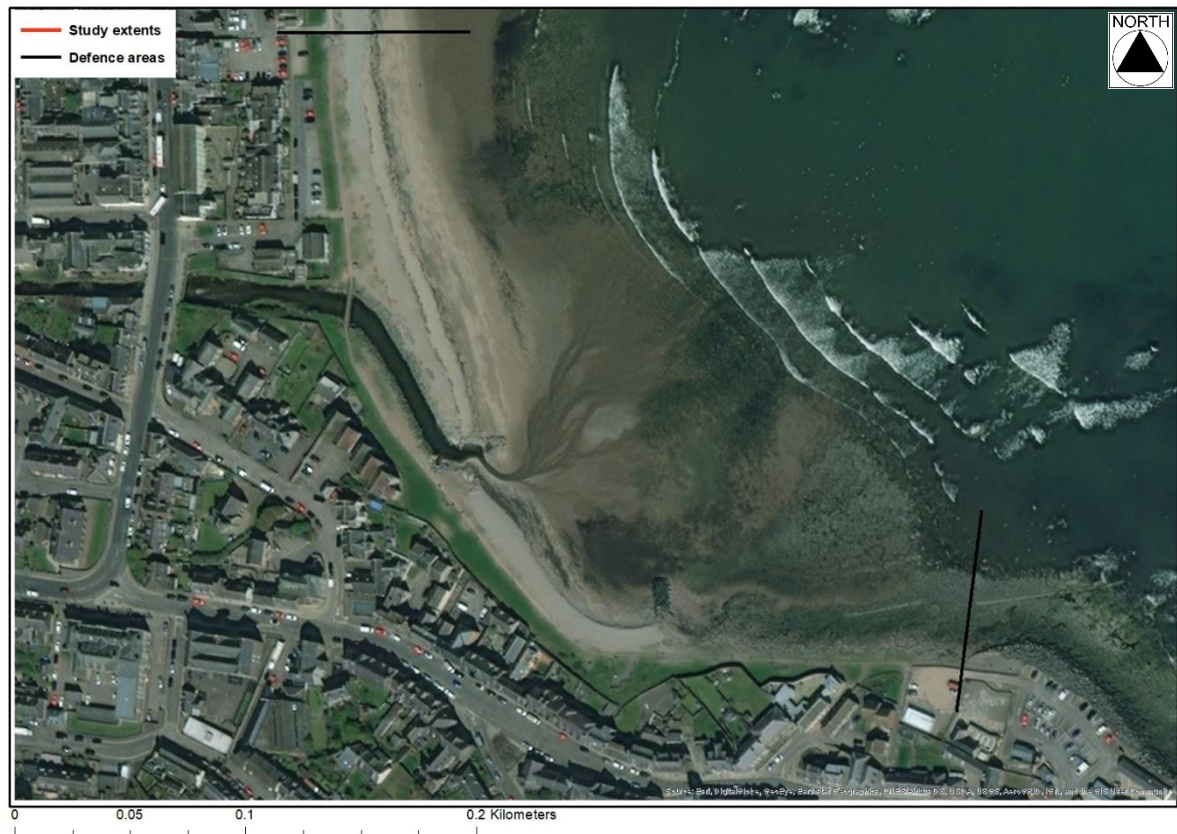
Figure 2-5: Aerial image of the boardwalk section

The boardwalk section is a mixture of shingle beach to the north and a rock armour structure to the south. The beach is understood to be prone to erosion and the timber walkway washed away during the Dec 2012 event. Shingle deposited in the mouth of the River Cowie to the north is periodically recycled and redeposited along the beach of the Boardwalk section as a coastal protection measure.

The section also includes the outfall of the River Carron; the mouth of which is trained by rock armour structures.

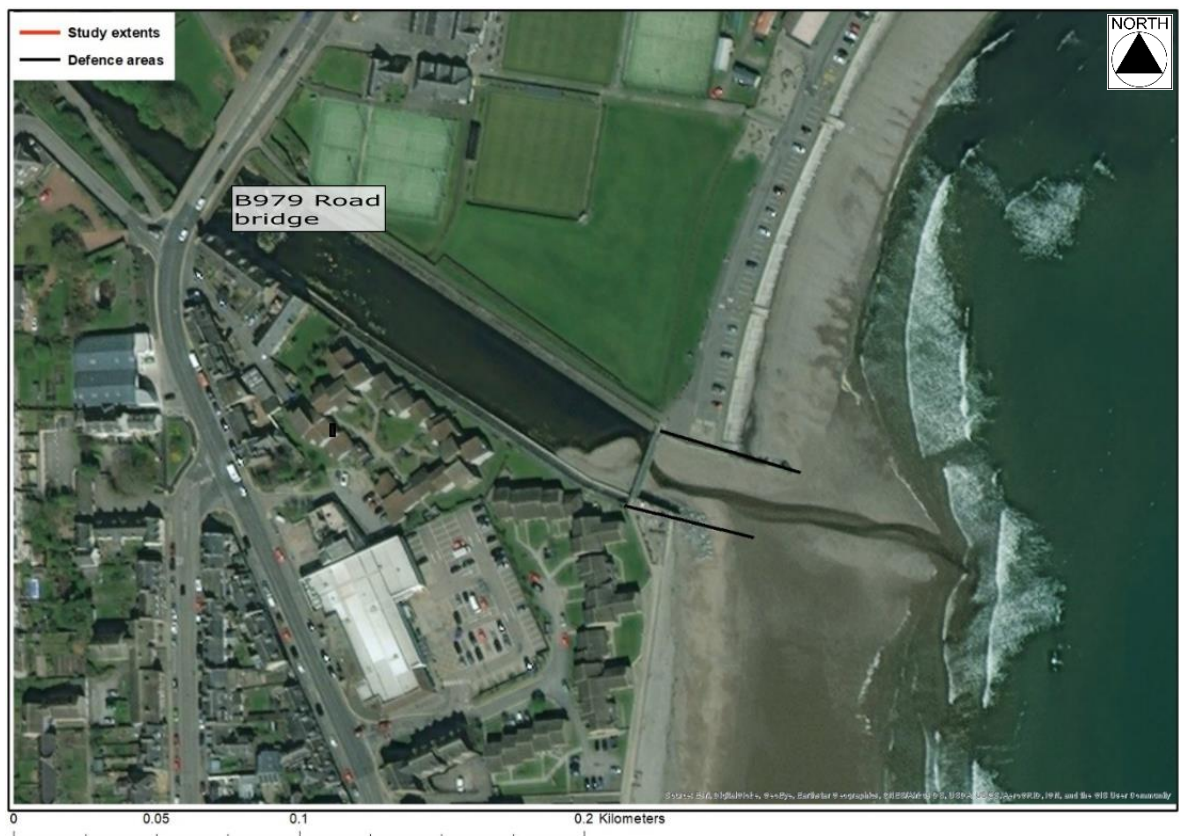
Figure 2-7: Aerial image of the River Cowie section

The River Cowie section consists of a combination of concrete walls, concrete revetments, and steel sheet piles. The defences extend from the mouth of the River to the B979 road bridge that is approximately 200m upstream. During storm events, waves can propagate into the mouth of the river and break on the weir beneath the B979 road bridge. The south bank of the river is also at risk from overtopping from oblique waves that enter the mouth and roll along the revetment. It is understood that the section of wall on the north bank has been undermined in the past and will likely require engineering works to stabilise it.

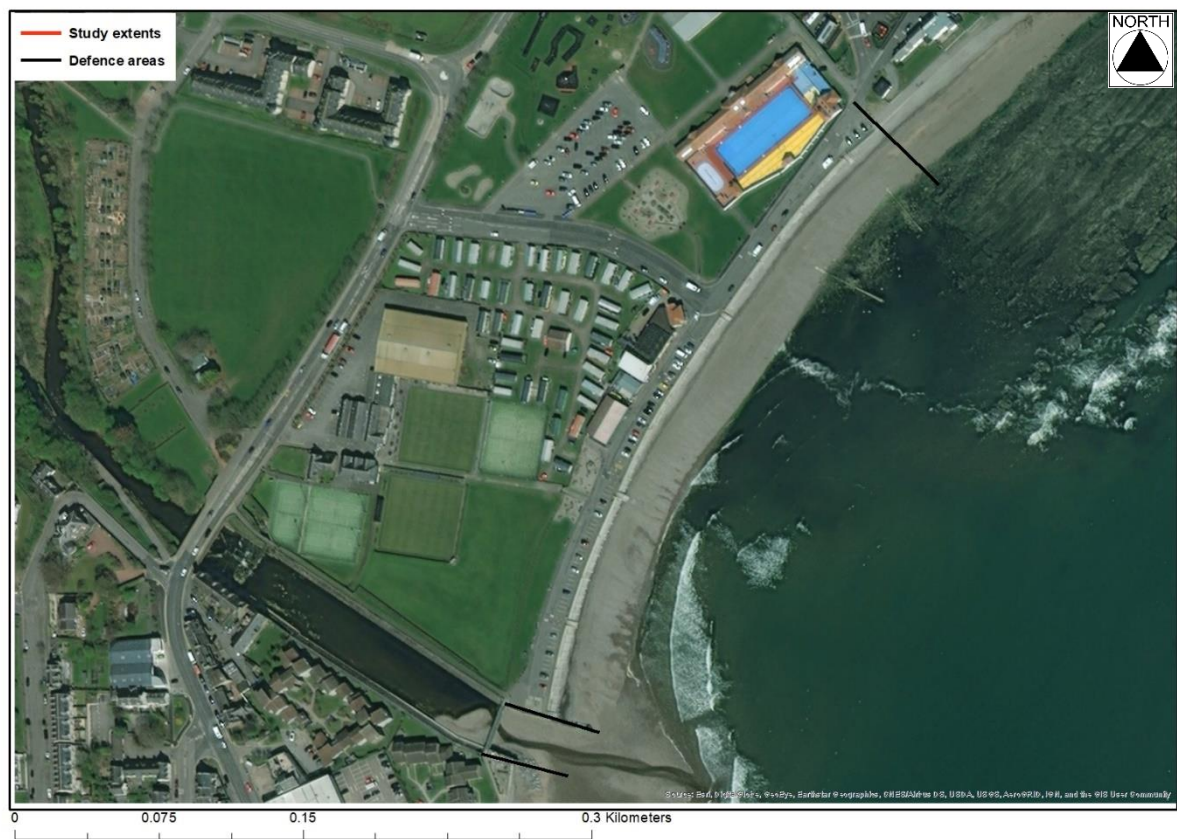
Figure 2-8: Aerial image of the stepped revetment section

The stepped revetment section forms the main coastal defence along Cowie promenade. It runs from the mouth of the River Cowie to the northern end of the open-air pool. It consists of a stepped concrete revetment with a wave return wall at the crest; a rock armour toe was added to the defence in 2006. There is also a short steel piled section at the north, in front of the parking spaces opposite the swimming pool. The sheet piles were recently undermined, with a sink hole opening up behind; this has been rectified, with concrete now backing the defence.

Over the years there has been significant damage to the structure from undermining and scour at the toe, as well as the high frequency of overtopping causing significant damage to the shorefront commercial properties due to the local topography.

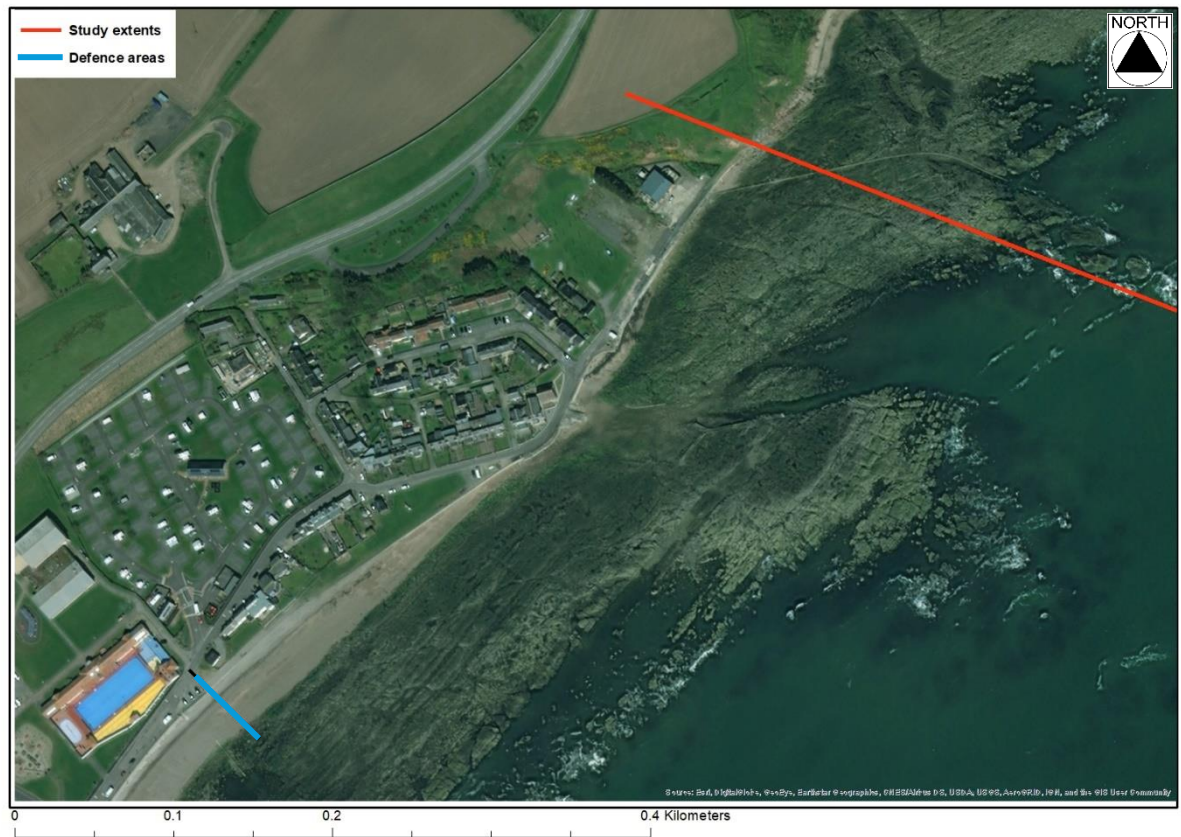
Figure 2-9: Aerial image of the Cowie wall section

The Cowie wall section runs from the open-air pool to north of the pumping station in Cowie. There is a concrete wall for part of the length, the height and construction of which varies. At the north end there is a masonry wall and in the middle a short section of exposed steel sheet piling. The natural rocky foreshore provides a degree of protection from incoming wave energy, but frequent overtopping occurs and results in flooding of properties during the more extreme events.

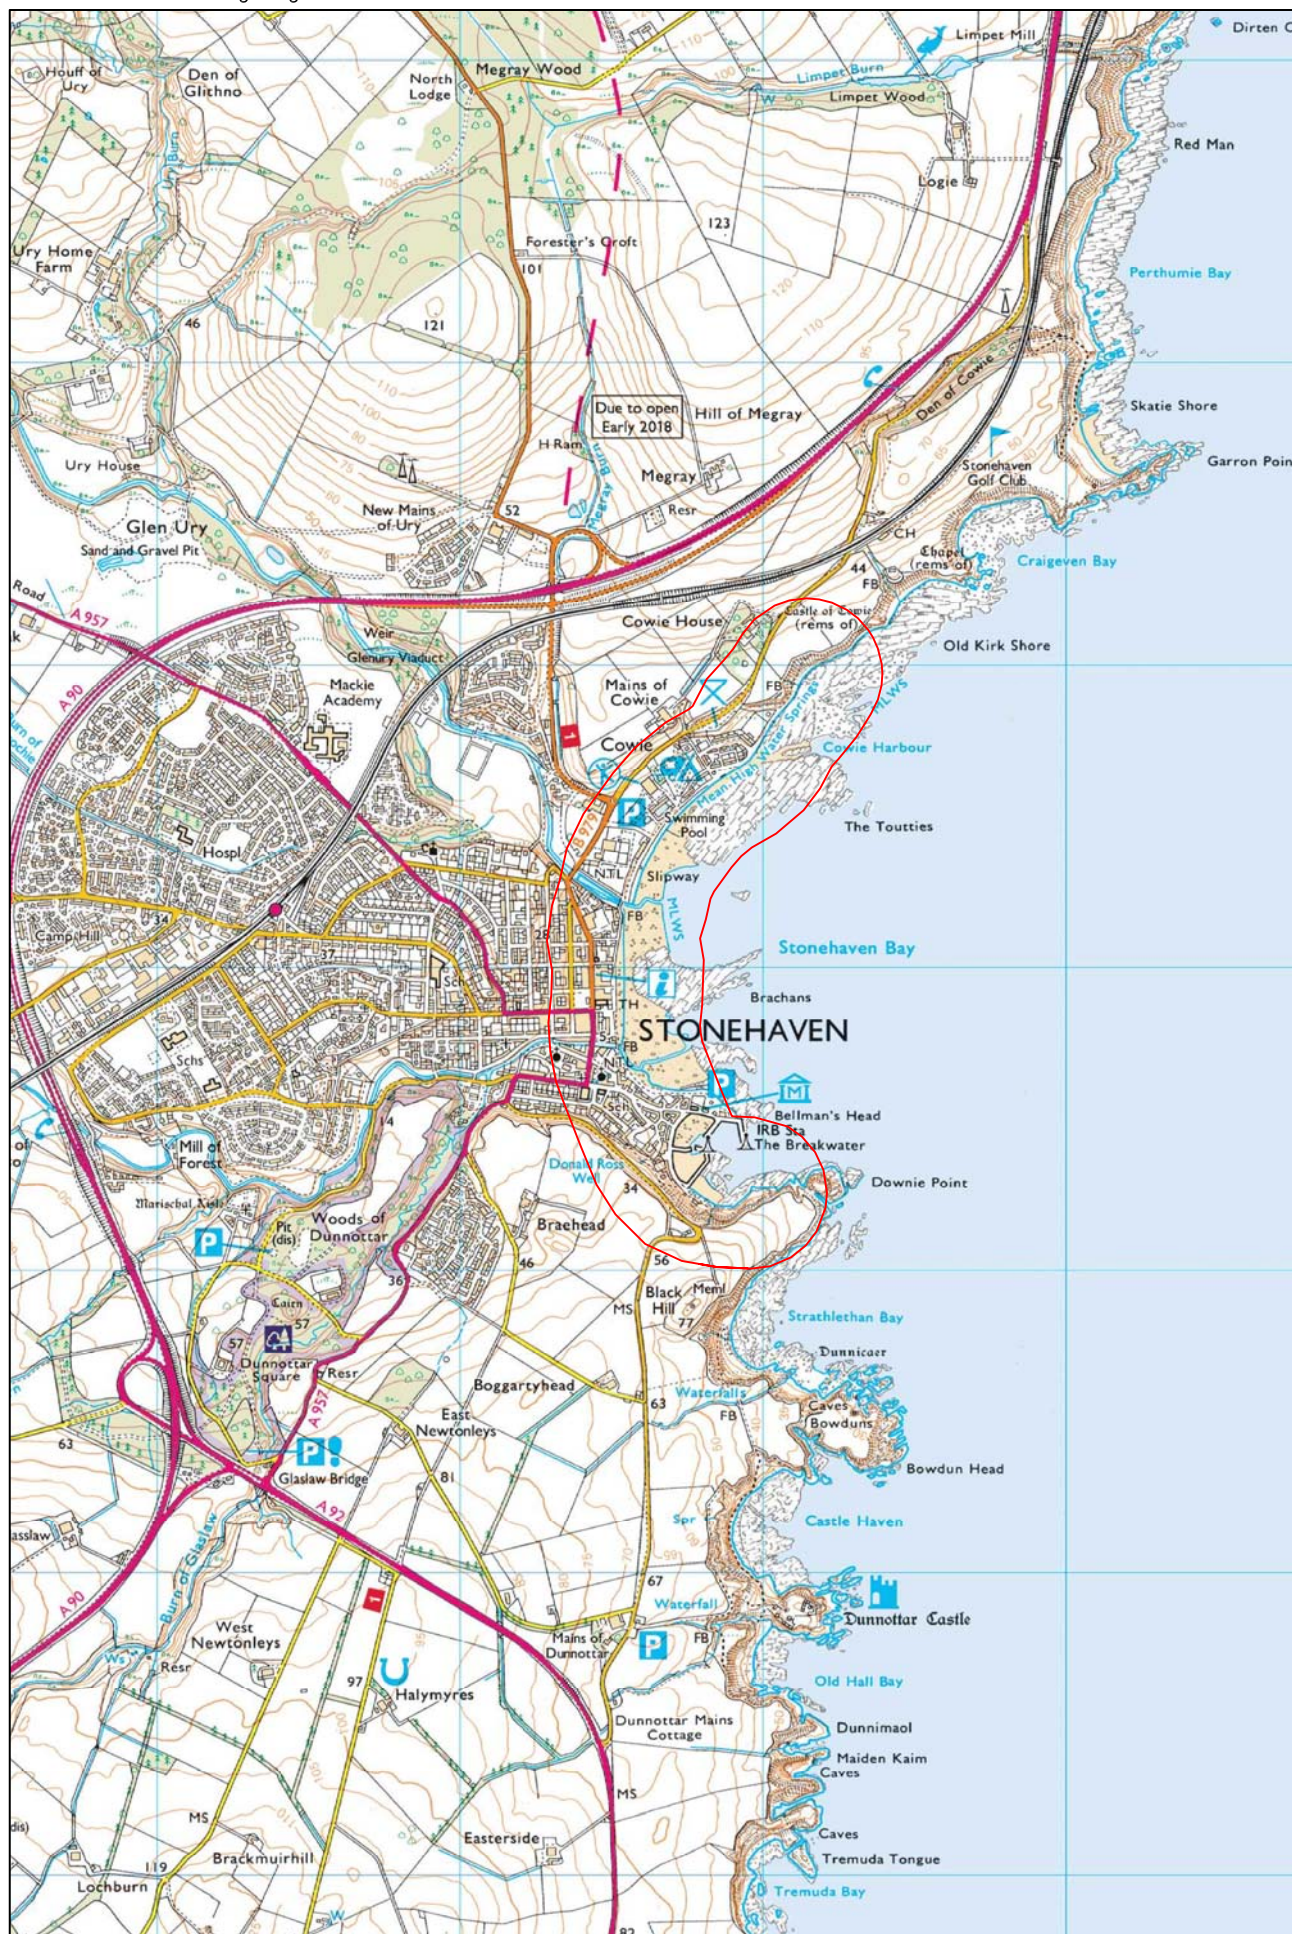
Location map and study area

The study area defined represents a 250m buffer from the coastline along Stonehaven Bay (see Figure 1).

SMR data was provided for a 250m buffer along the coast of Stonehaven (see Figure 1 for study area). This provided information on:

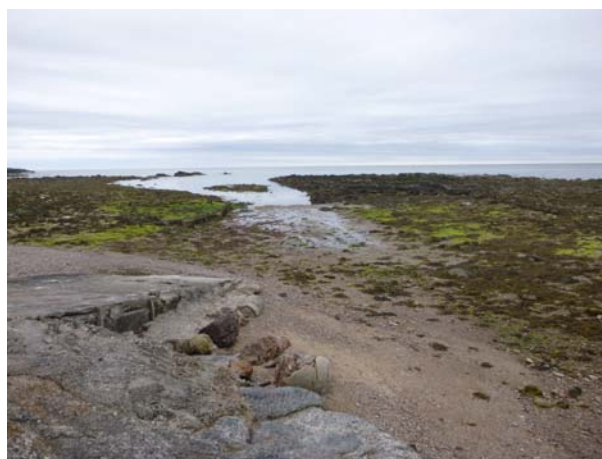
Plate 7 Cowie harbour, with jetty visible

By 1903, a jetty had been constructed at Cowie Harbour—elements of this are still extant (HA 157)(Plate 7). In the Old Town harbour, the breakwater had been constructed perpendicular to the northern part of the harbour (Plate 9) and by 1924, land to the north and east of the Tollbooth had been made-up and reclaimed to create the larger area developed today.

The historic map regression identified that a jetty was constructed at Cowie Harbour before 1903, the form of which is partly legible today (HA 157). This feature could potentially be affected if works are undertaken in this area.

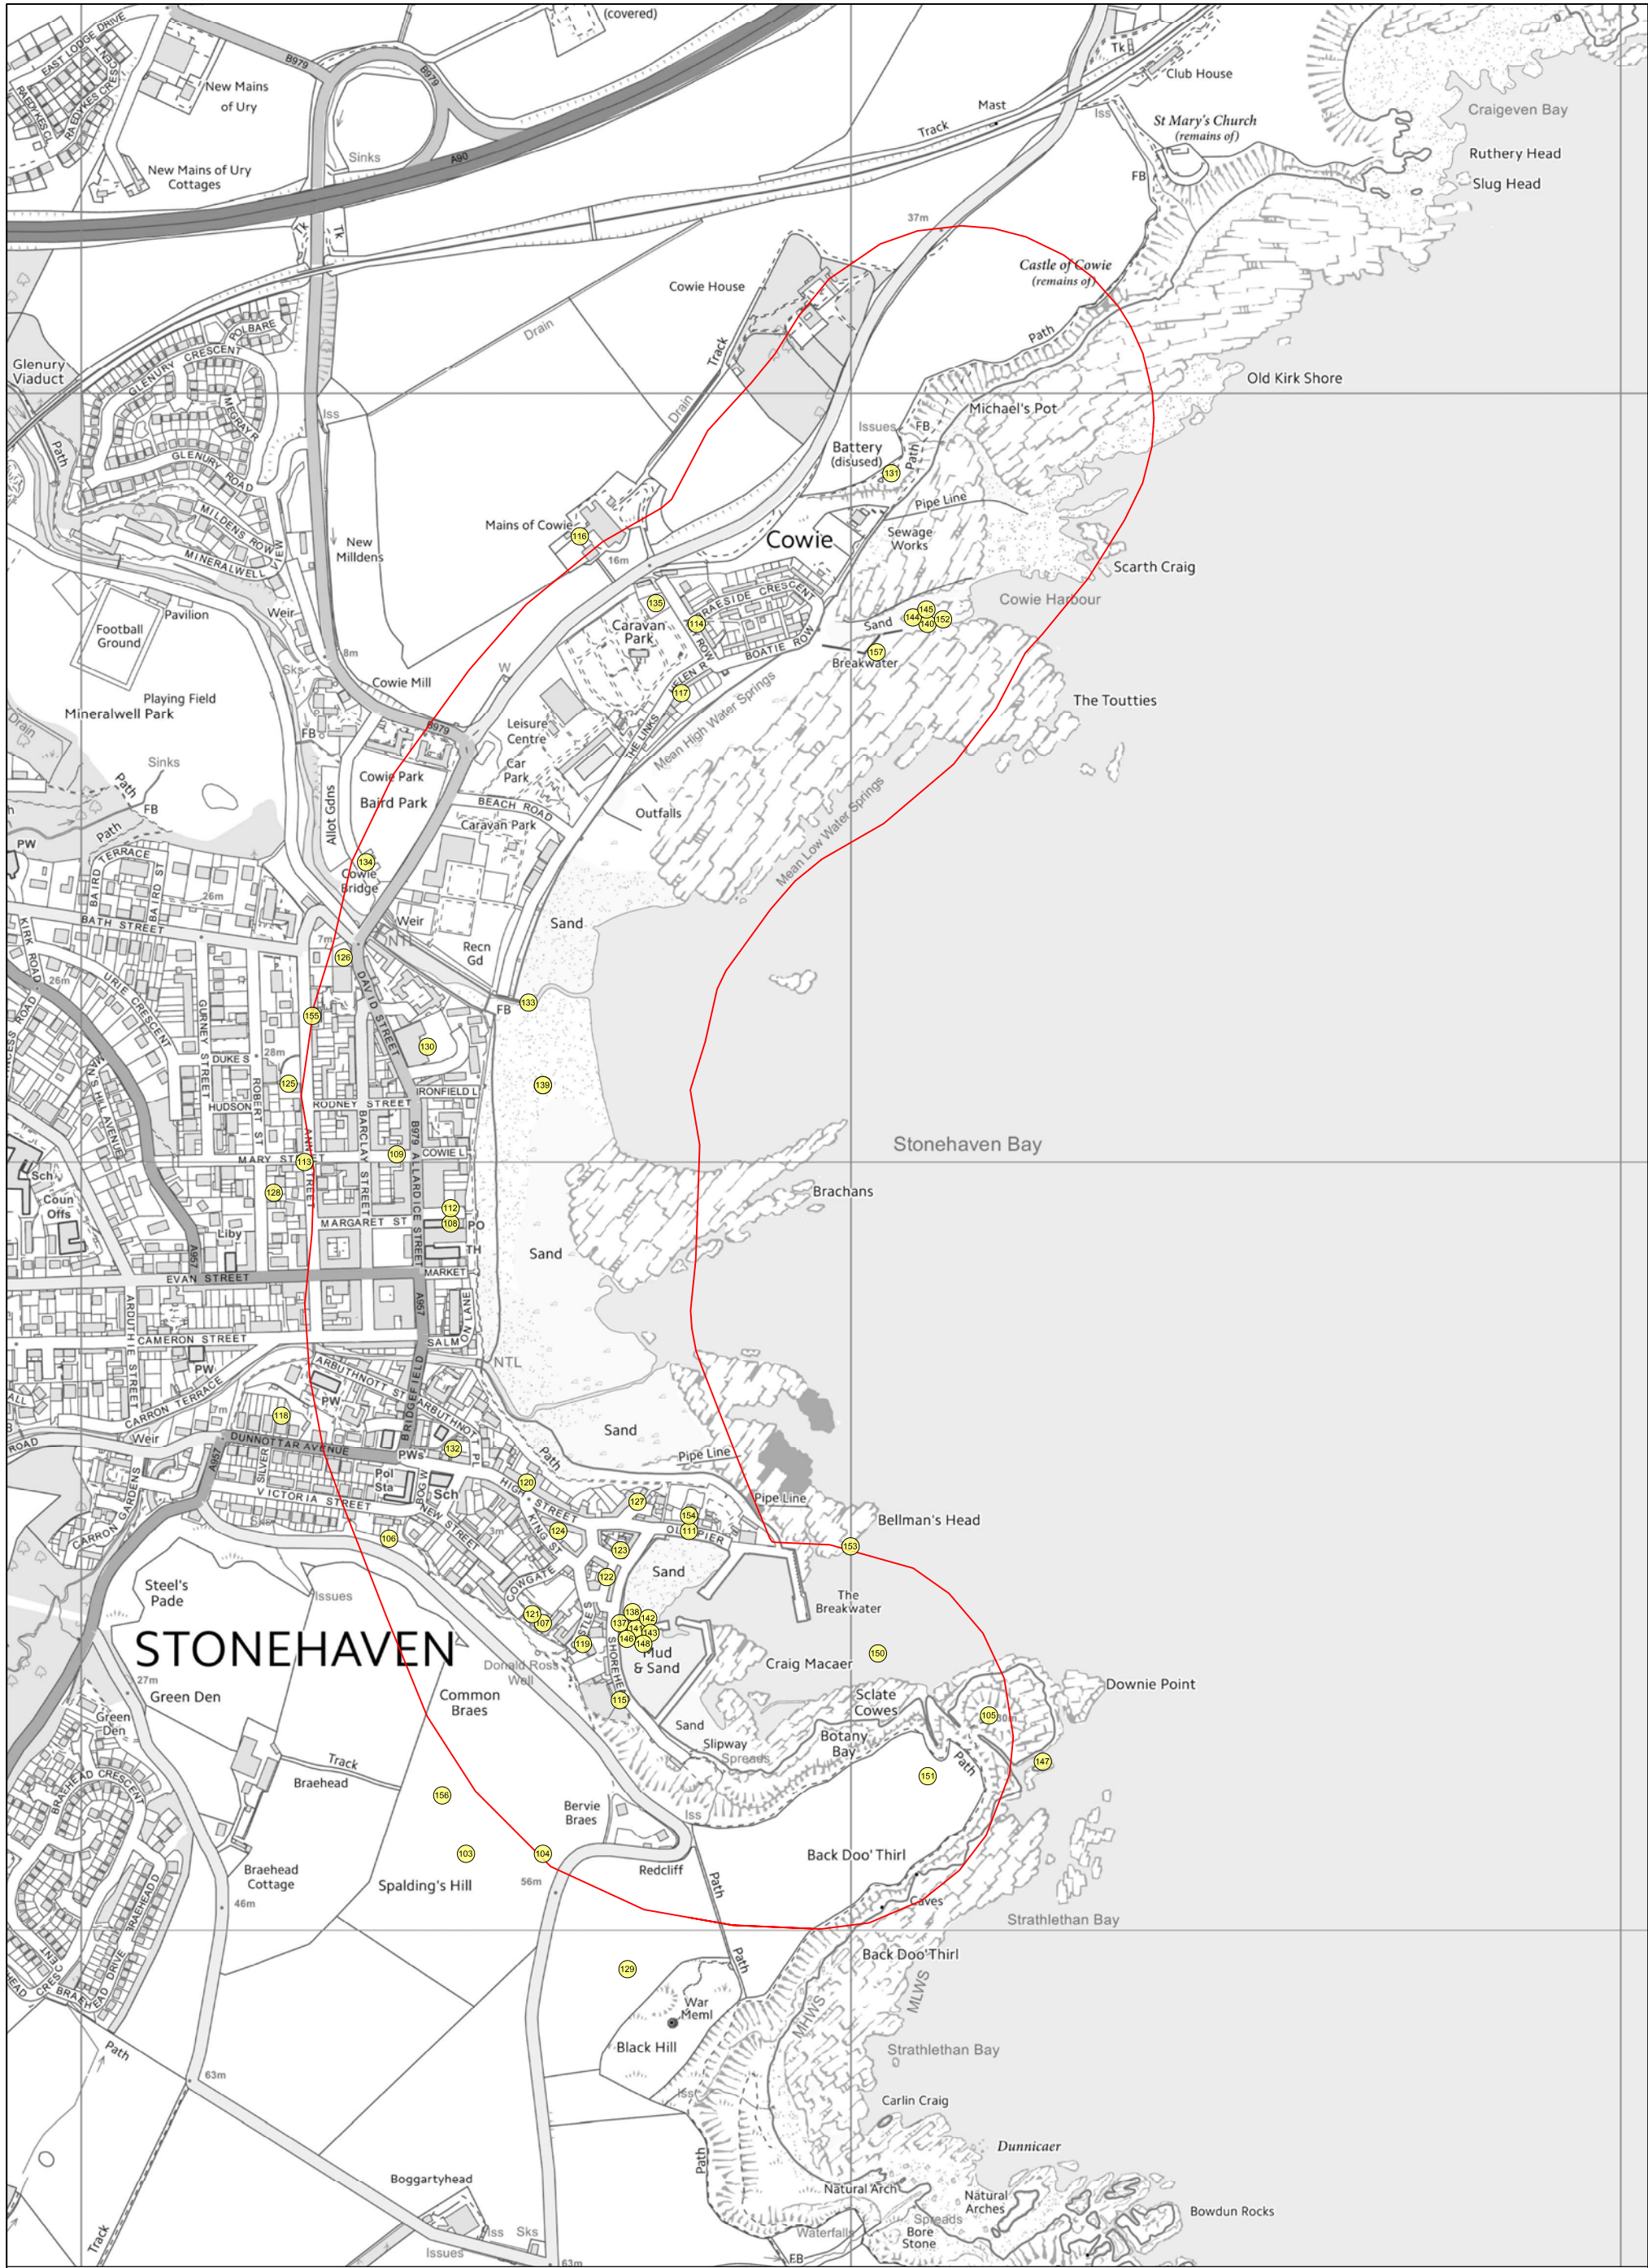
Figure 4

Location of non-designated heritage assets

The following sets out known heritage assets within the study area. Designated heritage assets are shown on Figure 2 and Figure 3, and non-designated heritage assets in Figure 4.

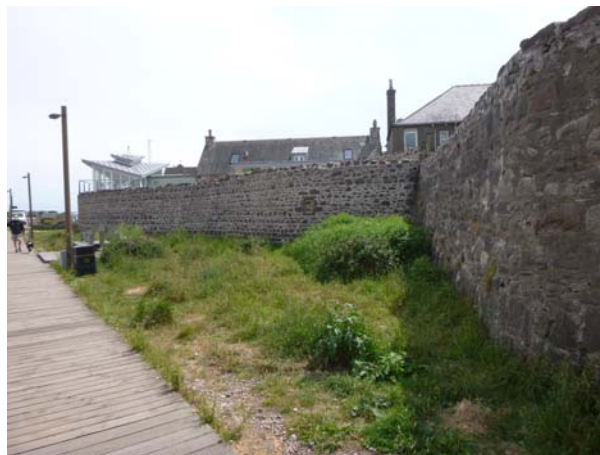
Plate 20 View of seawall to rear of Keith Place

At Keith Place (HA 82), a 17th-century former textile yard has a historic seawall to the rear that contributes to the historic character of this area and is clearly visible when walking along the seafront to the rear of these properties. This area is more permeable in terms of views towards the coast, and the seawall contributes significantly to the setting and character of these buildings (Plate 19 and Plate 20). The wall is included in the Listing.

To the north of the harbour, a Category A Listed former textile yard of 17th-century date occupies a site on Keith Place. A historic seawall to the north represents a key element of the form and character of this site. It is recommended that physical impact on this heritage asset is avoided, and that the design of any works in this area is sympathetic to the historic character of this heritage asset. Listed Building Consent may be required for works in this area, if they extend as far as the historic seawall.

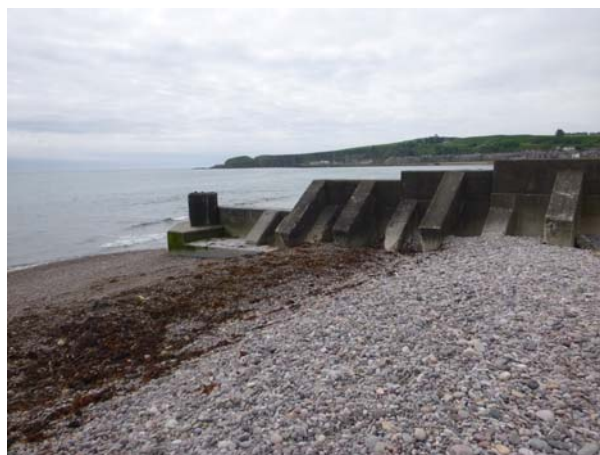
Plate 22 Anti-tank cube on breakwater

One of a series of anti-tank cubes (HA 133) survives on the breakwater at the end of the Cowie Water—a further twelve survive upstream of Cowie Bridge (Plate 22). This could potentially be affected by flood defence works, and mitigation should be in place if this is the case. As the feature is *ex situ*, significance would not be harmed by relocation to a suitable position in the immediate vicinity.

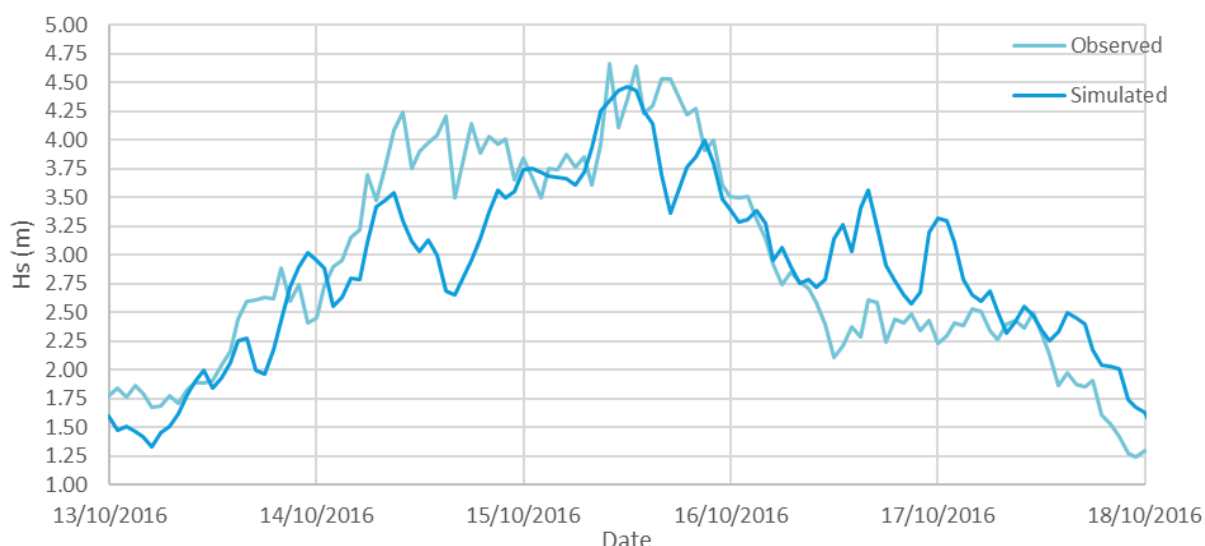
The emulated data at the buoy was validated against three observed events at the wave buoy in Stonehaven Bay. These events can be seen below in Figure 2-10 to Figure 2-12. They show good performance of wave transformation at the wave buoy with regard to wave heights, timings and the duration of the events.

Figure 2-10: Emulator performance at wave buoy - mid Oct 2016 event

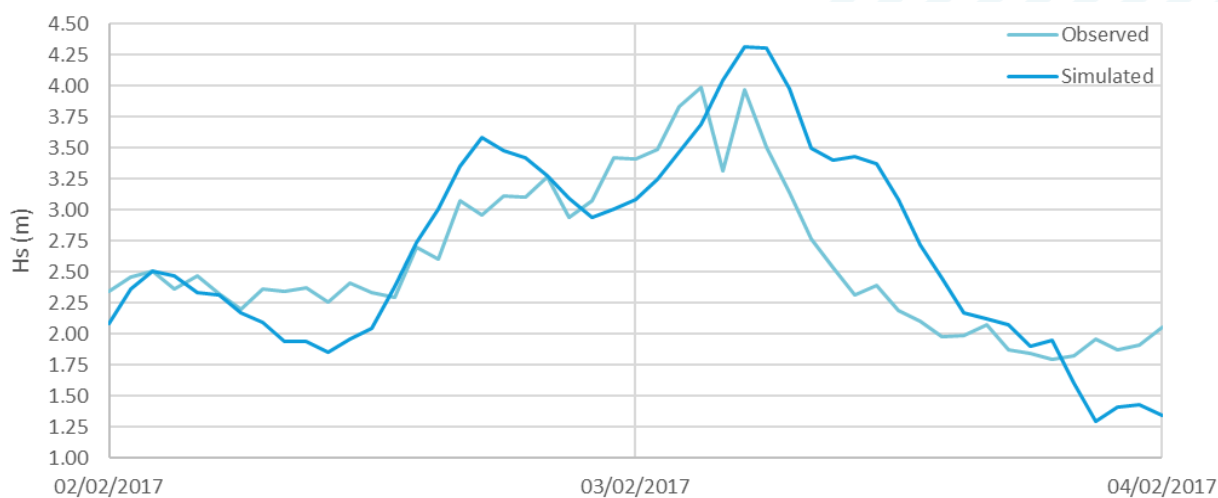
Figure 2-11: Emulator performance at wave buoy - early Feb 2017 event
