Stonehaven Bay Coastal Flood Protection Study

Final Report

December 2019

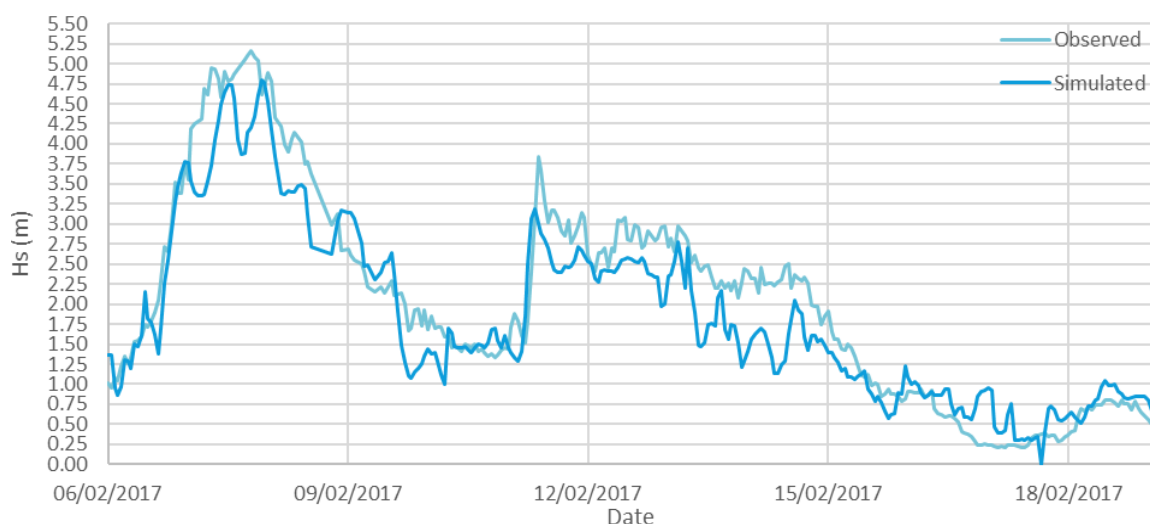
The emulated data at the buoy was validated against three observed events at the wave buoy in Stonehaven Bay. These events can be seen below in Figure 2-10 to Figure 2-12. They show good performance of wave transformation at the wave buoy with regard to wave heights, timings and the duration of the events.

Figure 2-12: Emulator performance at wave buoy - mid Feb 2017 event

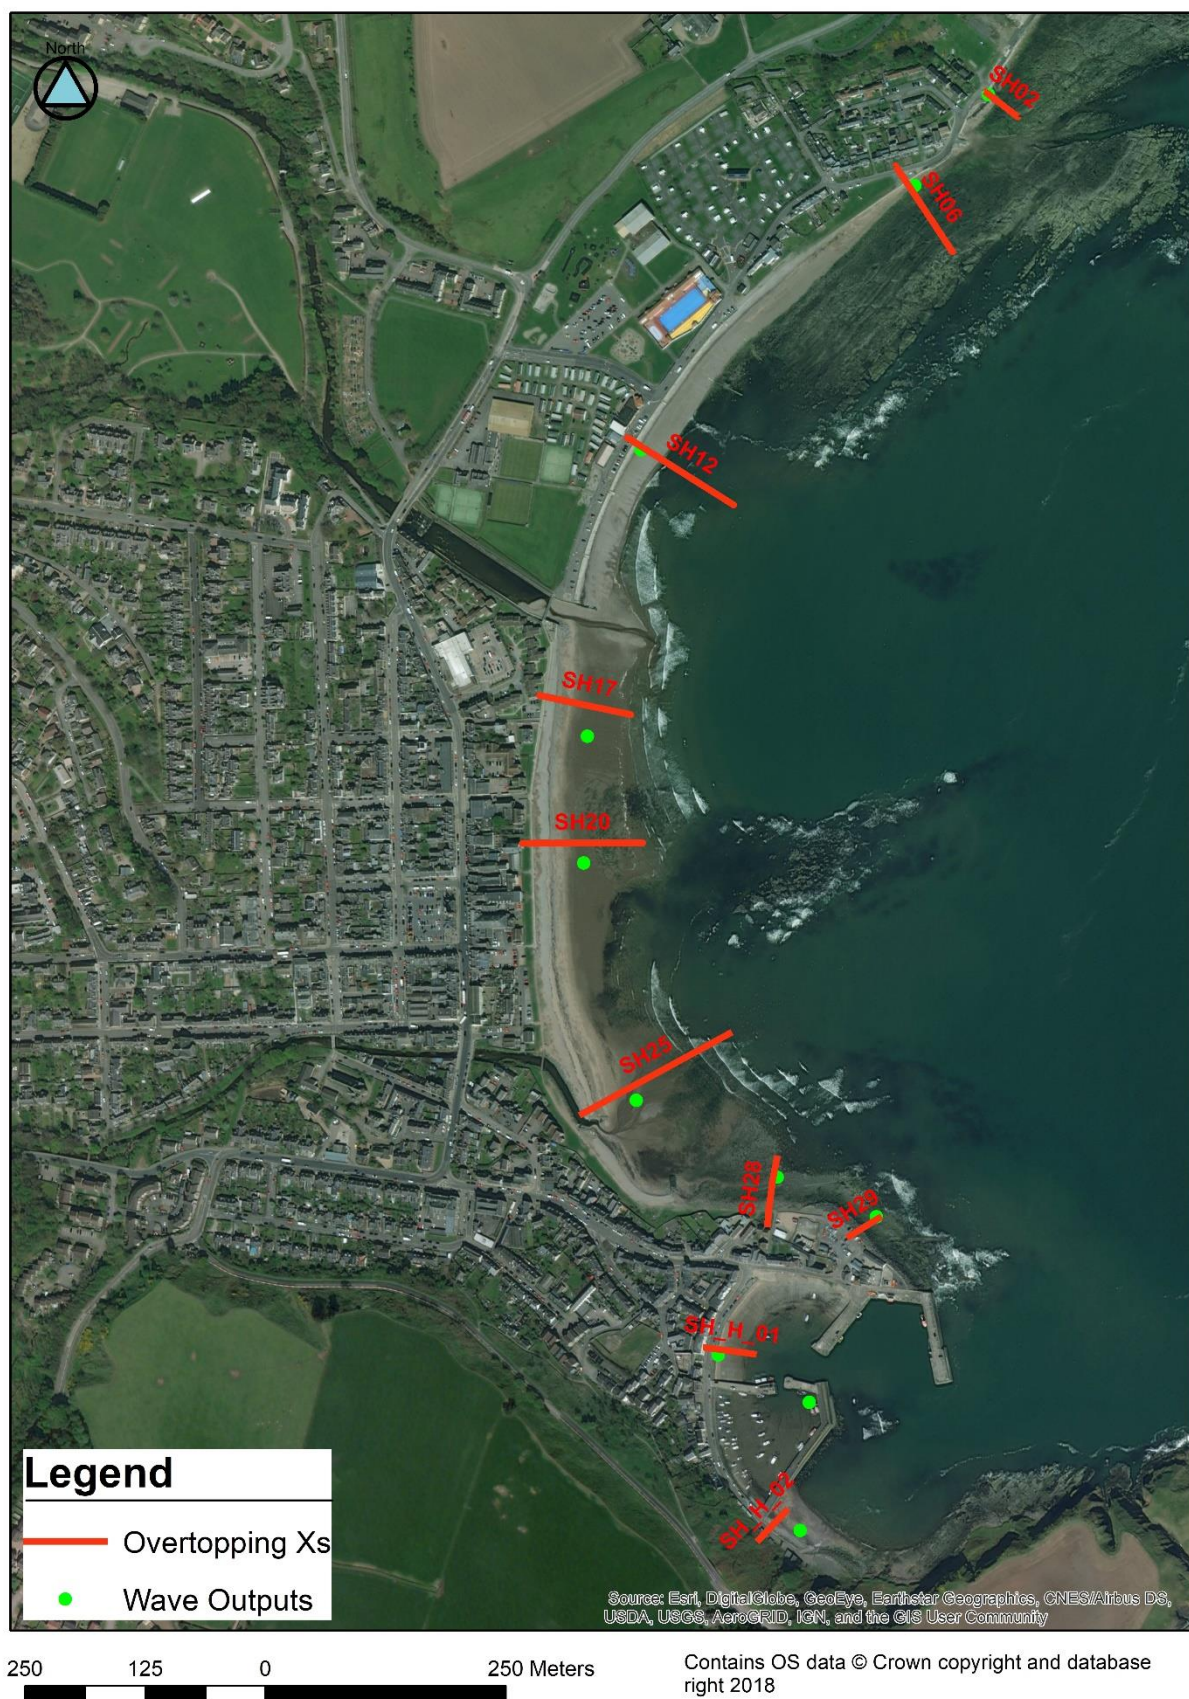
The locations themselves are provided in Figure 2-13; these are deemed sufficient to quantify the variation in risk, exposure and structure type within the bay. Table 2-6 presents these more specifically along with the Neural Network schematisations developed from the JBA survey.

Figure 2-13: Overtopping profile locations

To provide consistency between the SWAN wave model and the overtopping models, the level of the SWAN output node and the schematised toe depths within the overtopping models must be at a similar depth. Table 2-5 shows the depths of each of these, while Figure 2-13 shows their location. The majority of the toe depths match the SWAN toes, with the exception of toes that have been elevated to calibrate with observed overtopping rates (SH02, SH28 and SH29). Wave conditions forcing SH_H_01 are taken at deeper water depths to maximise wave heights. The difference seen at these toes is discussed further within section 2.8.

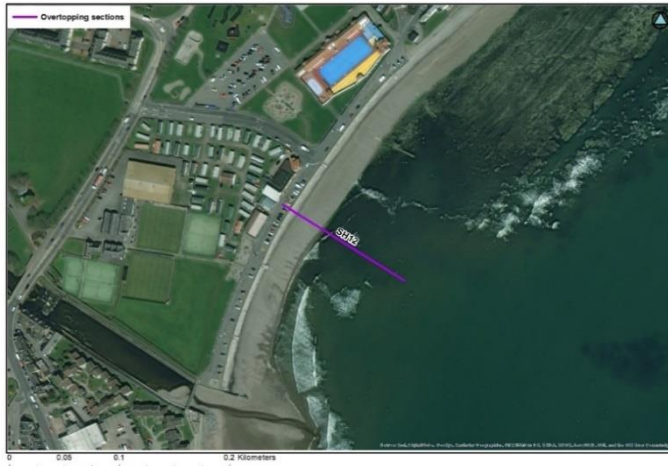
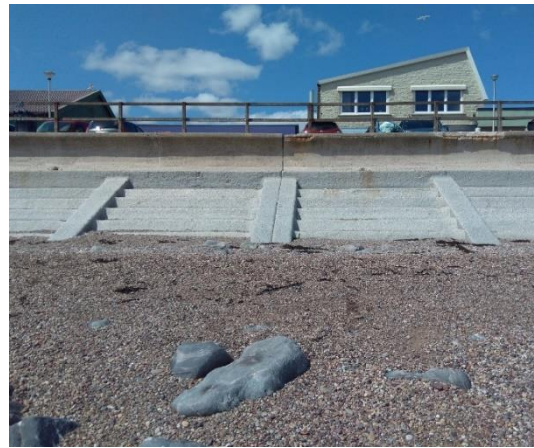
SH12

XS Ref.	Location on aerial imagery	Photograph	Schematised and measured cross section
SH02			
SH06

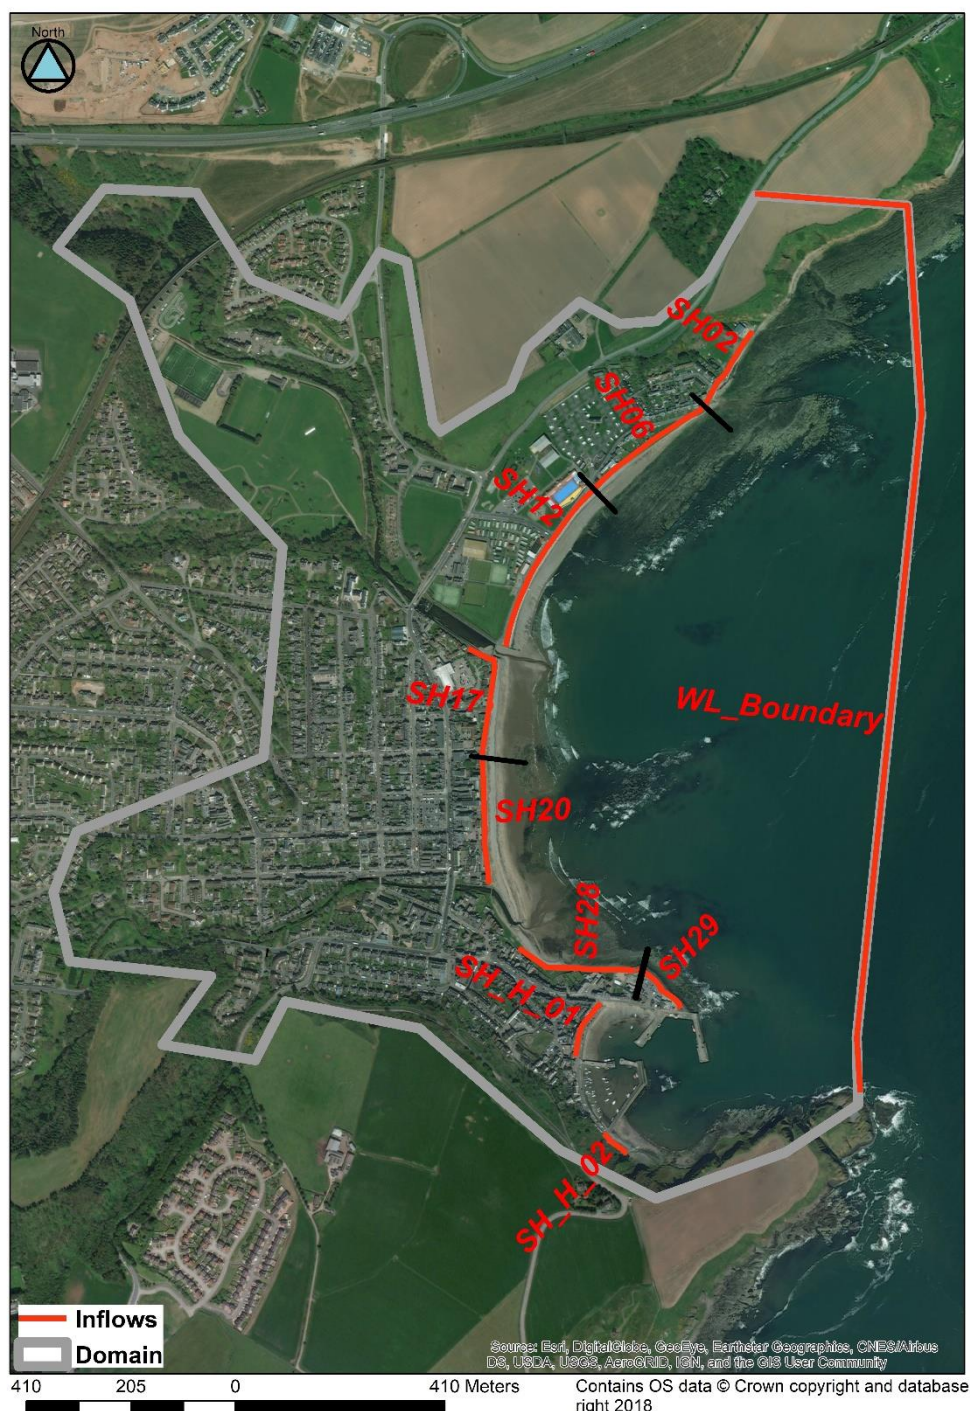
Figure 2-15: TUFLOW model domain and inflows

A 2D flood inundation model was constructed in the TUFLOW modelling package for Stonehaven and Cowie. The model extends from the mouth of the bay to high ground as well as along the rivers Carron and Cowie (Figure 2-15). It has been used to estimate flood extents and depths for extreme events from a combination of still water levels and wave overtopping.

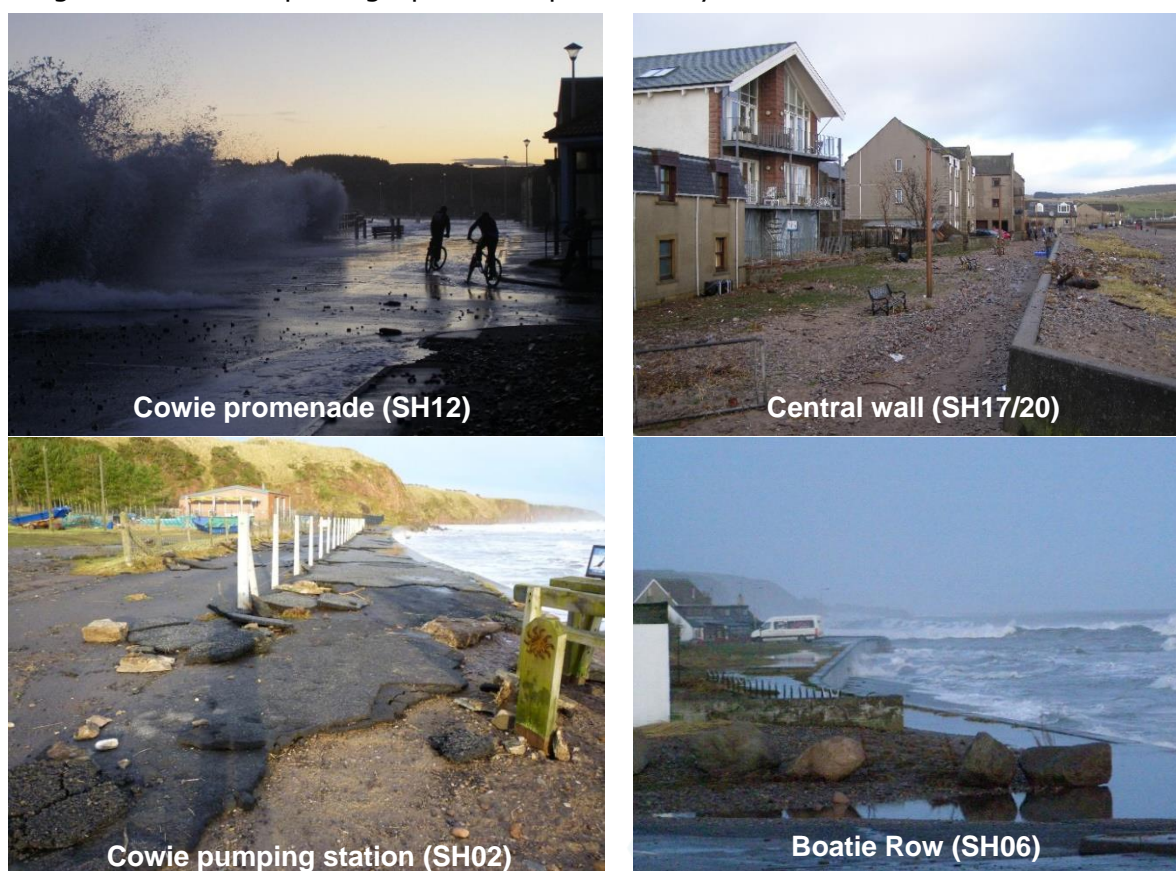
Figure 2-16: Observed overtopping during the December 2012 event

For reference, examples of the observed overtopping during Dec 2012 are presented in Figure 2-16. The photographs were provided by Aberdeenshire Council.

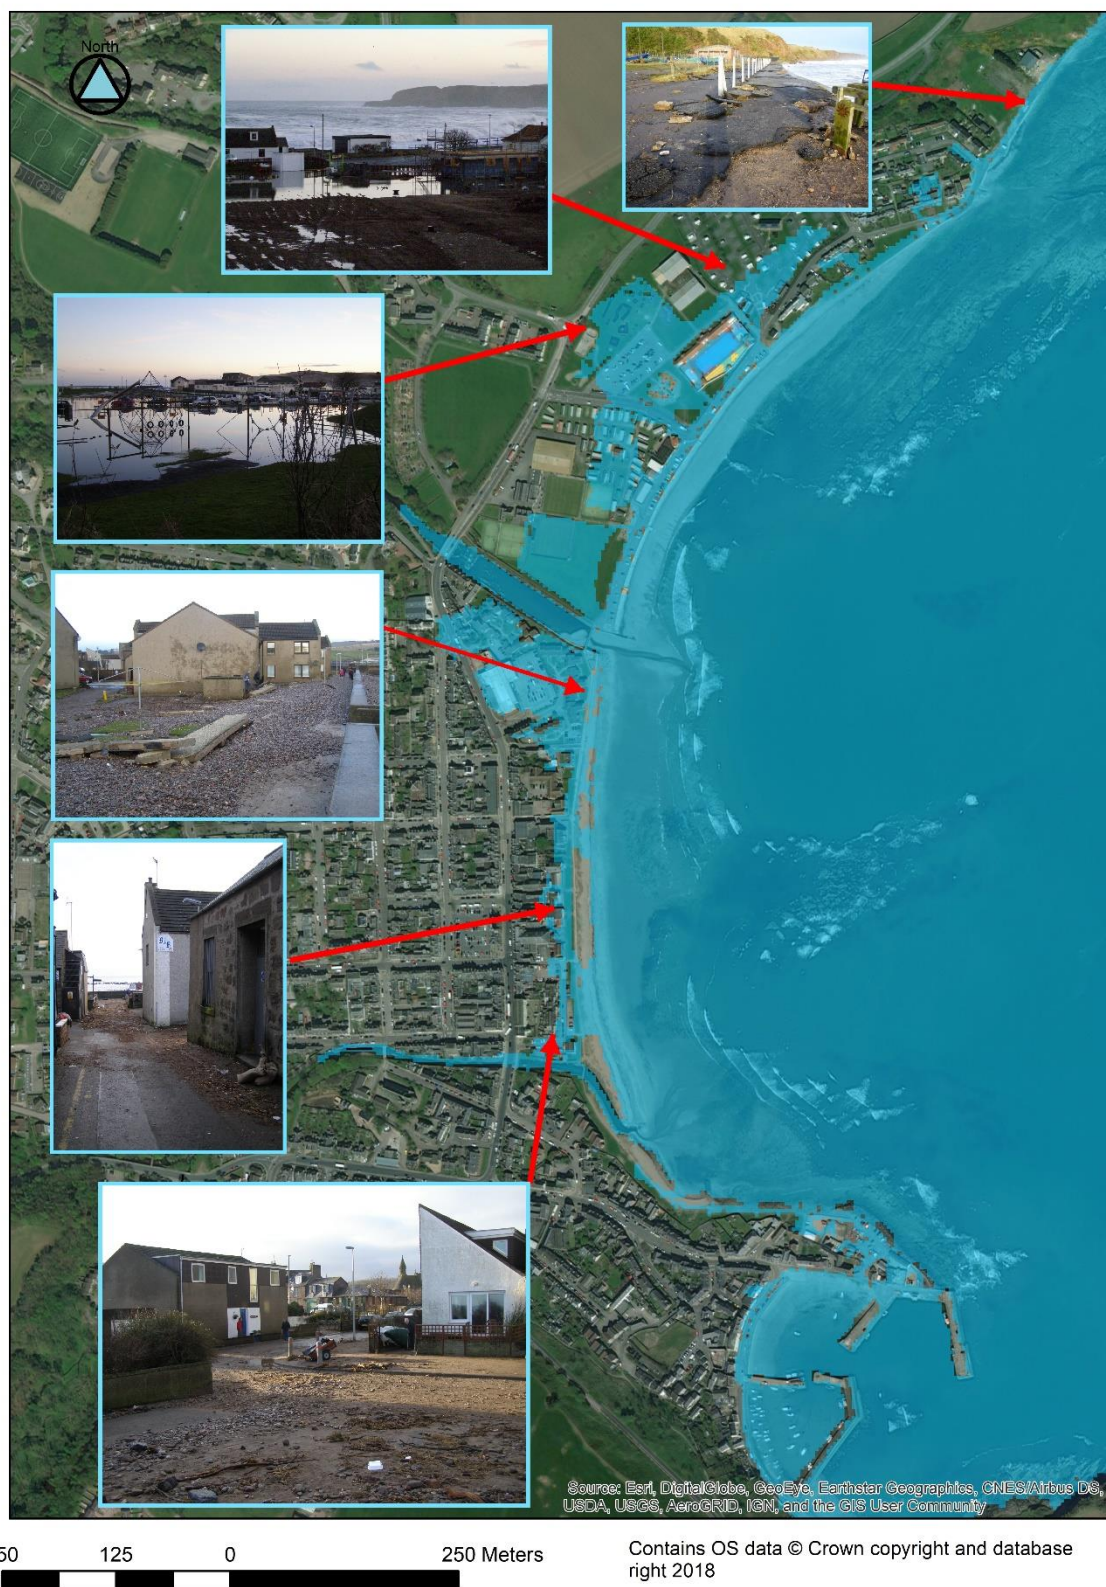
Figure 2-18: Modelled flood extent for 15th December 2012 event, along with photo evidence from Aberdeenshire Council

The flood extent for this event can be seen in Figure 2-18 are shown to match well to observed inundation. This is particularly true in the sheltered housing (south of the Cowie) and the area surrounding the leisure centre. At Boatie Row, no photos of inundation are available although overtopping was reported along the Cowie frontage. Given the extent of previous flooding in the area, the modelled extent is appropriate for an event of this magnitude.

Observations also indicate a flow of inundated defences from south to north. This is corroborated by modelling which shows a watershed between Ironfield Lane and Cowie Lane from where water flows north toward Turners Court and ponds in the area to the south, surrounding Beachgate Lane.

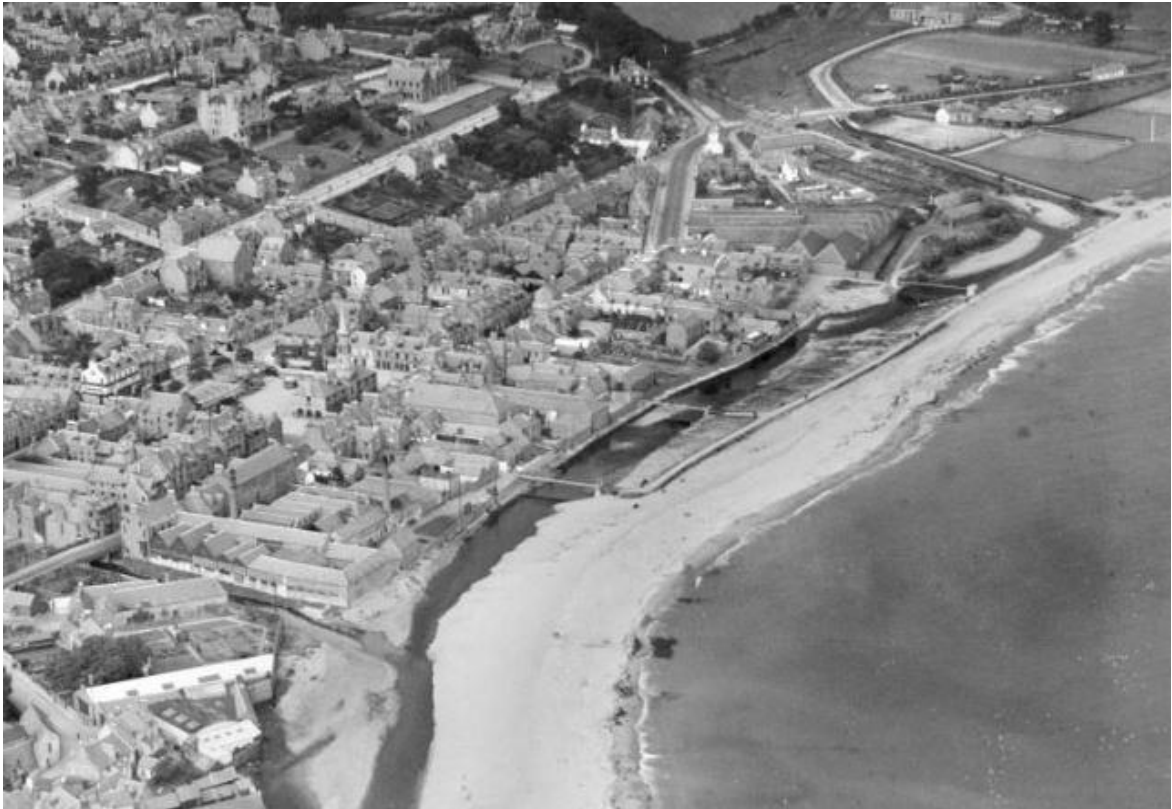
Figure 2-23: Image showing historical path of the Cowie Water, River Carron and the shingle bar

The photograph presented in Figure 2-23 was taken in 1932 and shows the historical flow path of the Cowie Water behind the shingle bar⁷, whereas Figure 2-24, which was taken in 1948, shows that the two rivers have separate outfalls onto the beach⁸.

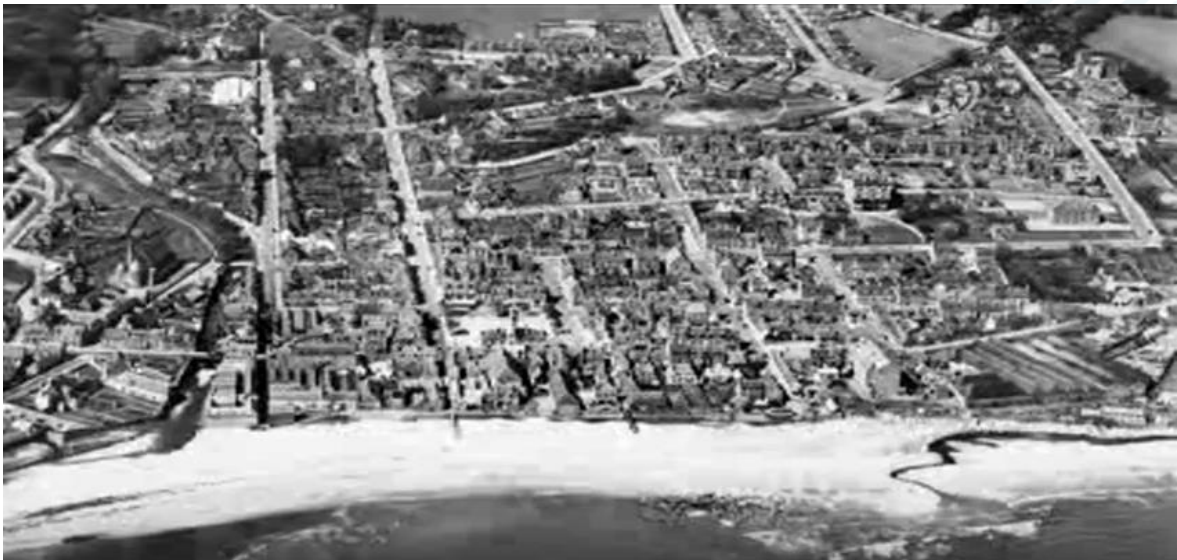
Figure 2-24: Image showing the river mouths in 1948 following the Cowie breaking through the shingle bank

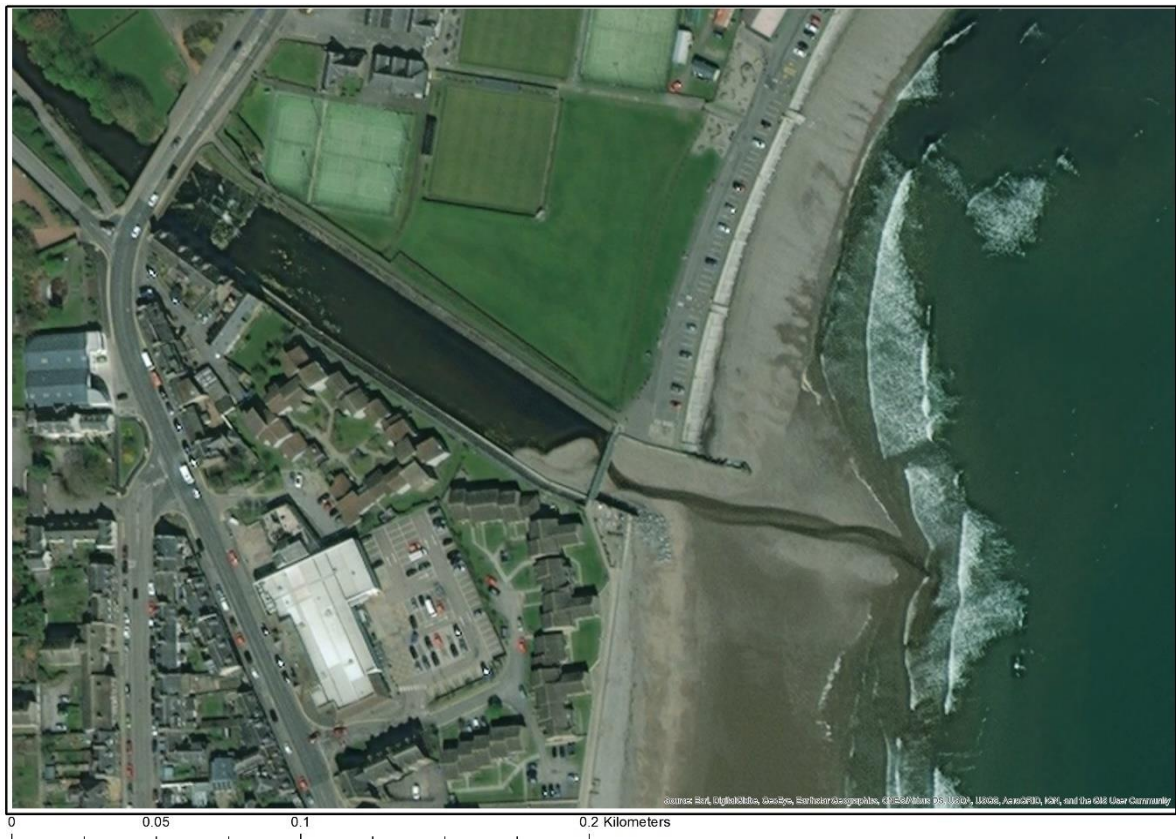
Figure 2-25: Aerial image showing the present day mouth of the Cowie Water

footbridge the channel sides are formed by sheet piles topped with a sloped concrete revetment (Figure 2-26). The current configuration can be seen within the aerial image presented in Figure 2-25; however, it should be noted that the path of the river at the mouth and across the beach does vary.

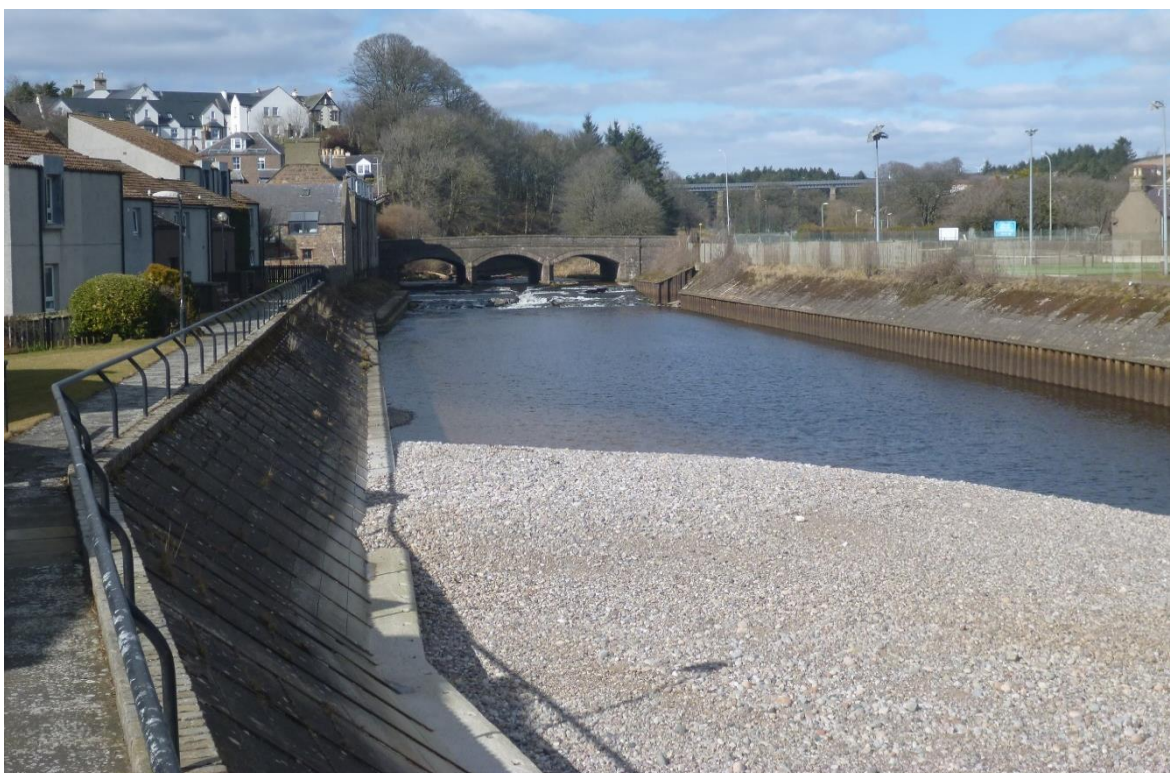
Figure 2-26: Looking upstream from the mouth of the Cowie Water to the weir and B979 road bridge

During storm conditions, it is understood that waves propagate into the mouth of the river. Video footage, provided by Aberdeenshire Council and dated 16 March 2018, shows waves breaking on the shingle bank, resulting in splash over the right hand bank of the river, with smaller waves then running along the right bank revetment and breaking on the weir beneath the B979 road bridge.

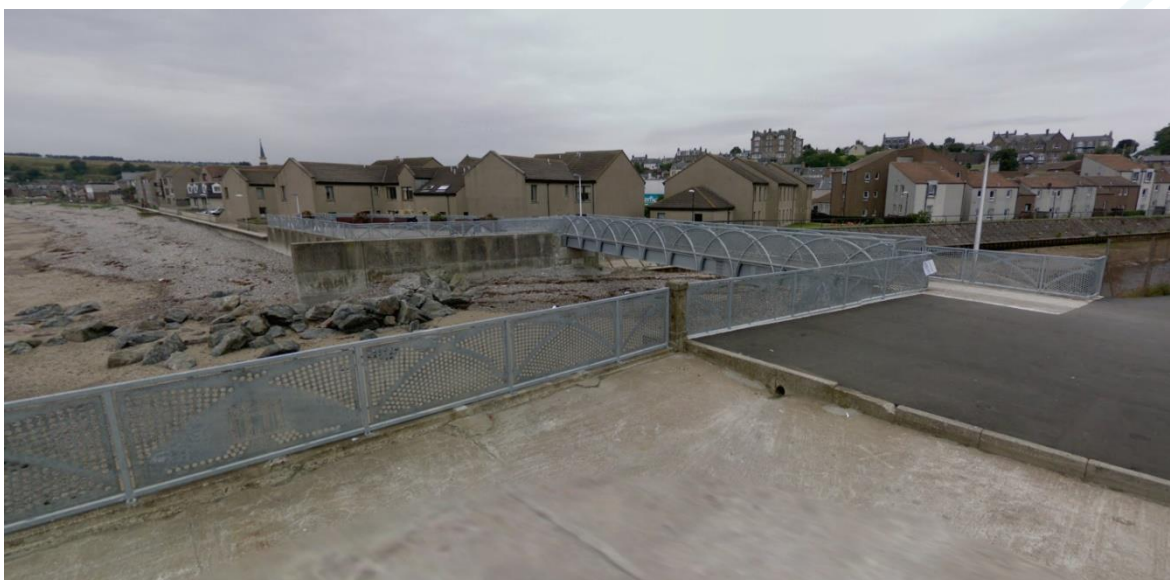
Figure 2-27: Right bank and footbridge at the mouth of the Cowie Water

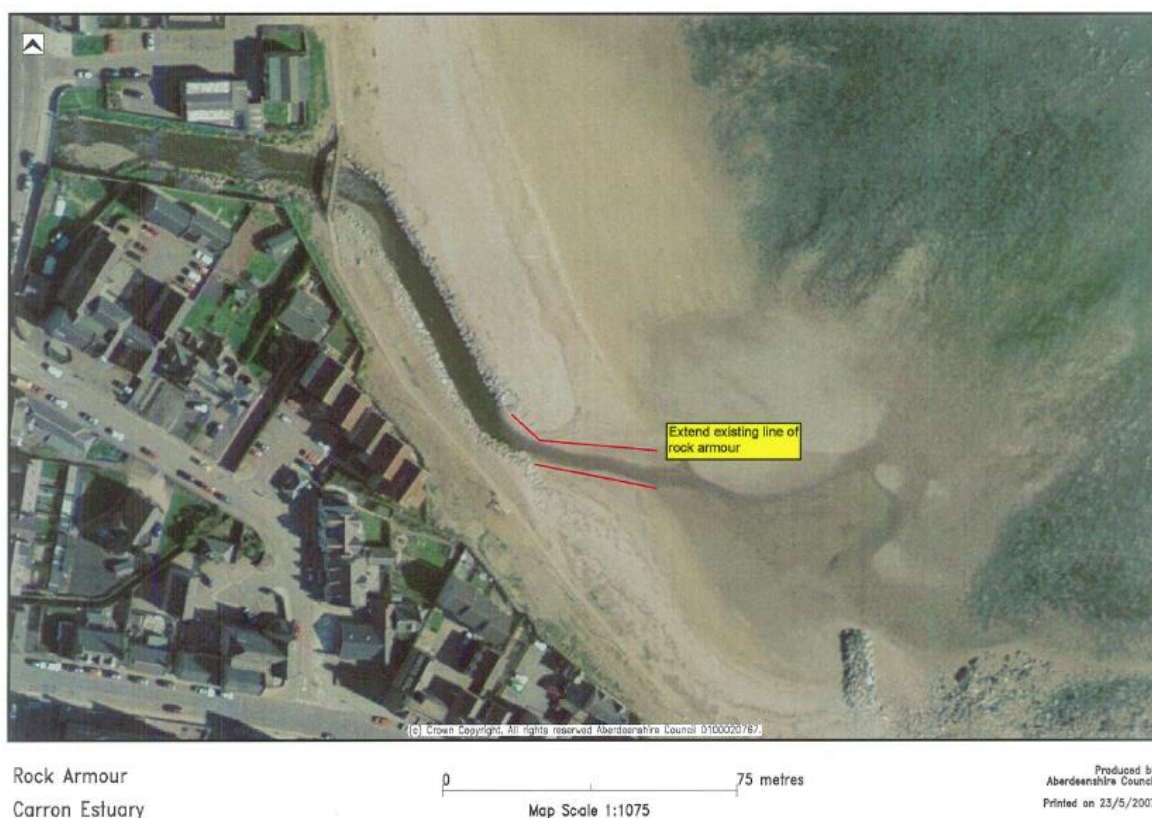
Figure 2-36: Proposed extension to the training structures, 2007

The configuration of the rock armour training structure that was built at the mouth of the Carron differs from that shown above. Details of the final design and the date of construction have been requested from Aberdeenshire Council, however the information available is limited. It is understood that initial training structures were built between 1998 and 2006, with these were then extended in 2008 (Figure 2-36).

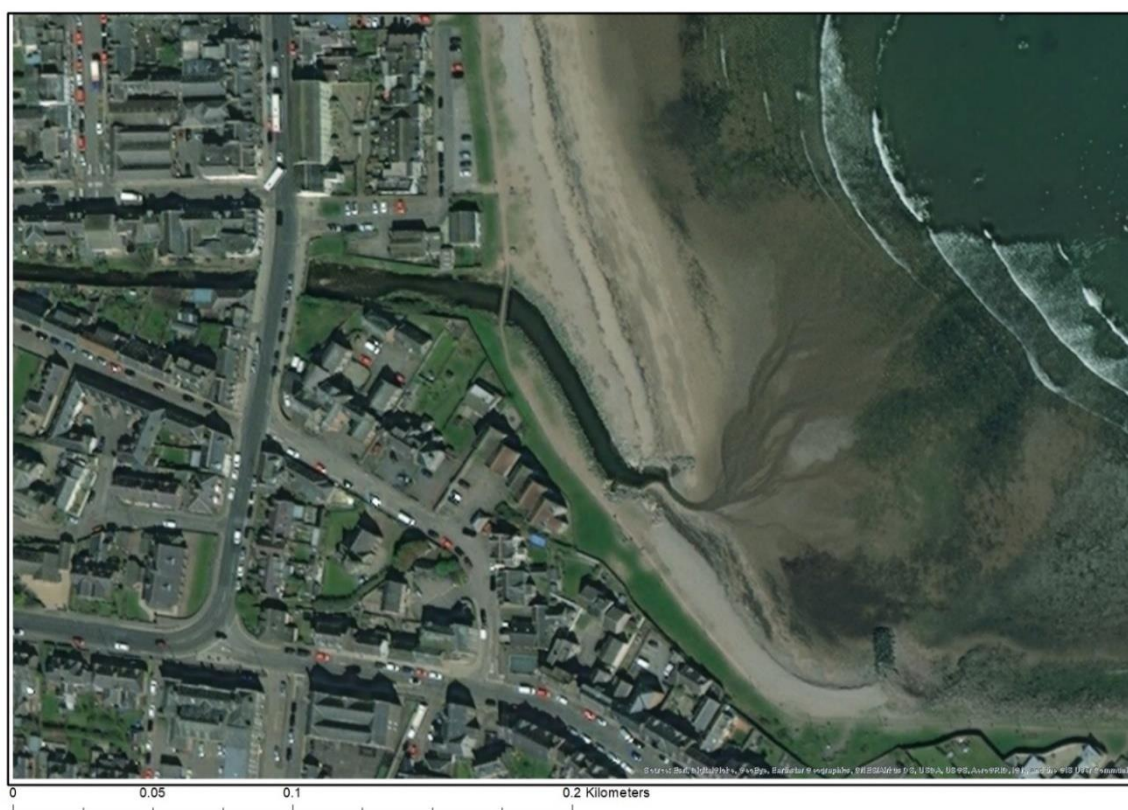
Figure 2-37: Current configuration at the mouth of the River Carron

The present day configuration at the mouth of the Carron can be seen in Figure 2-37.

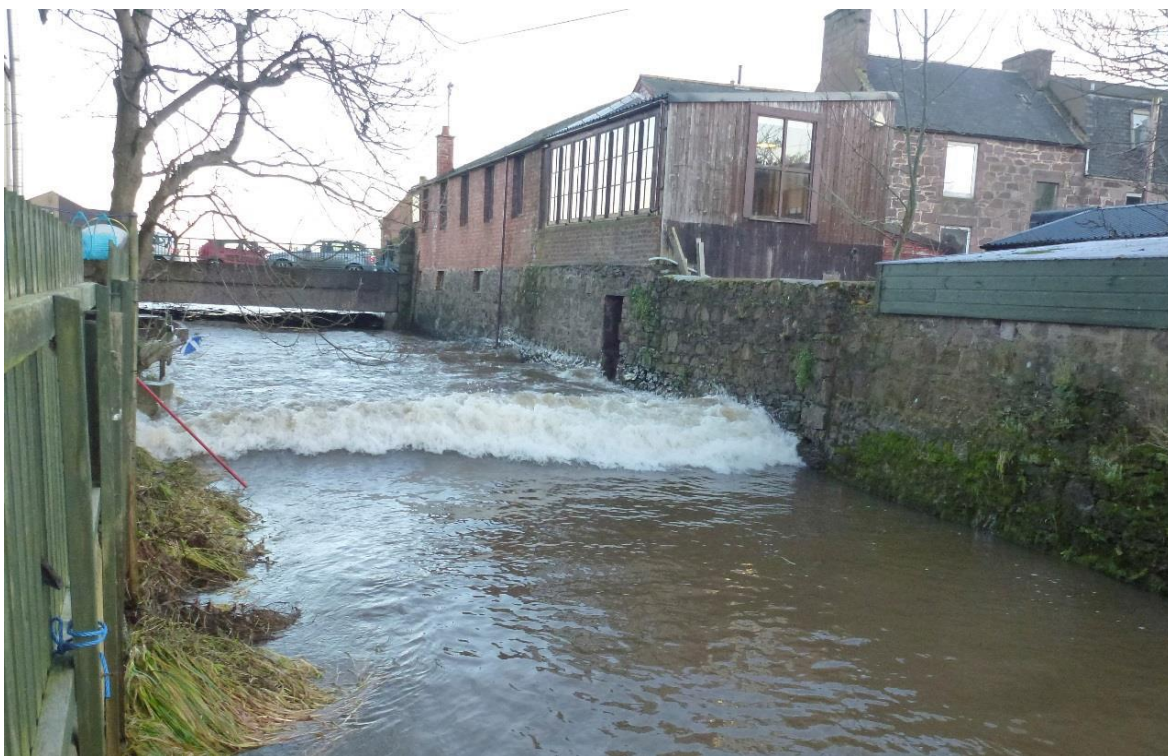
Figure 2-41: Wave propagation up the River Carron on 15 December 2012¹³

In 2014 JBA were commissioned by Aberdeenshire Council to undertake a study to investigate wave propagation up the River Carron, as has been observed historically, e.g. as shown in Figure 2-41. The study combined information gathered from historical events with numerical modelling to assess potential wave heights within the downstream reach of the Carron and discuss the potential implications of this on the design of the fluvial scheme.

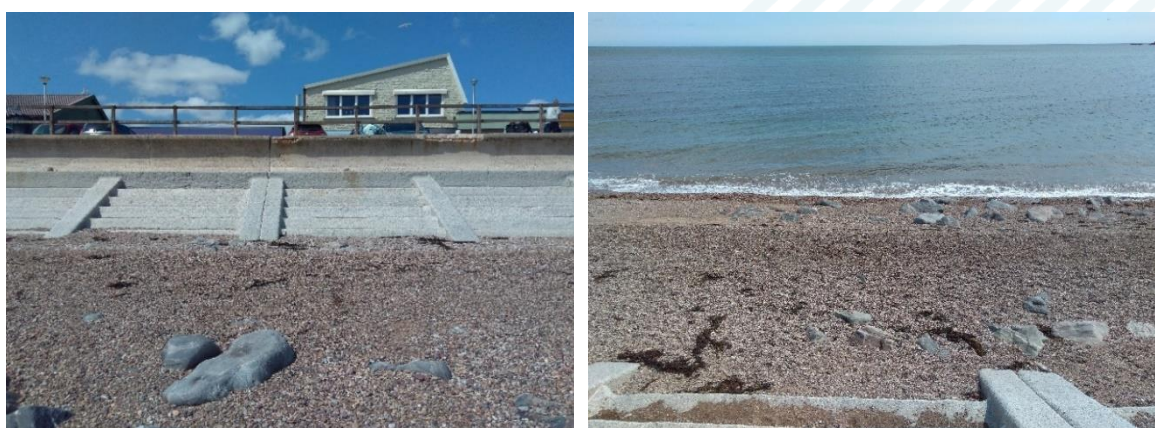
Figure 3-6: Section B/XS12: Stepped revetment and shingle beach

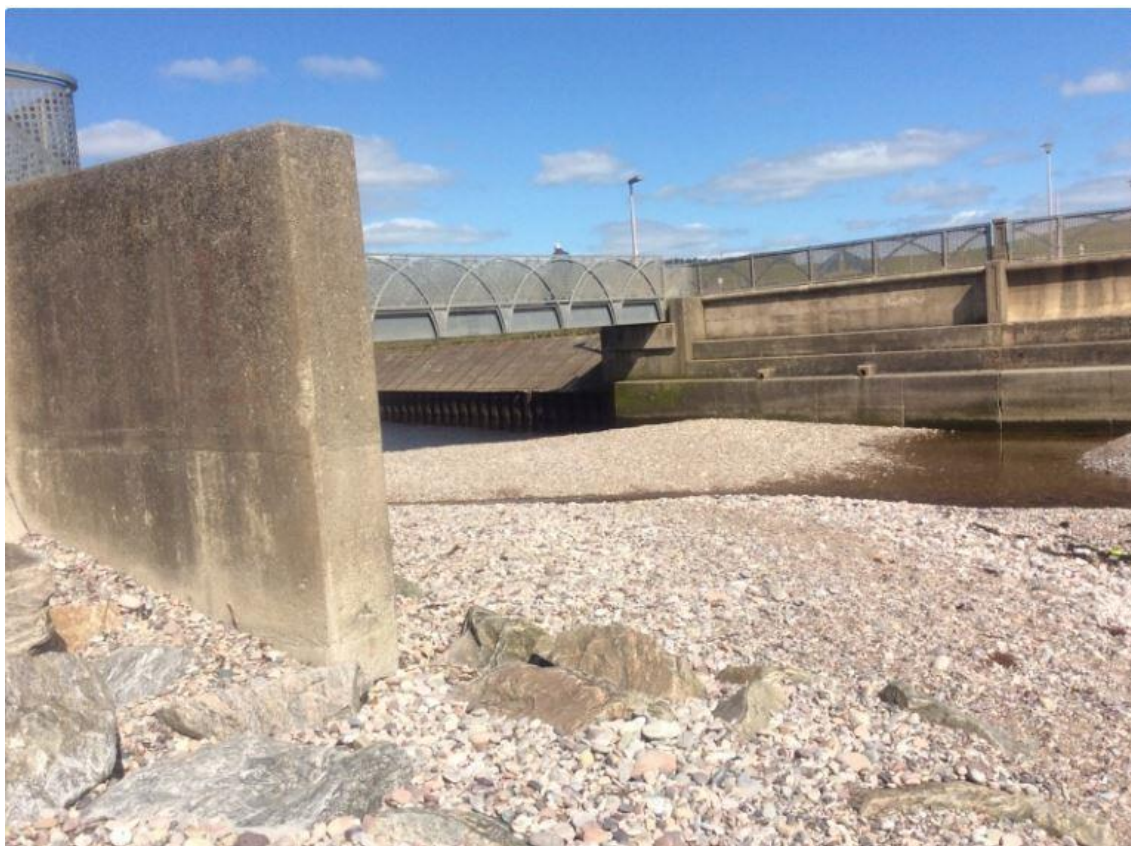
Figure 3-7: Cowie Water estuary from the south with sediment accumulation

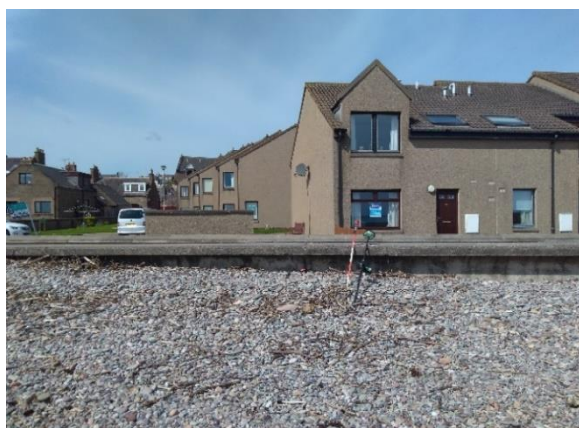
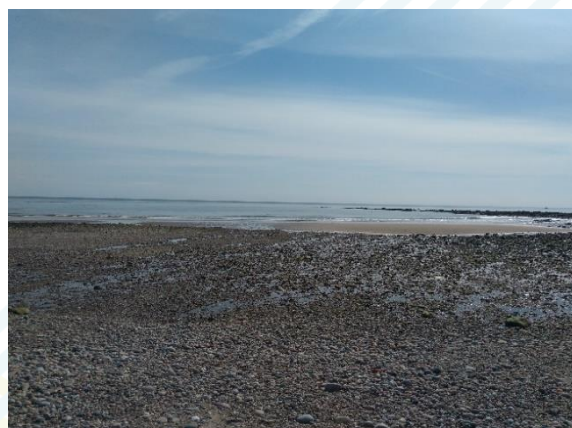
Figure 3-8: Section C/XS17: Seawall with sediment build up and shingle beach

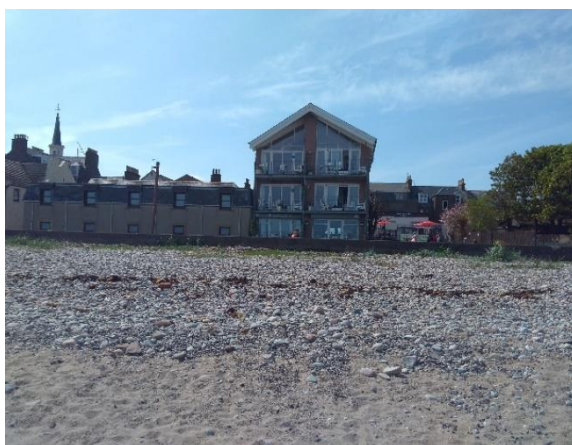
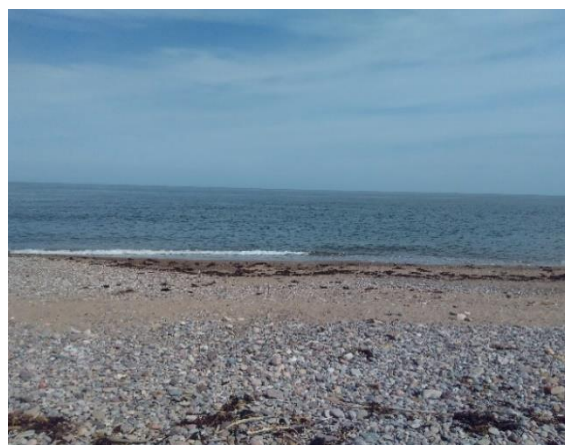
Figure 3-9: Section D/XS20: Seawall with sediment build up. Shingle and coarse sand beach.

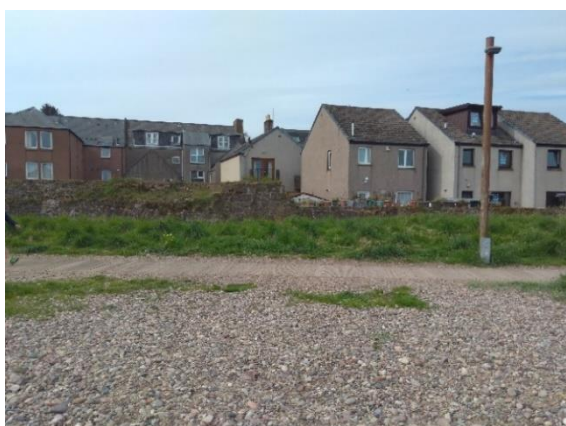
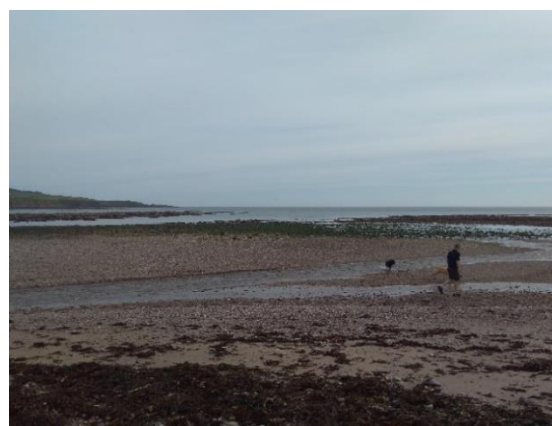
Figure 3-10: Section E/XS26: Boardwalk at the top of the beach; River Carron discharging into the sea across the beach

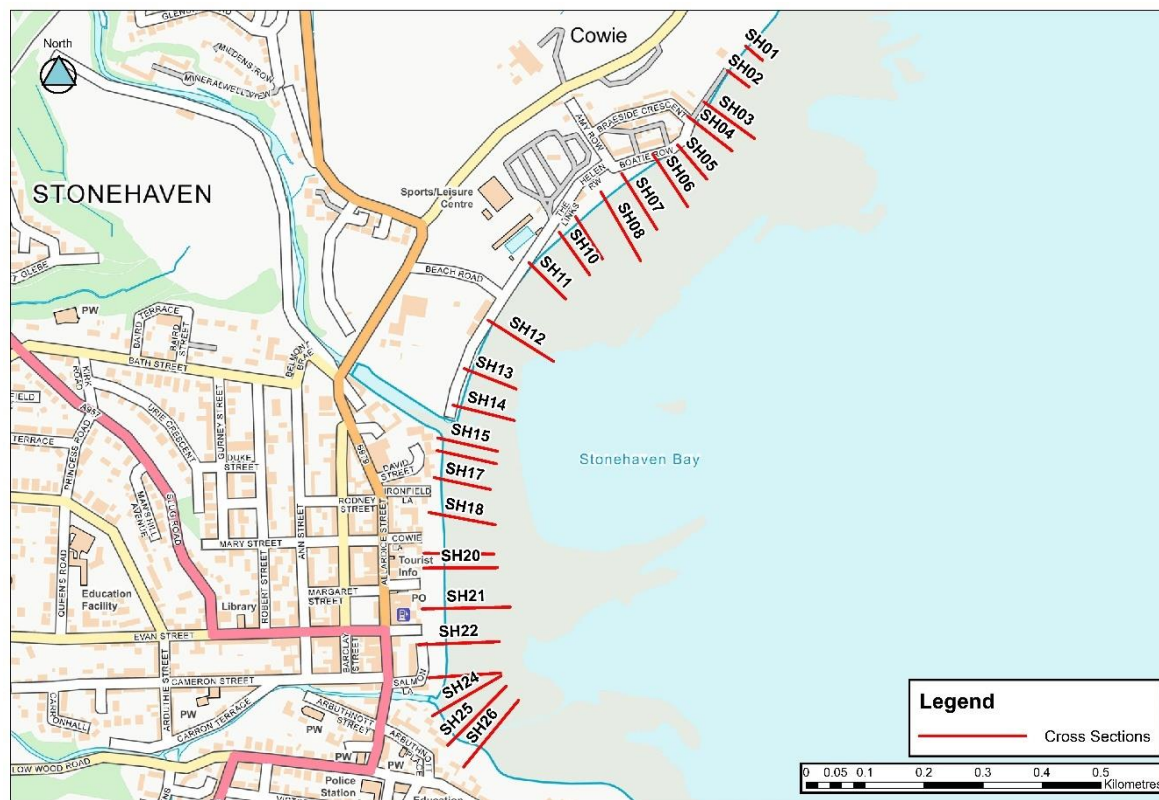
Figure 3-15: Cross sections at Stonehaven Bay

As part of the earlier surveys, cross-sectional profiles were taken at 26 locations along the beach (Figure 3-15).

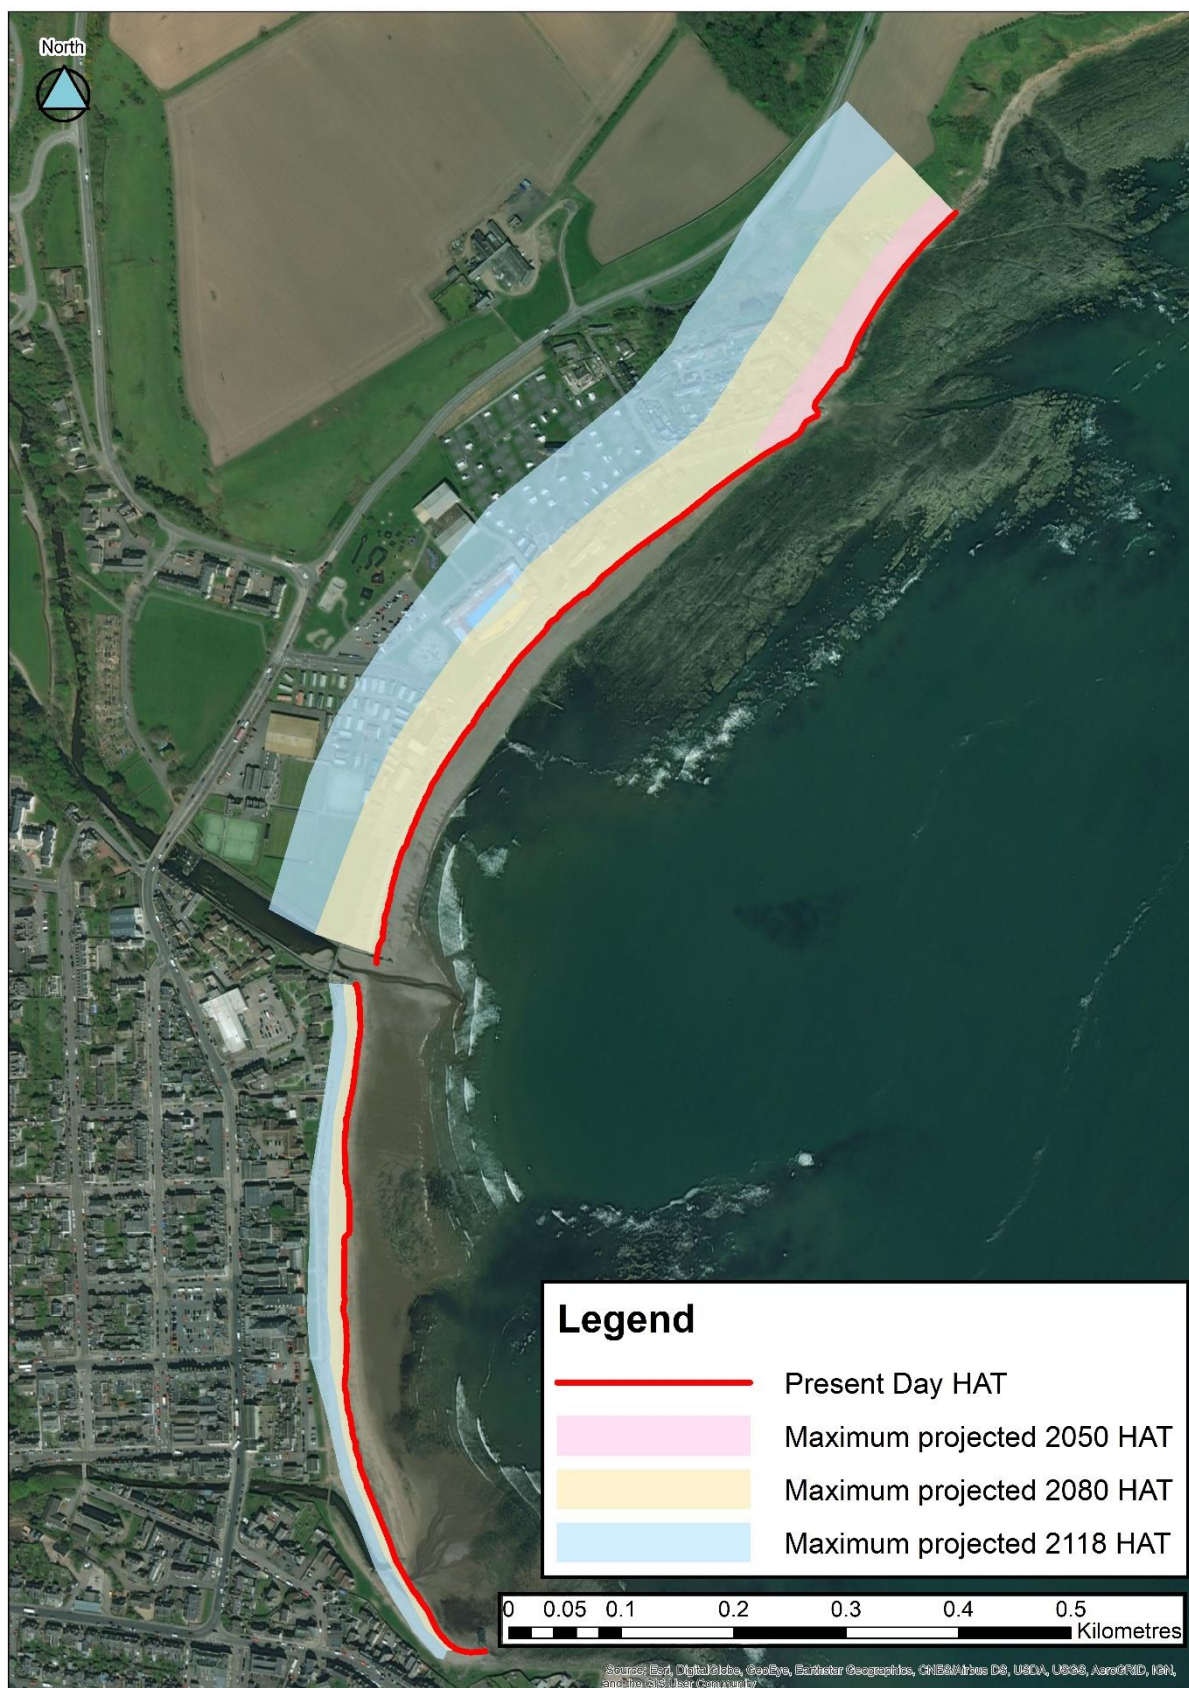
Figure 3-38: Projected HAT retreat by 2050, 2080 and 2118.

In the northern section of Stonehaven Bay (Cowie), sediments are predicted to significantly erode, and therefore a retreat of the HAT line will be seen. The HAT average retreat near the Cowie Water has been identified as c. 50 metres by 2080, and c. 110 metres by 2118. The shaded area highlights the maximum area at risk of erosion between 2018, 2080 and 2118 (Figure 3-38), if all defences were to fail at the end of their given lifespan. Assuming a similar erosion pattern at XS01-04 as at XS08, and given the failure of the defences 15 years earlier, by 2080 a retreat of c. 75 metres is seen and by 2118, a retreat of c. 138 metres at the north of the bay is predicted. The assets within this erosional zone are therefore potentially at risk.

This modelling and analysis approach have an extremely high degree of uncertainty and assumes that the backshore consist of fill material similar to the beach. In reality, the: slow failure of the defences, man-made surfaces, buildings and other materials will significantly influence the erosion rates.
