Stonehaven Bay Coastal Flood Protection Study

Final Report

December 2019

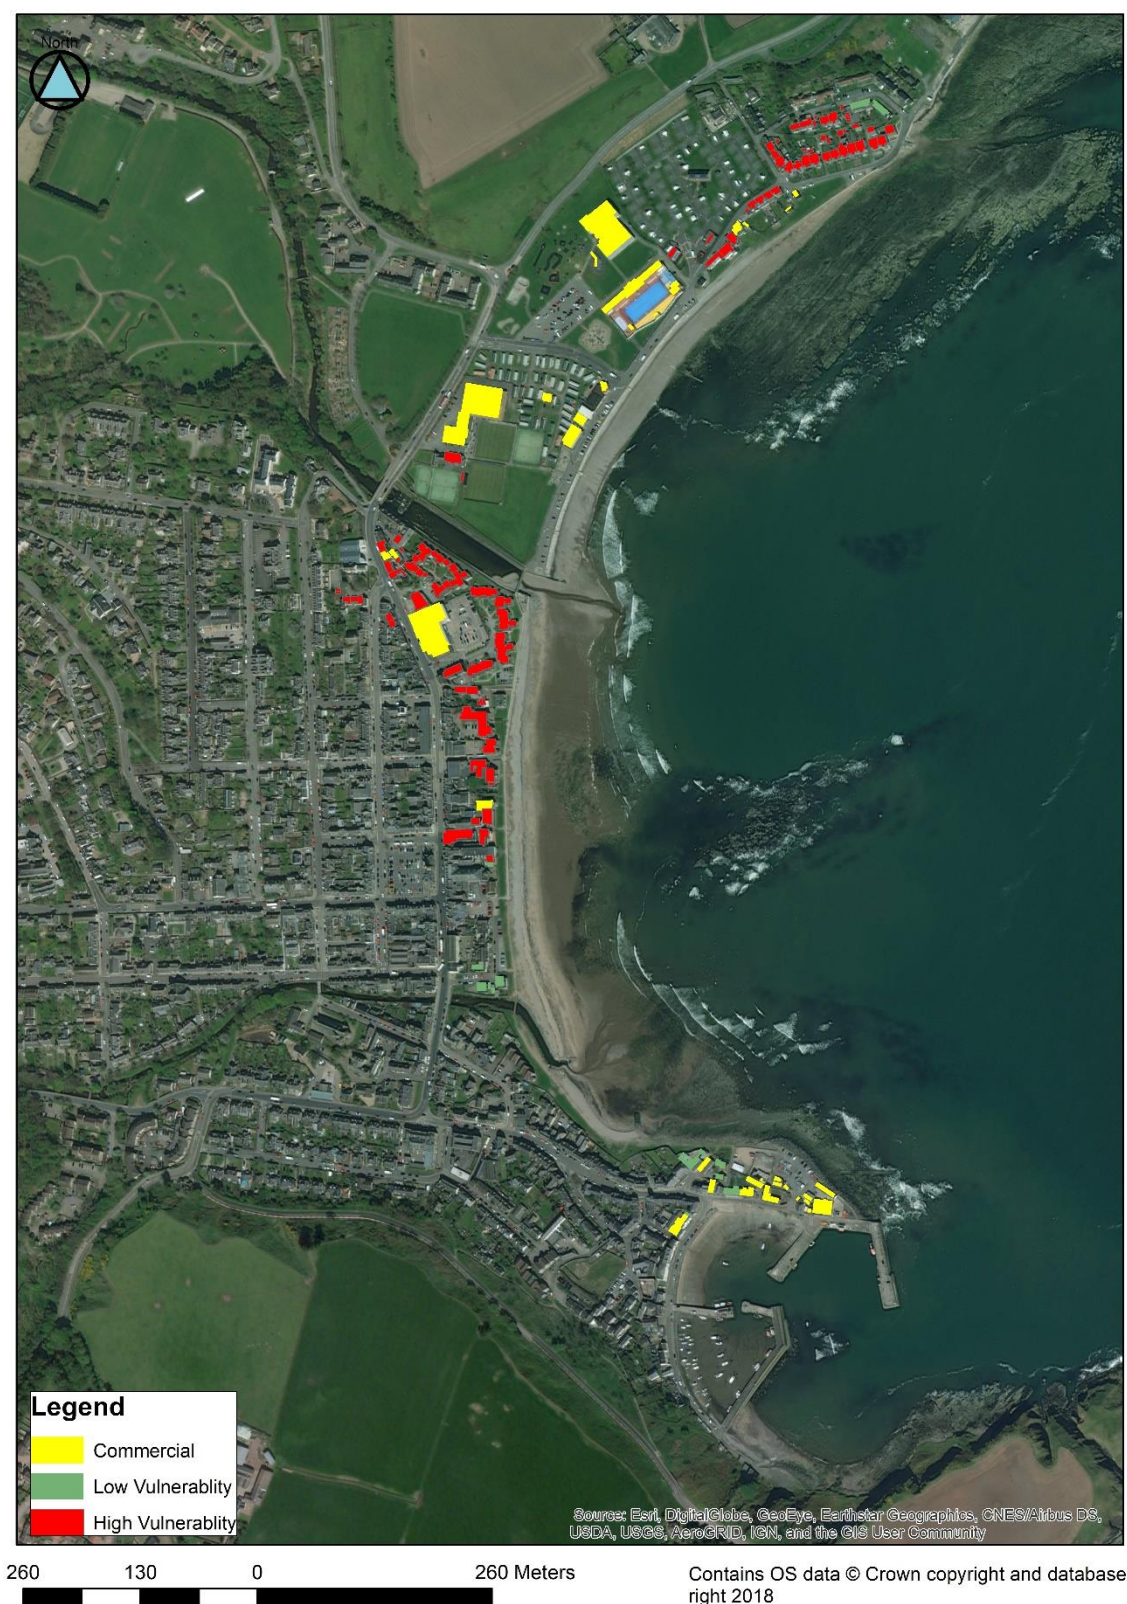
Figure 4-2: Property vulnerability index for properties in Stonehaven

available in the SEPA's strategic receptor dataset. This combines over 75 and vulnerable people scores, with higher scores indicating higher levels of vulnerability. The average vulnerability index for residential properties within 20m of the present day 1,000-year coastal inundation extent was found to be 38.8, significantly greater than the average score within Stonehaven (14.63). The classification of vulnerable properties at risk of flooding from the present-day 1000-year event in Figure 4-2.

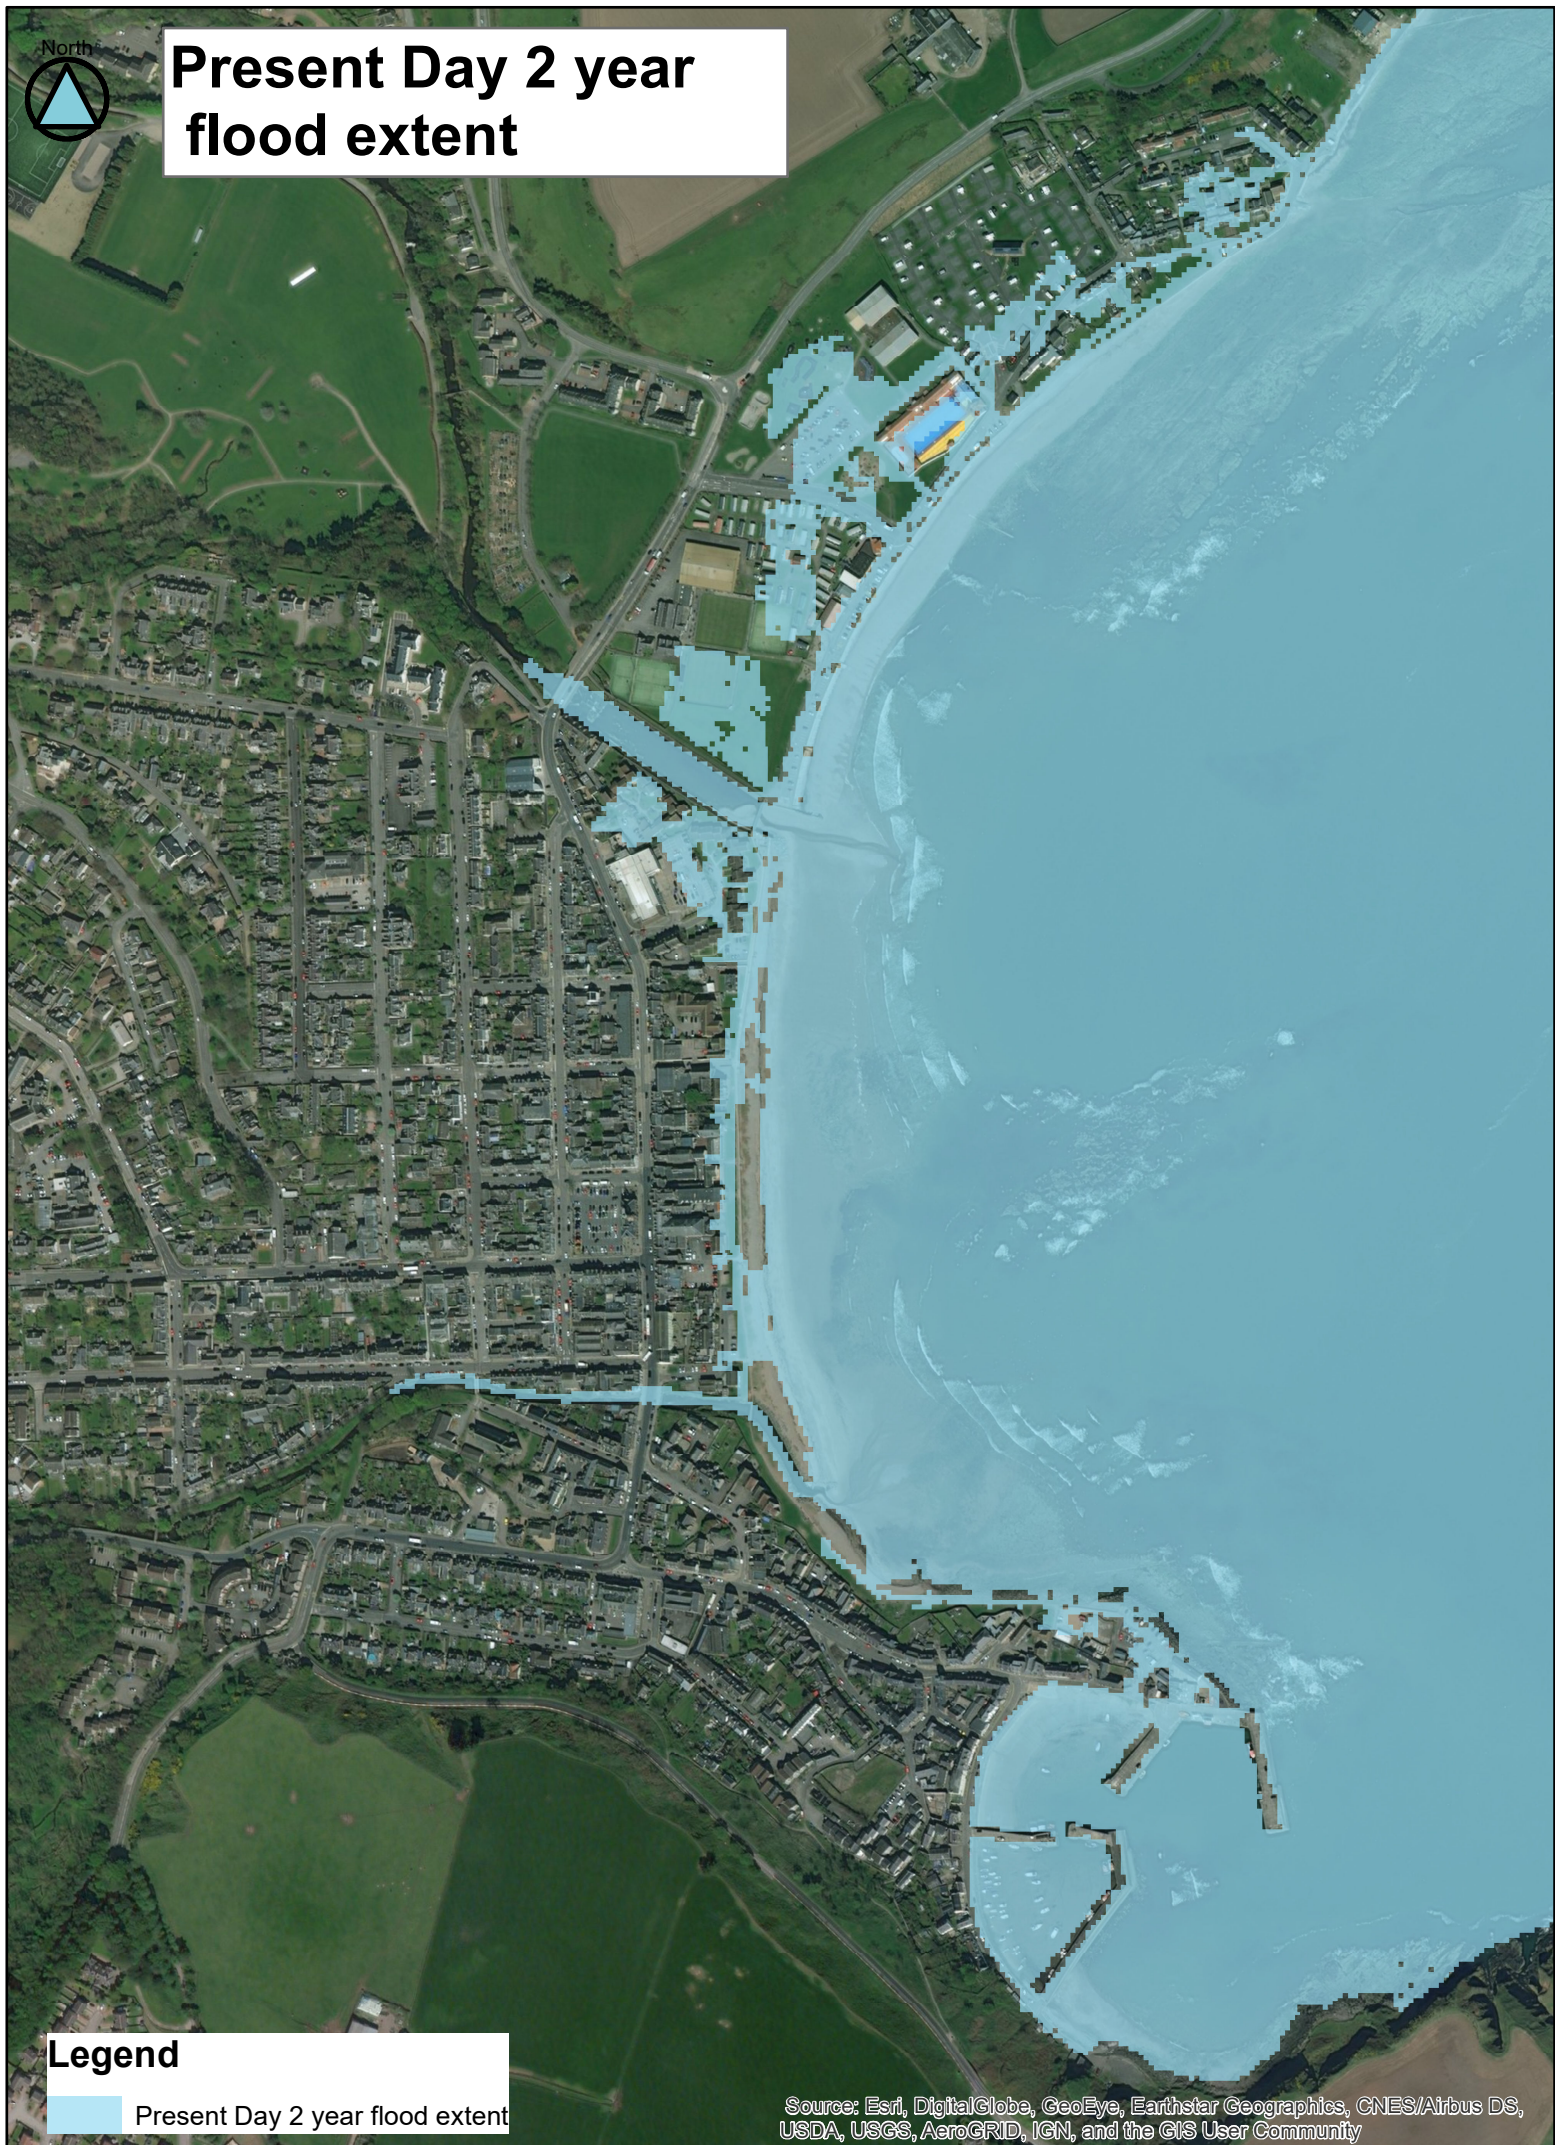
Present Day 2 year flood extent

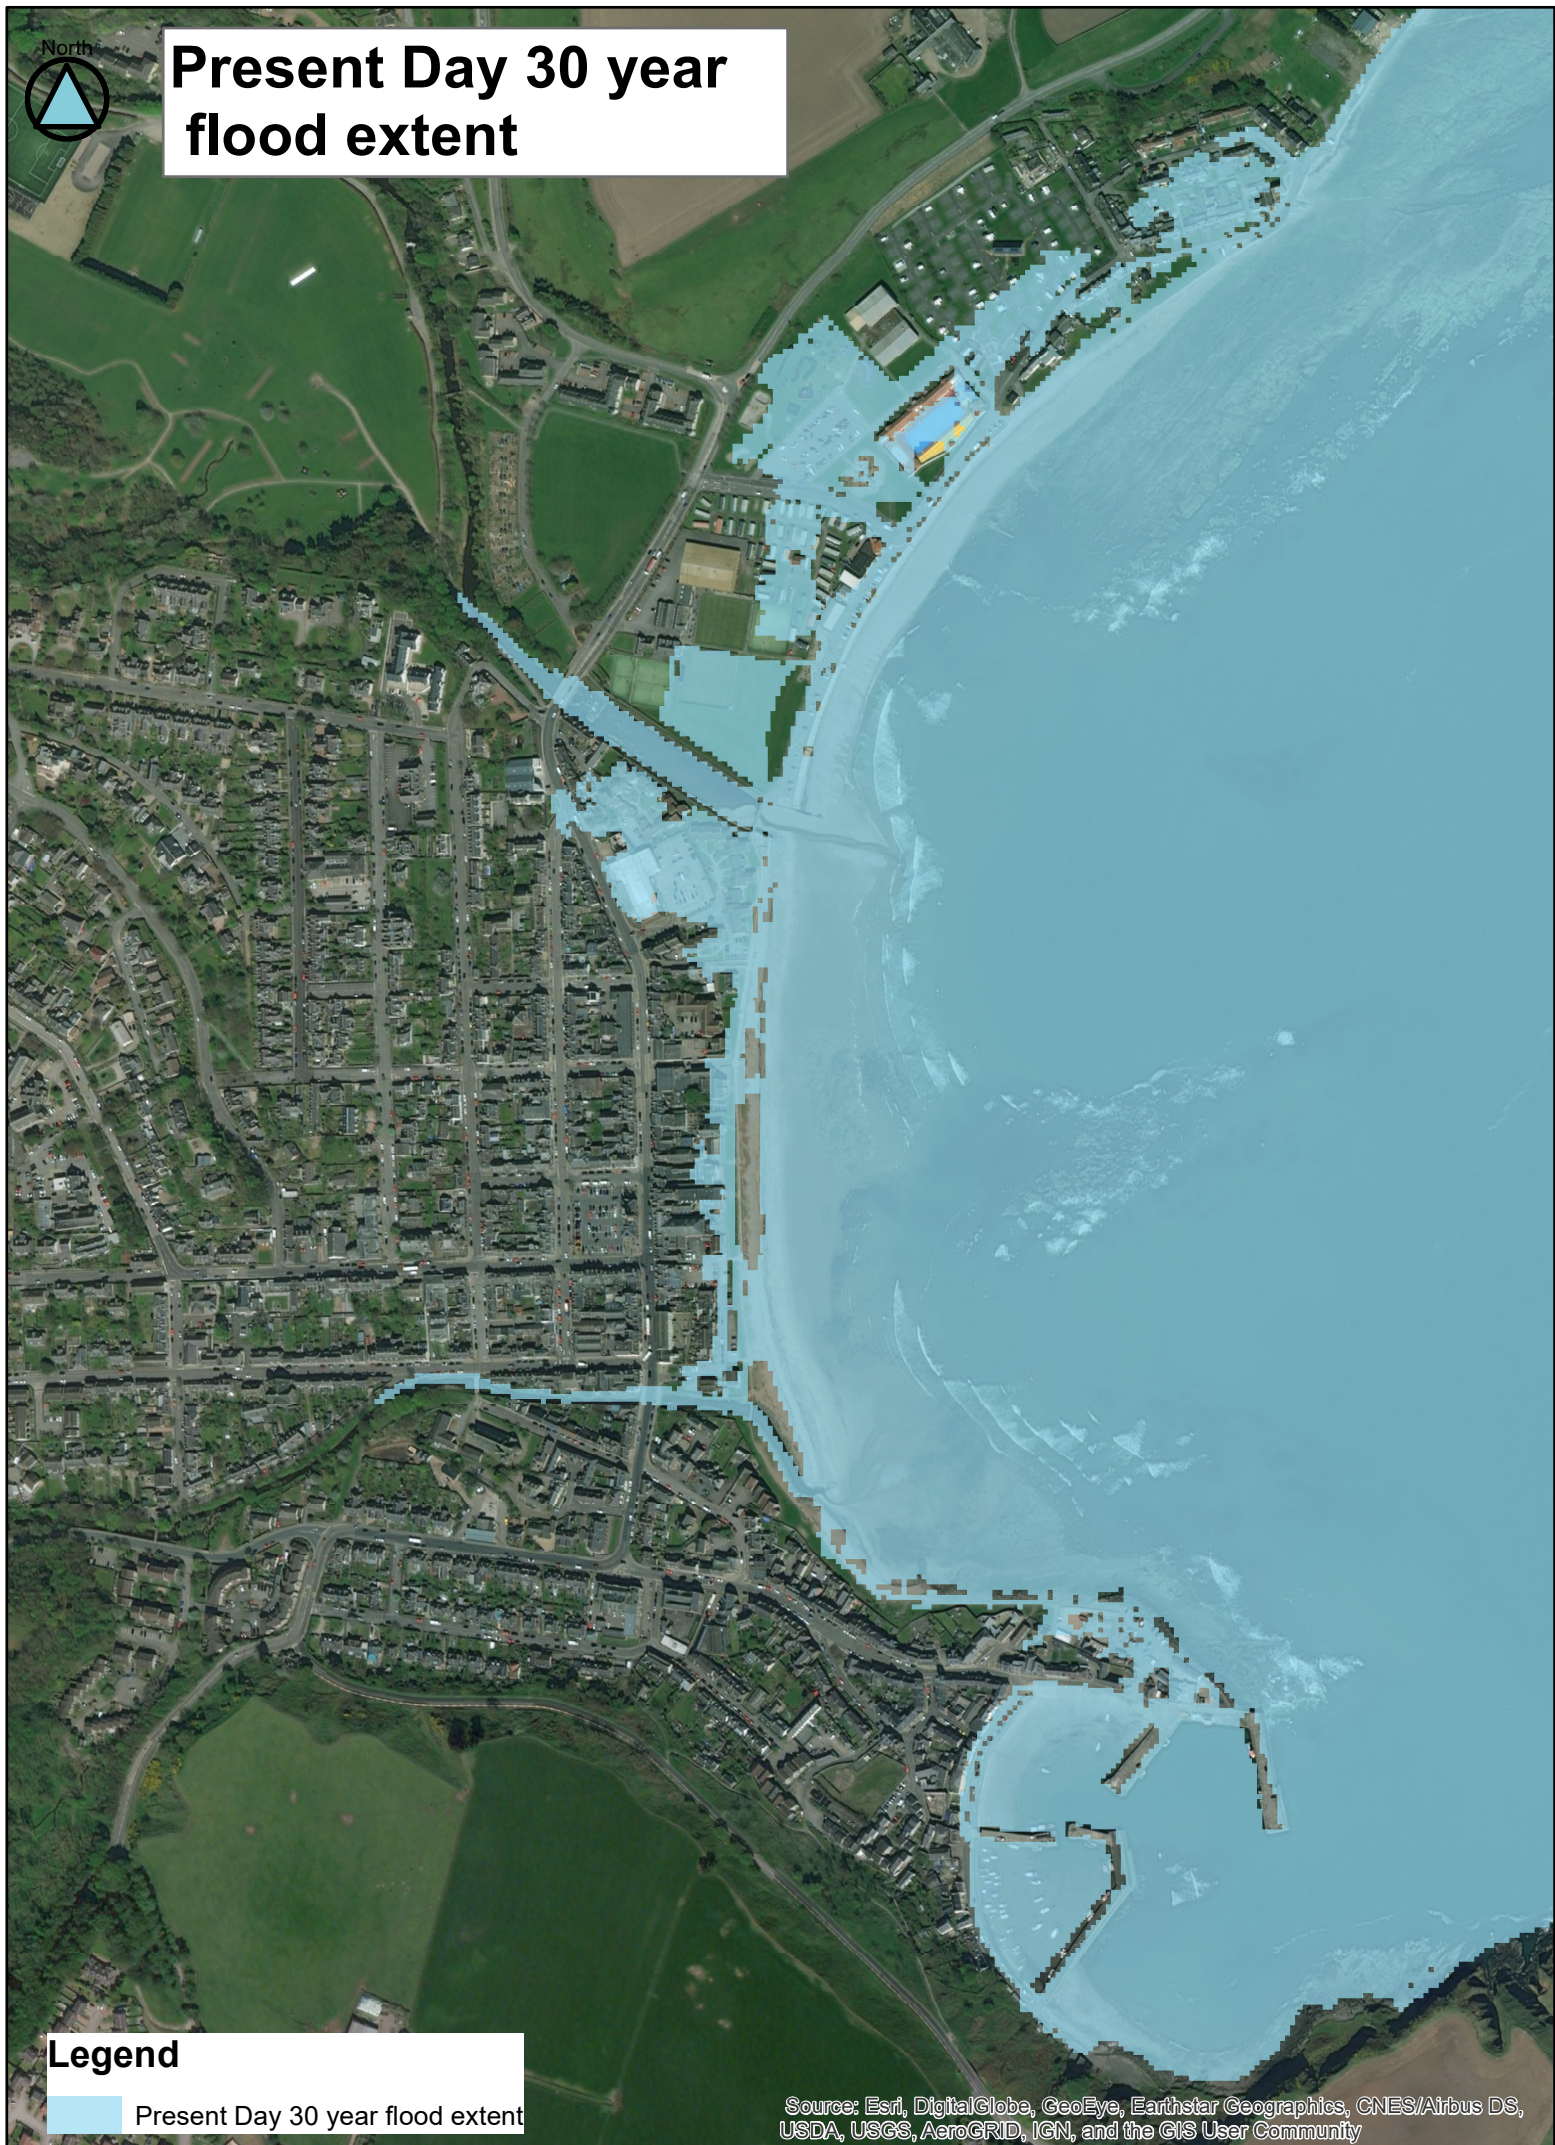
Present Day 30 year flood extent

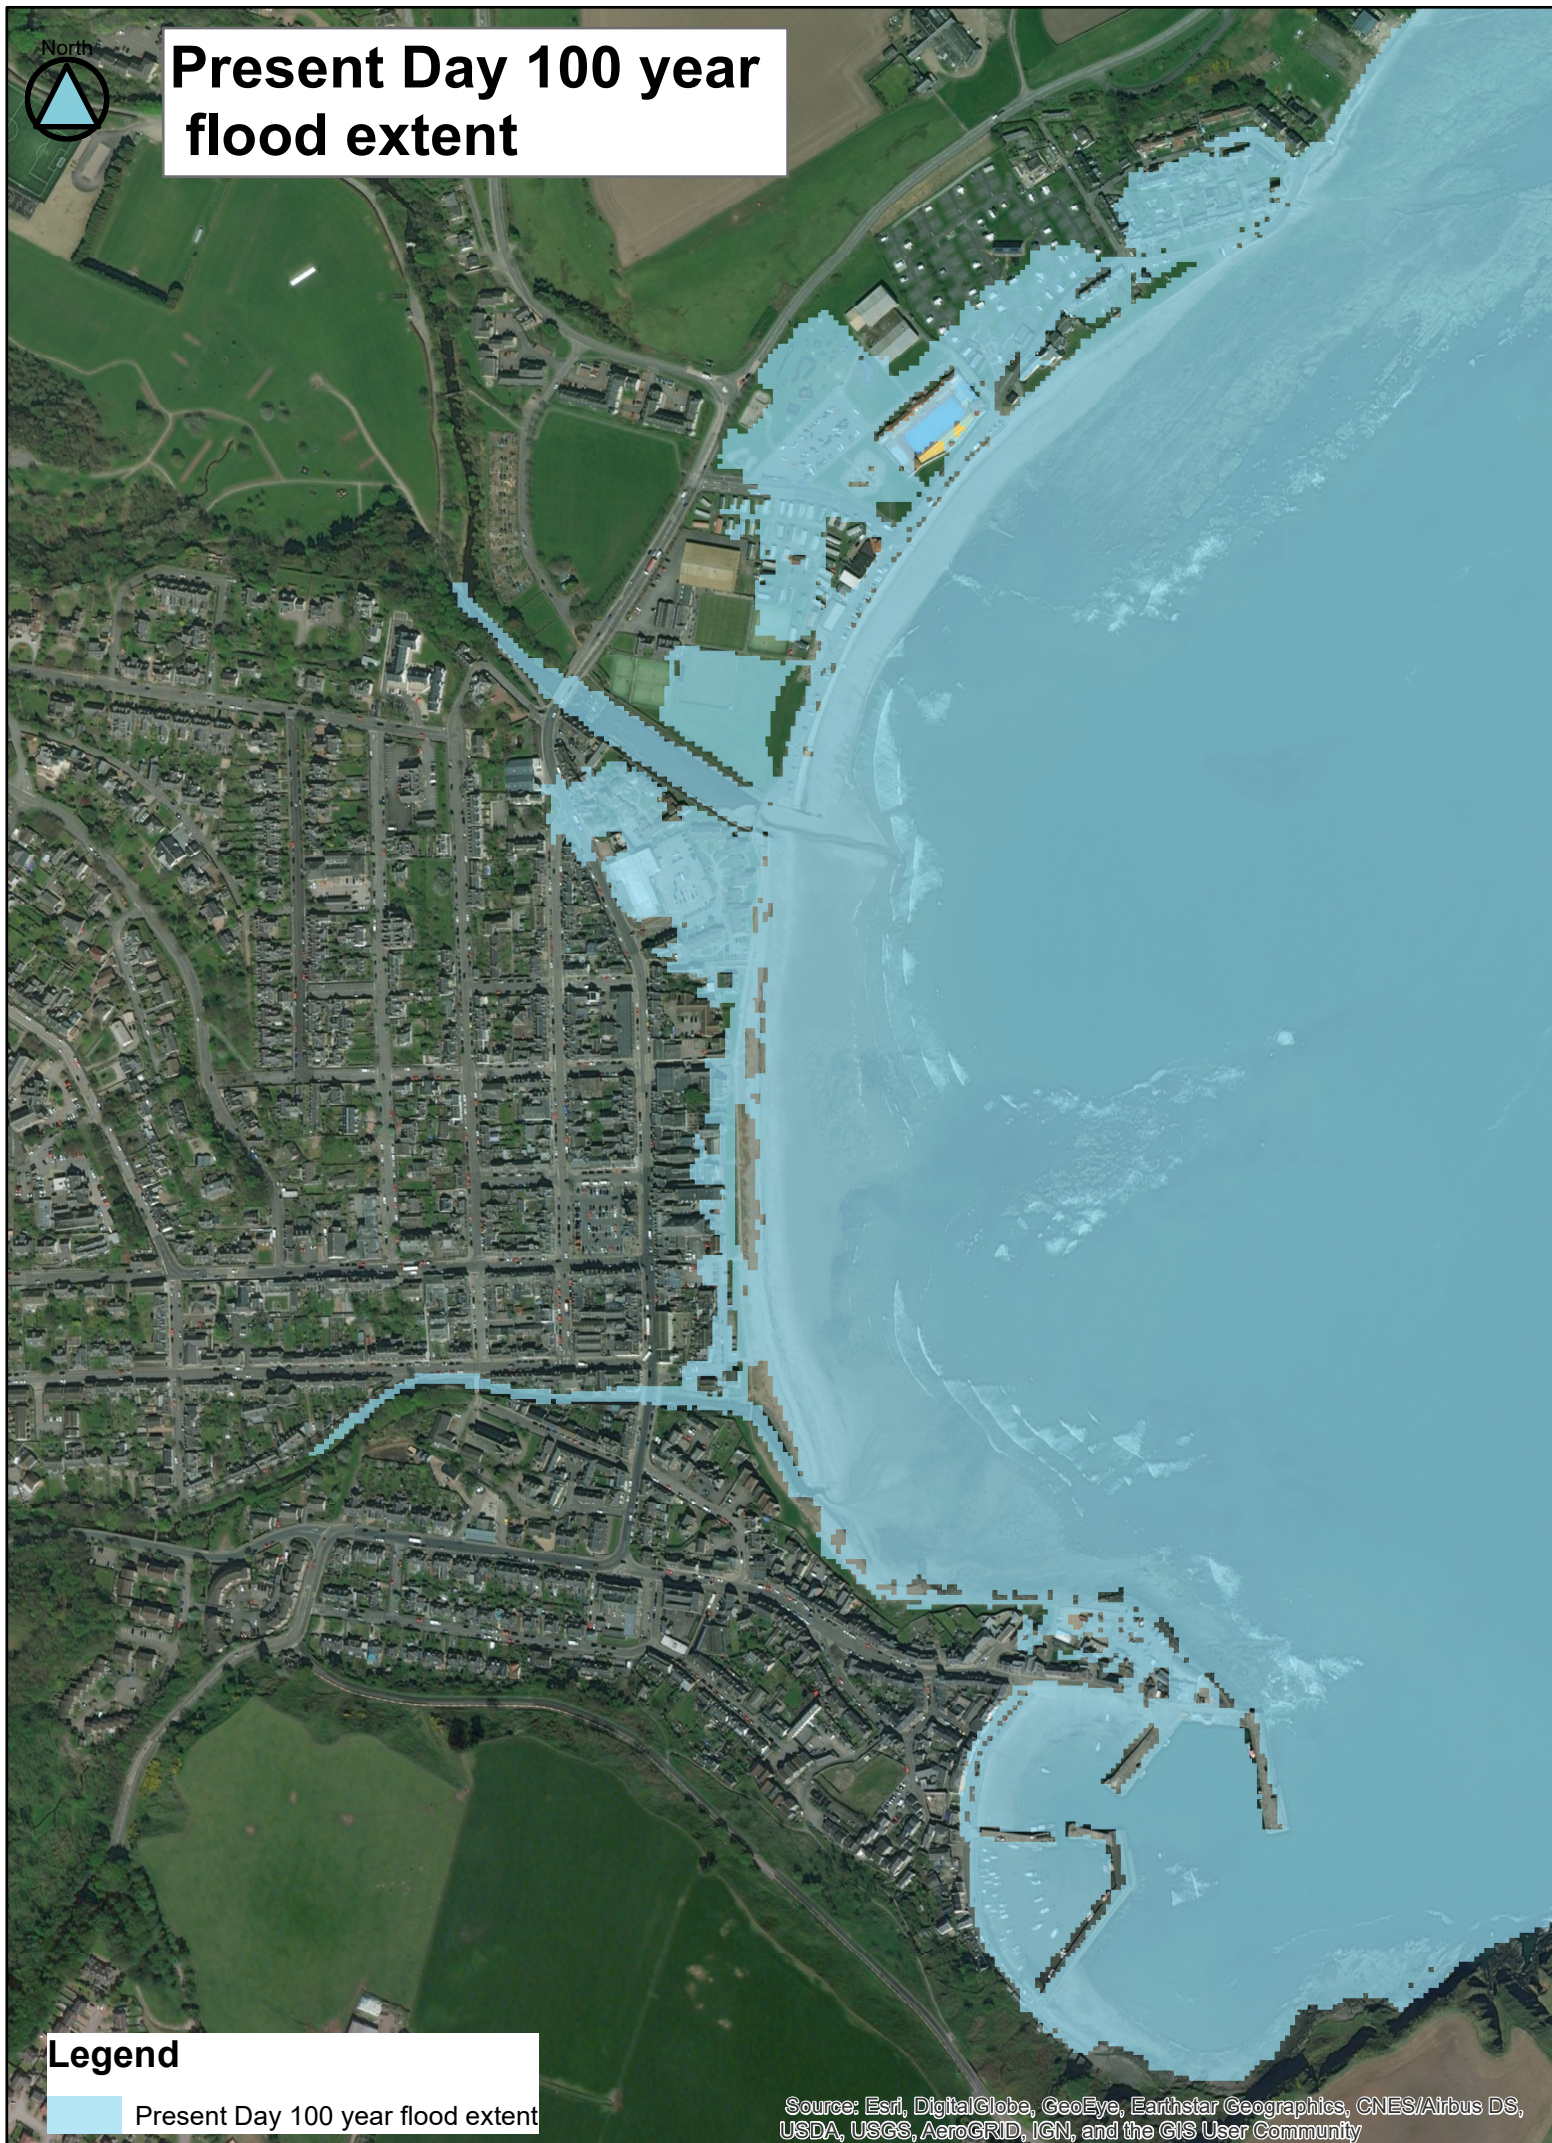
Present Day 100 year flood extent

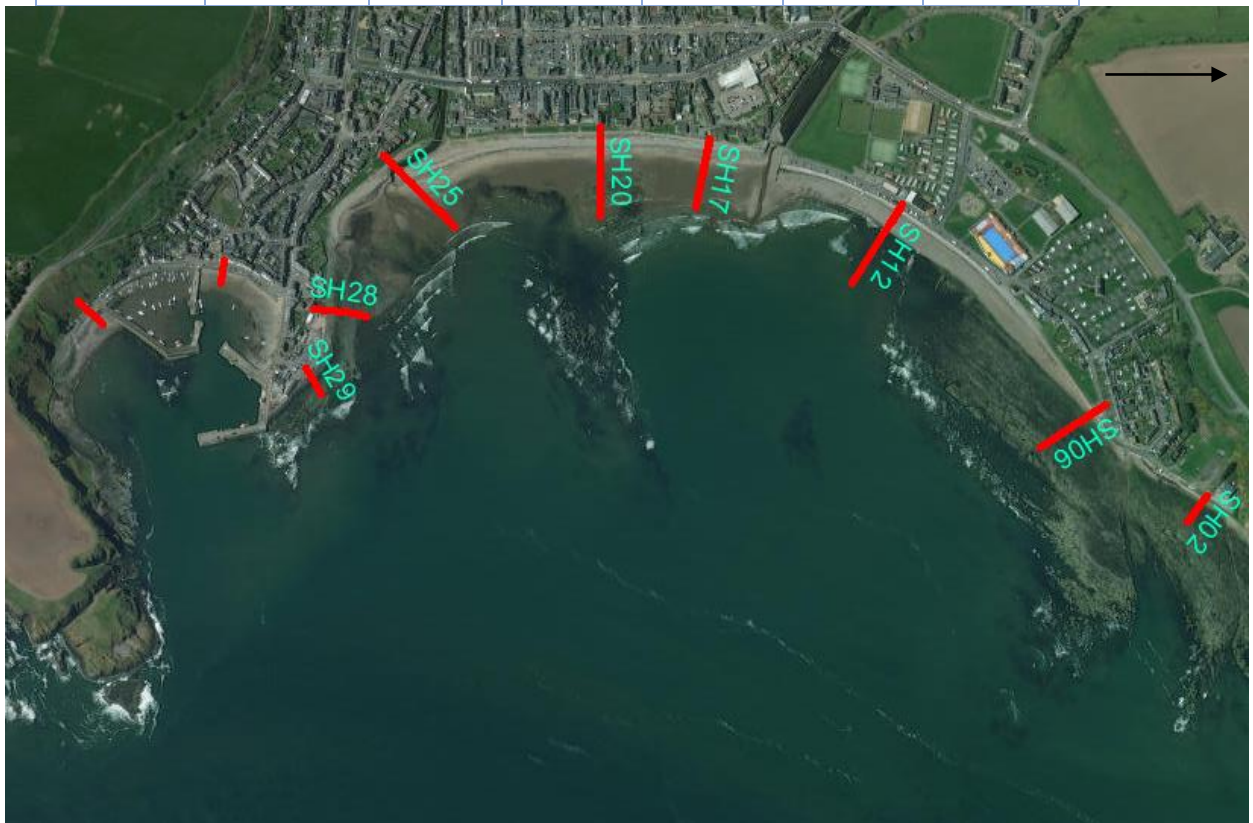
Figure 4-3: Overtopping crossections within Stonehaven Bay

Ten cross-sections were schematised within Stonehaven Bay from Cowie in the north to the harbour at the south, as can be seen in **Error! Reference source not found.** with cross-sections SG_H_01 in the inner harbour and SH_H_02 to the south of the inner harbour. The toe depths were adapted to match SWAN Bathymetry and the appropriate node for extraction identified. These can be seen in Table 4-1 below with the schematisations seen here in the workbook “2018s0343-JBA_EurOtopII_calculation2.xlsx”

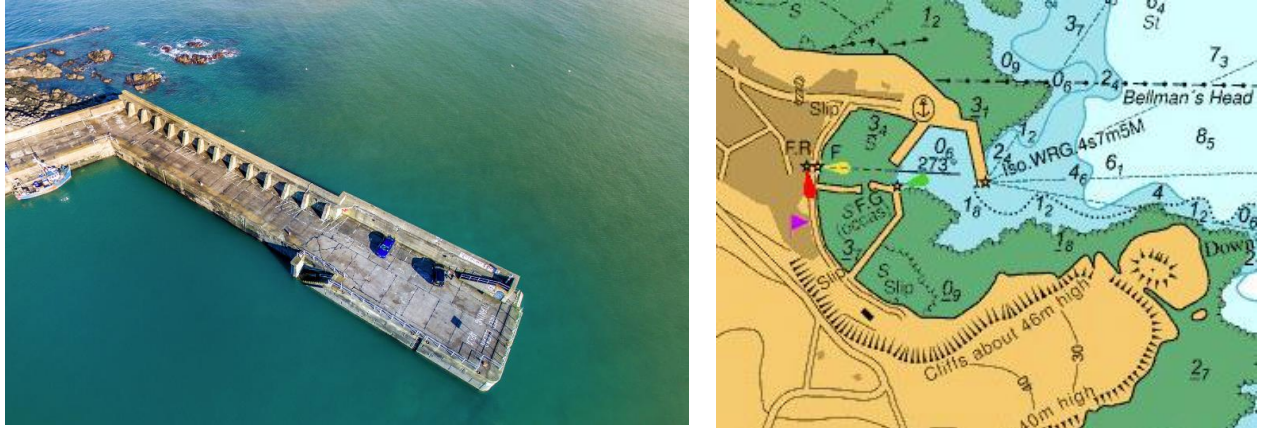
Figure 4-4: Stonehaven Harbour wall and representation within charts

Stonehaven Harbour was included within the mesh with the internal breakwaters removed. It is recognised that the phase averaging computational engine does not resolve well within confined, complex wave environments where non-linear wave processes become dominant. The desired output location within the Harbour can be seen in Figure 4-5 along with the representation of the outer breakwater (represented as a Obstacle Line within Swan and the toe levels represented within the bathymetry). Figure 4-4 shows an aerial view of the harbour wall. Bathymetric features to the northwest can be seen that are included within the model mesh (Figure 4-5). Areas in front of the wall are known to be shallow and is corroborated by oceanwise (but not charts) and so a representation of the shallow water in the vicinity of the primary harbour wall was left in the mesh

Inner harbour walls were not represented within the mesh as these impact the convergence of the model. This is discussed further in section 0.

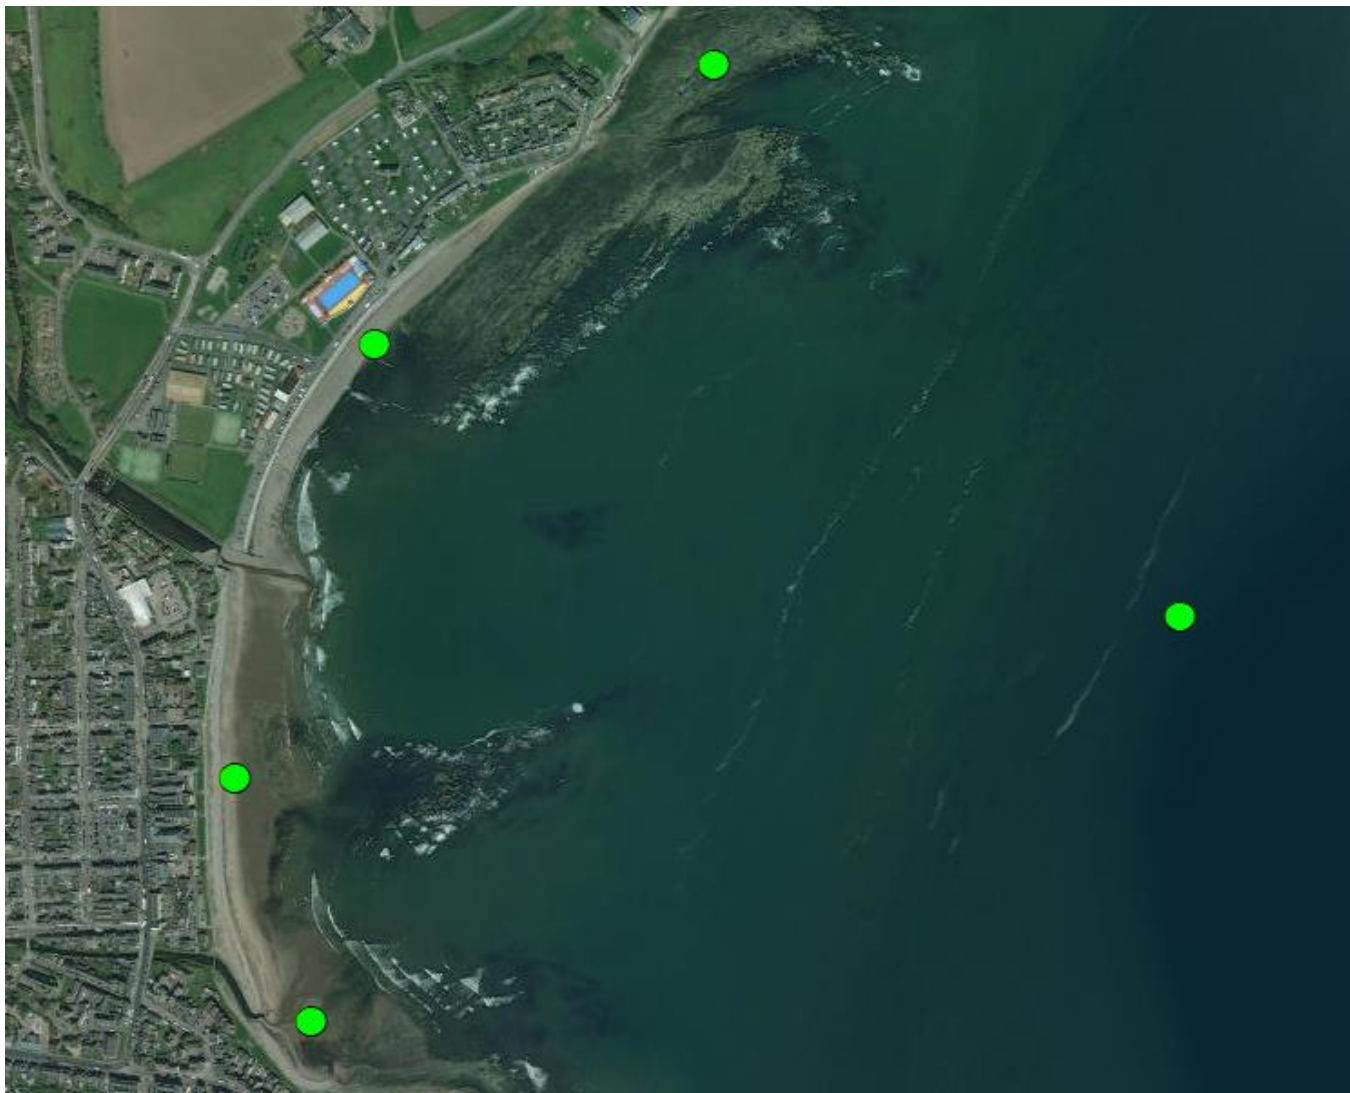
Figure 5-3: Nearshore toes used for analysis in lieu of final toe depths along with the wave buoy location

The impact of wave growth and energy dissipation scheme parameter selection on wave heights was assessed in the nearshore of Stonehaven Bay and Harbour (locations shown in Figure 5-3). As the actual toe extraction points were not available, representative nodes were used in the nearshore. The selection of wave growth and energy dissipation scheme parameter was found to have an impact on modelled H_s , generating an average variance of 0.093m for H_s at the four nearshore locations (with a maximum of 0.35m).

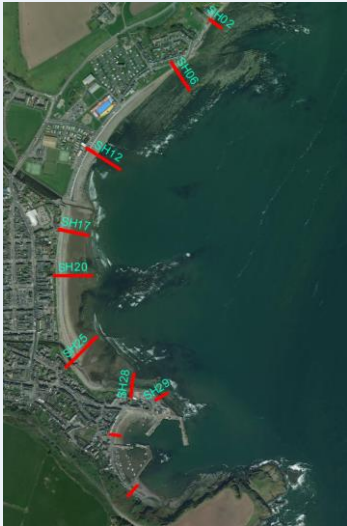
<p>The isolated error identified within Stonehaven bay for run 7 is a highpoint of elevation, associated with “The Brachans” rock formation at -0.4mAOD (visible offshore of SH20 in the image above). This feature, along with the low waterlevel of the run (-0.39mAOD @ Aberdeen) is attributed to causing the longer period wave identified by the reviewer. The model setup is considered an accurate representation of conditions and no changes were made No output points are proposed to be extracted here.</p> <p>Reviewer comments were addressed within the text</p>

<p>Modeller's comments on issues raised by reviewer and how these have been addressed.</p>	<p>Wave results are not being used outwith Stonehaven Bay with the final output location being at Cowie, See below. The errors identified by the reviewer to the north of the bay are localised rock features and considered appropriate. No changes were made</p>

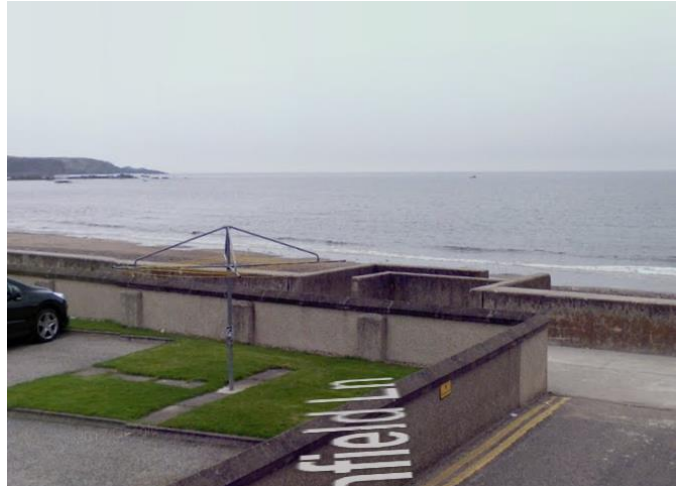
There is a gap in the defence line at the end of Ironfield Lane assumption that this is to allow overtopping discharge rates to flow back to sea where this is a beach access point (see image below) – modeller to confirm that this is correct.

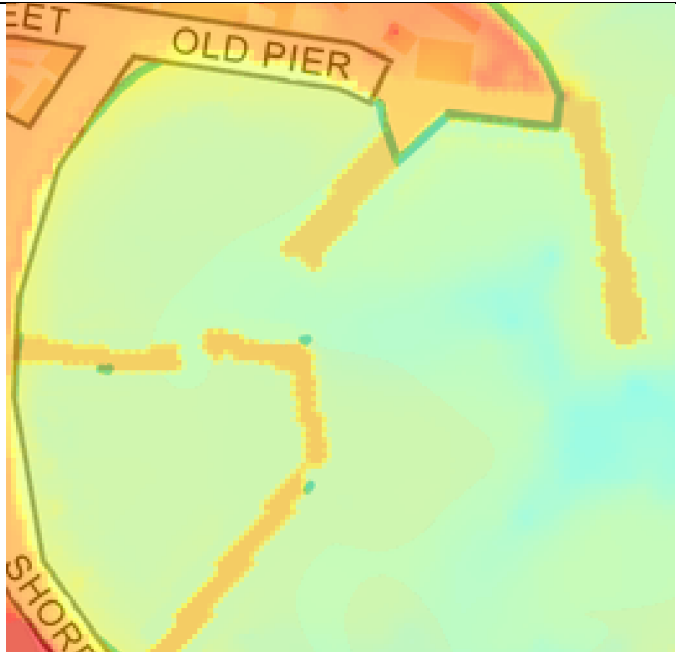
Other than the four harbour walls (see below) no additional breakwaters are present in the model, this is appropriate – from inspecting the LIDAR and satellite imagery no breakwaters exist in reality□ modelling is therefore correct, modeller to confirm reason for comment overleaf (is the modeller just referring to the harbour walls in both comments□).

The harbour walls have been stamped in at a fixed elevation, this is appropriate as the maximum height and full extent are not picked up accurately in either the Terrestrial laser scanned Topography or Phase 2 1m LiDAR – the resulting DEM_Z shows that the harbour walls are 3.3-3.5m high – modeller to confirm where this level has come from.

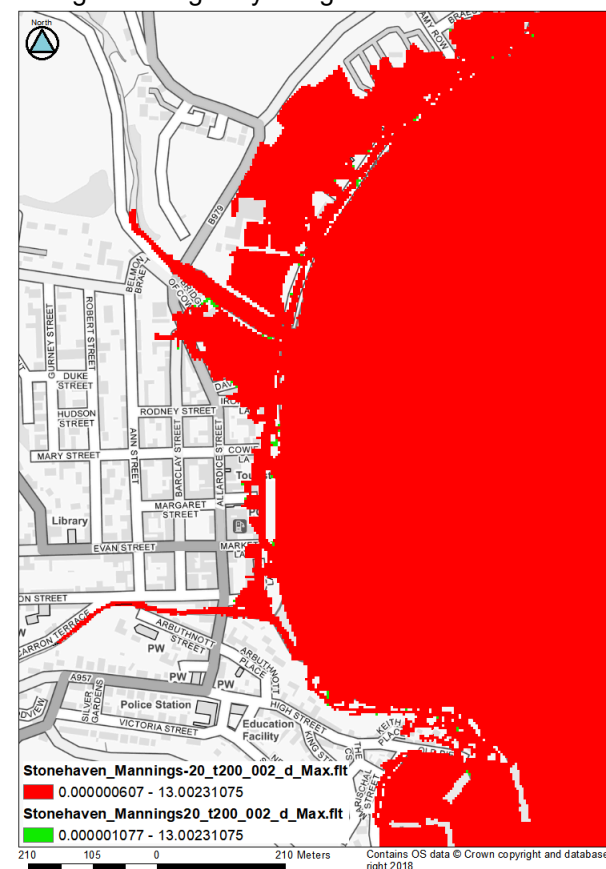
Model roughness was varied for $\pm 20\%$ for the baseline value for the present day 200 year extent. These roughness coefficients had an impact on model extents, with a reduction in Manning's value increasing flood extents and an increase in Manning's eliciting a decline in flood extents. The output extents can be seen below. These outputs illustrate step changes between manning's conditions with a lower manning value having marginally greater flood extents

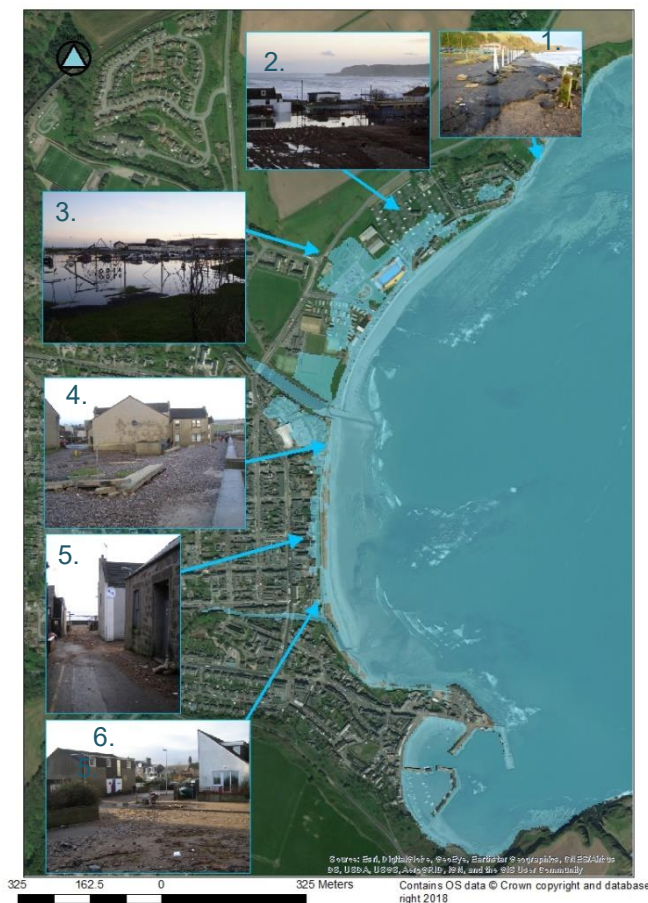
South of the Cowie, the sheltered housing that was evacuated during the event is inundated to an extent similar to that observed during the event.

Along the rest of this frontage, the modelling shows inundation behind the defensive crest which matches post event images of shingle in gardens and along pathways/ roads (images 4,5, and 6).

The inundation modelled at Braeside Crescent was not pictured for the 2012 event but is observed in other similar events (March 2008, November 2010). This coupled with the damage observed in Figure 1 for the December 2012 event is considered appropriate for this area.

From the information available on the extents and depths that occurred during the event, the model can be said to be representing the observed inundation extents and depths.

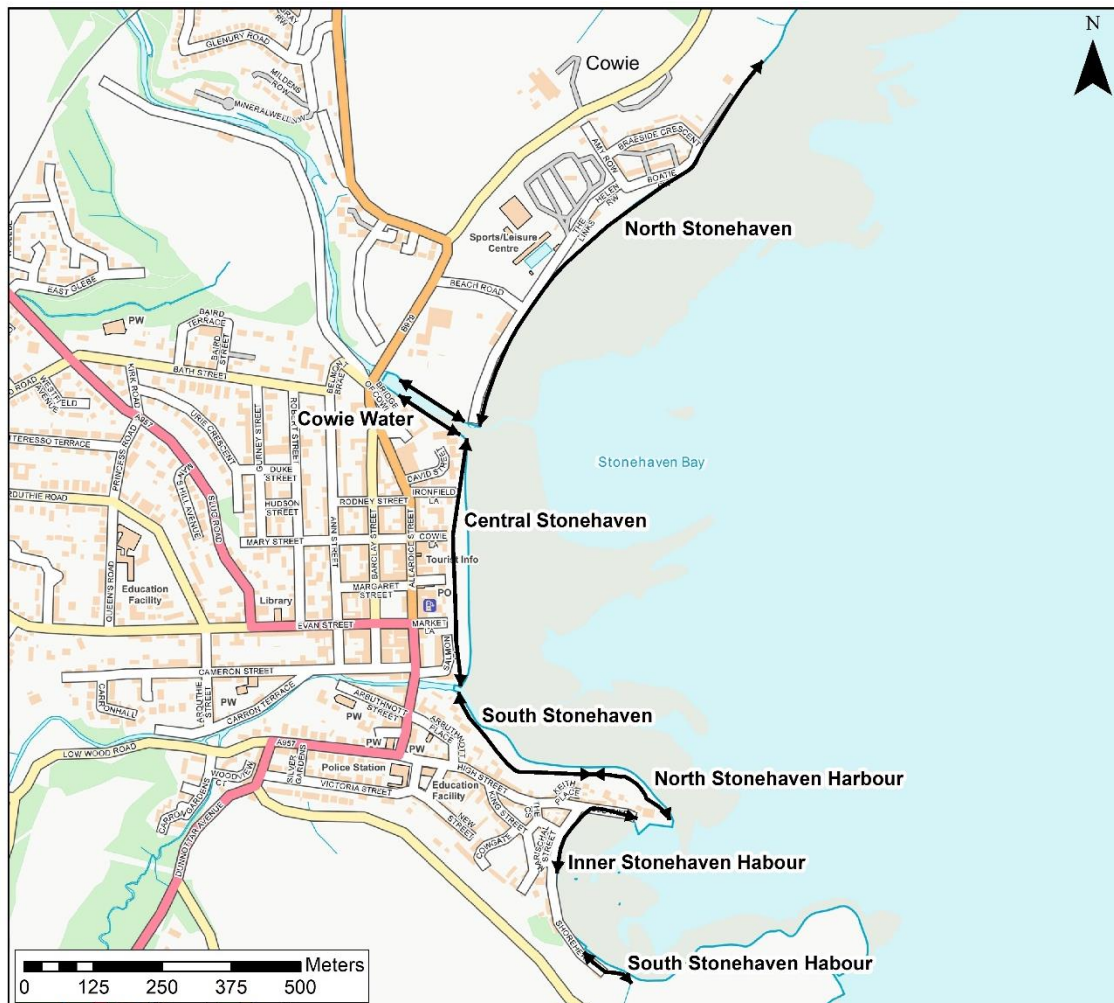
Figure 1-1 Frontages assessed within the Stonehaven Bay FPS

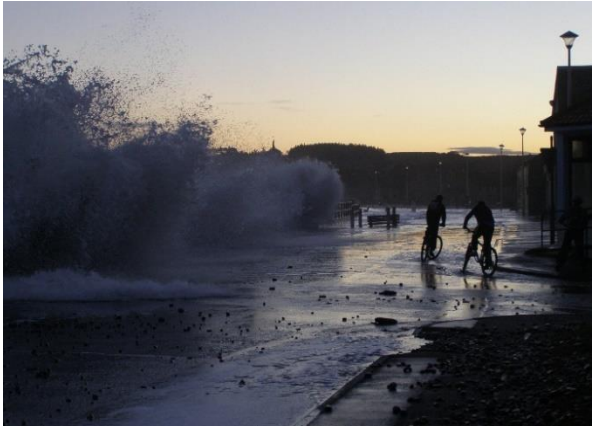
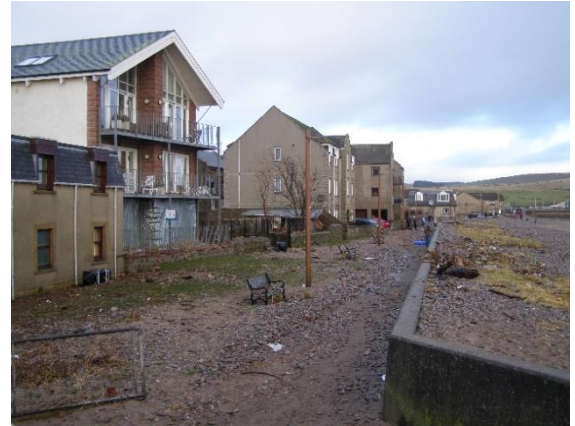
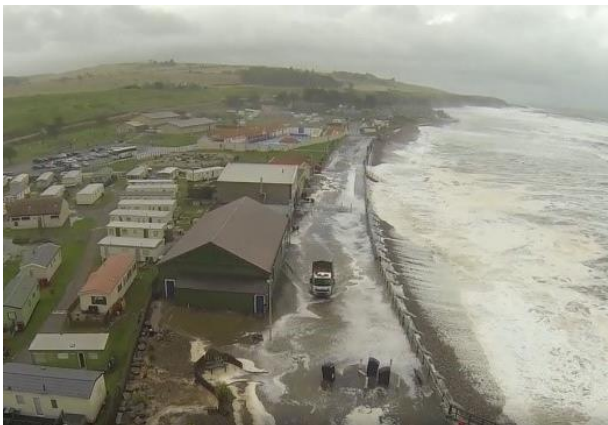
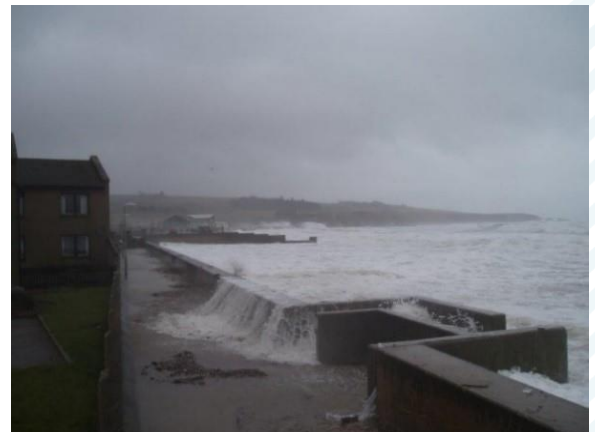
(a) Cowie promenade

(b) Central wall

(c) Cowie promenade

(d) Central wall

Figure 1-1 Observed overtopping and subsequent damage during historical flood events (photographs provided by Aberdeenshire Council)

The 15 December 2012 storm event was the most significant in regard to the resulting flooding, structural damage and risk to life. During this event a total of 69 properties, both residential and commercial, flooded internally. Figure 1-1 (a-d) shows some examples of the impacts caused by historical flood events.

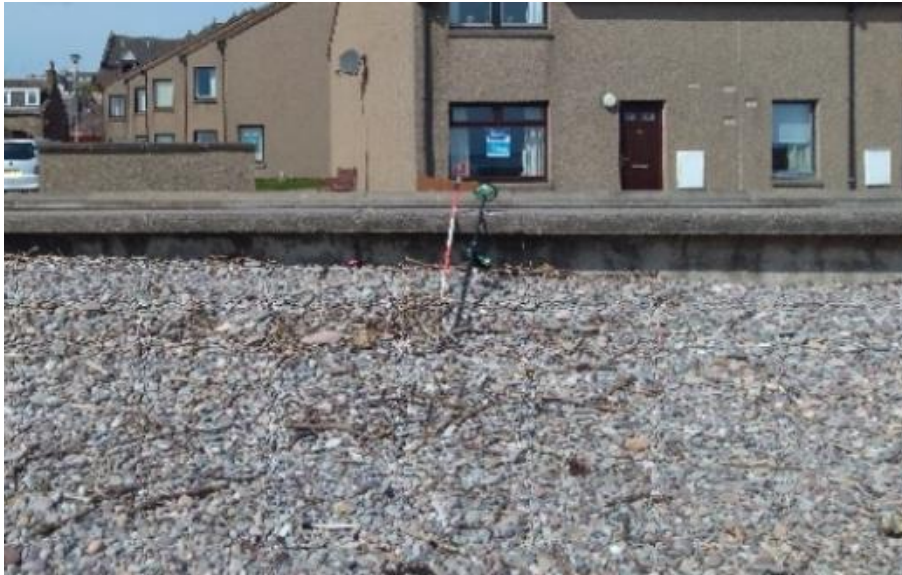
At this stage in the process the grain size distribution of the design beach has yet to be determined. The working assumption for the XBeach-G models is that sediment would have a D_{50} of 20mm; similar to the top of the existing beach.

Figure 6-2: Beach sediment at XS17
